Accident Investigation Report

Fatality Investigation Report

Consolidation Coal Company

Buchanan #1 Mine

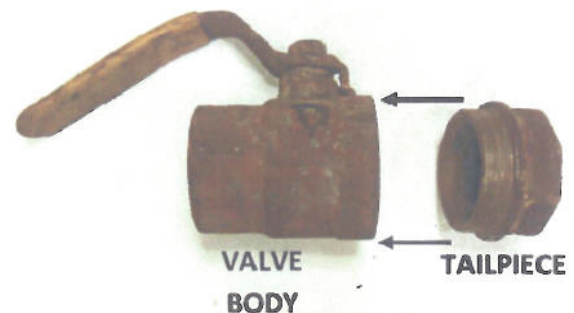
Figure 1

any, would be needed. They found that the impact had separated a threaded coupling on a 1 ½ inch brass cut-off valve (Figure 1). The tailpiece of the valve had been left attached to the steel waterline on the ground. The valve body remained attached to the water manifold that had been installed to provide a connection for the rockdust bin fire suppression system and fire outlet for the beltline. To the men, there were no obvious signs that the valve could not be reconnected so they threaded the manifold back onto the tailpiece of the separated valve. Mr. Greene stated that after he had tightened it by hand, Mr. Saunders

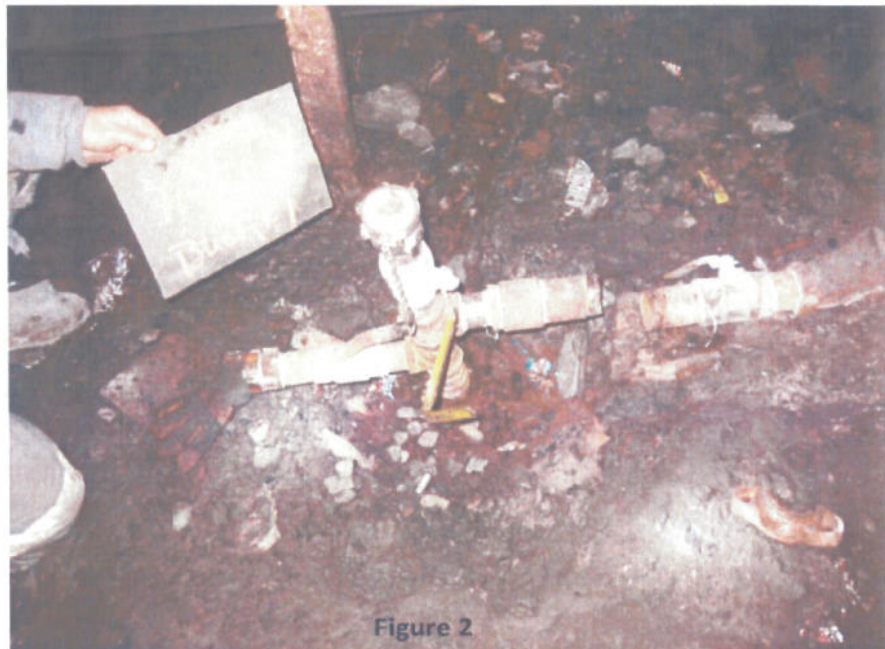
tightened it some more with a 18" pipe wrench. The final connection that needed to be made was for the rockdust bin fire suppression system. Figure 2 shows the assembly after it

has been reinstalled during the investigation. According to witnesses, this is how it looked as Mr. Saunders attempted to make the final connection. As the men were working, a small amount of water continued to flow from the open connection. The men assumed that it was just water draining from the pipe because it had no apparent pressure and once the 1 ½" valve had been reconnected, they closed it to stop the flow. However, this was not the case. The 6" valve on the crossover line at break 62 was not fully closed and bypassing into the line the men were working on and as soon as the 1 ½" valve was closed, pressure began to build.

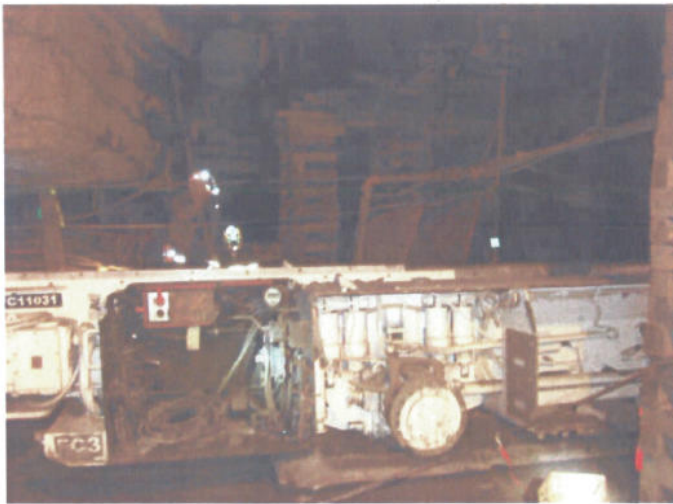
Figure 3

1. Ample clearance was not provided for the Freedom Car to be moved along the belt/track way. As the equipment was being moved, it struck a 1 ½" fire valve located along the travel way. During the investigation the water assembly was reinstalled in the same position it was located before the accident and the Freedom Car (which had not been moved from the scene or moved on its carrier-Figure 3) was pulled through the area in the same manner that it was being transported. Figure 4 shows how the newly installed battery compartment on the Freedom Car contacted the water assembly during the recreation. These findings correlate the statements of tram operator David Greene. He stated that as the car was being pulled through the area, he could only see as far as the wheel unit but once it cleared he thought it would be ok.

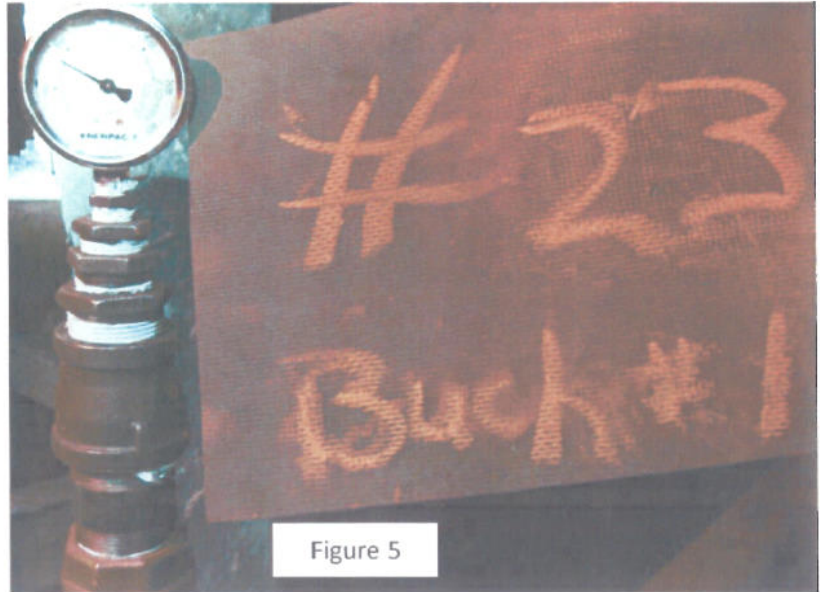
Figure 5

- The water pressure was measured at the accident scene and found to be approximately 850 psi. This measurement was taken the day following the accident with production idled. There were other activities going on in the mine but the measurement taken was basically a static pressure. (Figure 5)

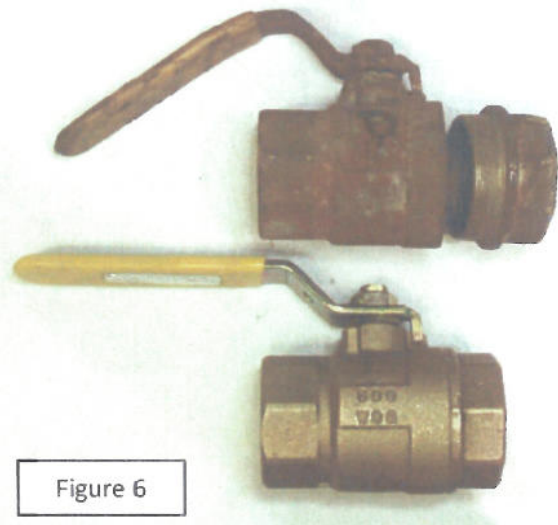
- The valve that was impacted and failed was a 1-1/2 inch bronze ball valve, model BA-100, two-piece, standard port, and was manufactured by Milwaukee Valve Company, Inc. The ball valve had a listed maximum allowable working pressure of 600 psig WOG (Water Oil Gas) and 150 psig SWP (Steam Working Pressure). The ball valve had female NPT (National Pipe Taper) threads on the inlet and outlet of the valve. Figure 6 shows the valve in question and a new valve of the same model from the same manufacturer.

- The 1 ½" brass valve used in the water assembly was not suitable for the pressures that were present in the water system. While the valves are designed and tested to higher pressures, once safety factors are taken into account, the ball valve had a listed maximum allowable working pressure of 600 psi. The water pressure was measured at the accident scene and found to be approximately 850 psi. These valves were in wide use at the Buchanan Mine. Their design specifications above the rated pressure had allowed them to be used for many years. It was the damage to the threads of the coupling that caused the valve to fail. When the Freedom Car impacted the assembly, the threaded pieces were "stripped" apart. This damage was not apparent to the men making the repairs but had weakened the valve to the extent that it was no longer able to contain the pressure. The Milwaukee

Valve Operation Guide states that “repair or replacement of two piece ball valves internal parts is not recommended. Damage can occur to the body and tailpiece during disassembly that would make the valve inoperable.” Such damage is almost guaranteed when the valve is forcefully broken apart. If the damaged valve would have not been repaired and reused the second failure that injured Mr. Saunders likely would not have occurred.

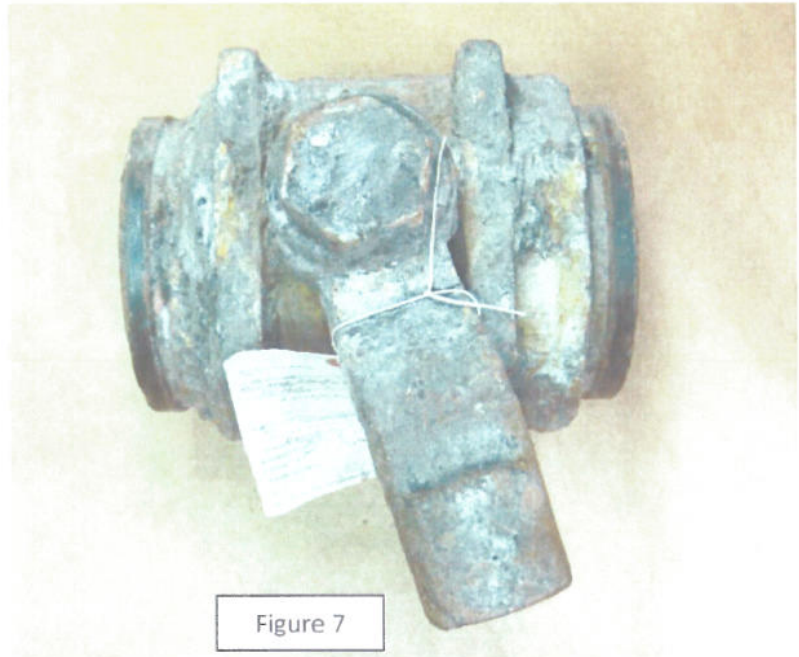
Figure 7

4. The 6" cut-off that was located on the cross over pipe and failed to close properly was a Series 721 six inch ball valve constructed of ductile iron and manufactured by Victaulic (Figure 7).

The valve was designed for 800 psig WOG service with reinforced tetrafluoroethylene (TFE) seats. The valve had an end to end dimension of approximately 10 inches, grooved connections, the outside diameter was approximately 8 inches, and the valve

- The 6” cut-off valve on the crossover pipe was not maintained in a usable and operative condition. The buildup of material on the exterior of the valve prevented the handle from moving to the fully closed position. This allowed a small opening in the valve to pressurize the pipe while Mr. Saunders was working on it. In addition, these repairs were being made adjacent to a running conveyor belt and the noise from the conveyor would have made it very difficult to hear whether or not the valve was bypassing. If this valve had been operating properly, the damaged pieces would not have been pressurized until repairs were completed and everyone was in a safe position.

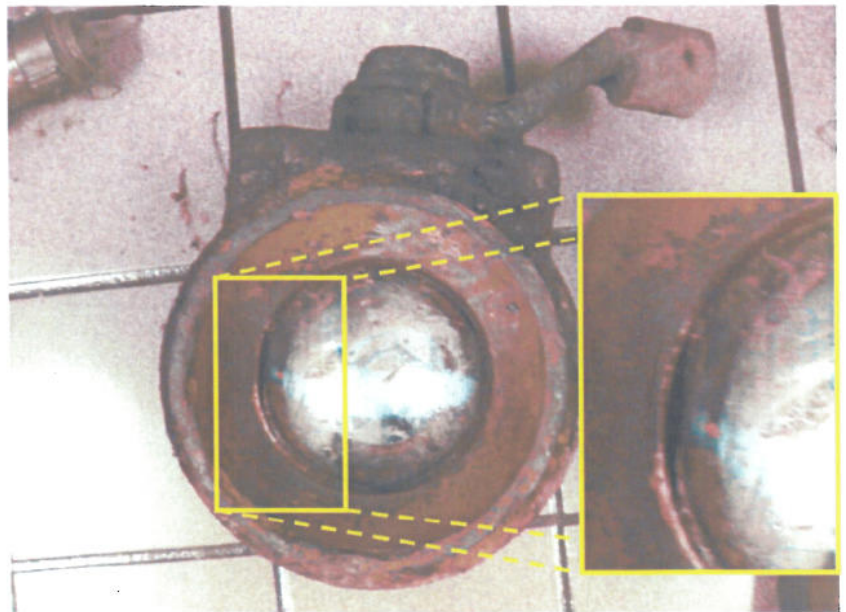
had a manufacturer's listed weight of 75 pounds. There was some foreign material buildup on the fully closed side of the valve stop. The material appeared to be coal dust and rock dust that had adhered to surfaces between the valve stem and valve stop. The valve easily closed to the point where the valve stem contacted the material buildup on the valve stop and would not close further. Figure 8 illustrates the closest approximation of the

opening that investigators believe existed given the amount of material that was preventing the valve from fully closing.
