Virginia Department of Mines, Minerals & Energy
Division of Mines

Accident Investigation Report
Preparation Plant

Pump Explosion Fatality
January 28, 2002

Island Creek Coal Company
VP No. 8
Mine Index No. 08776C
Buchanan County, Virginia

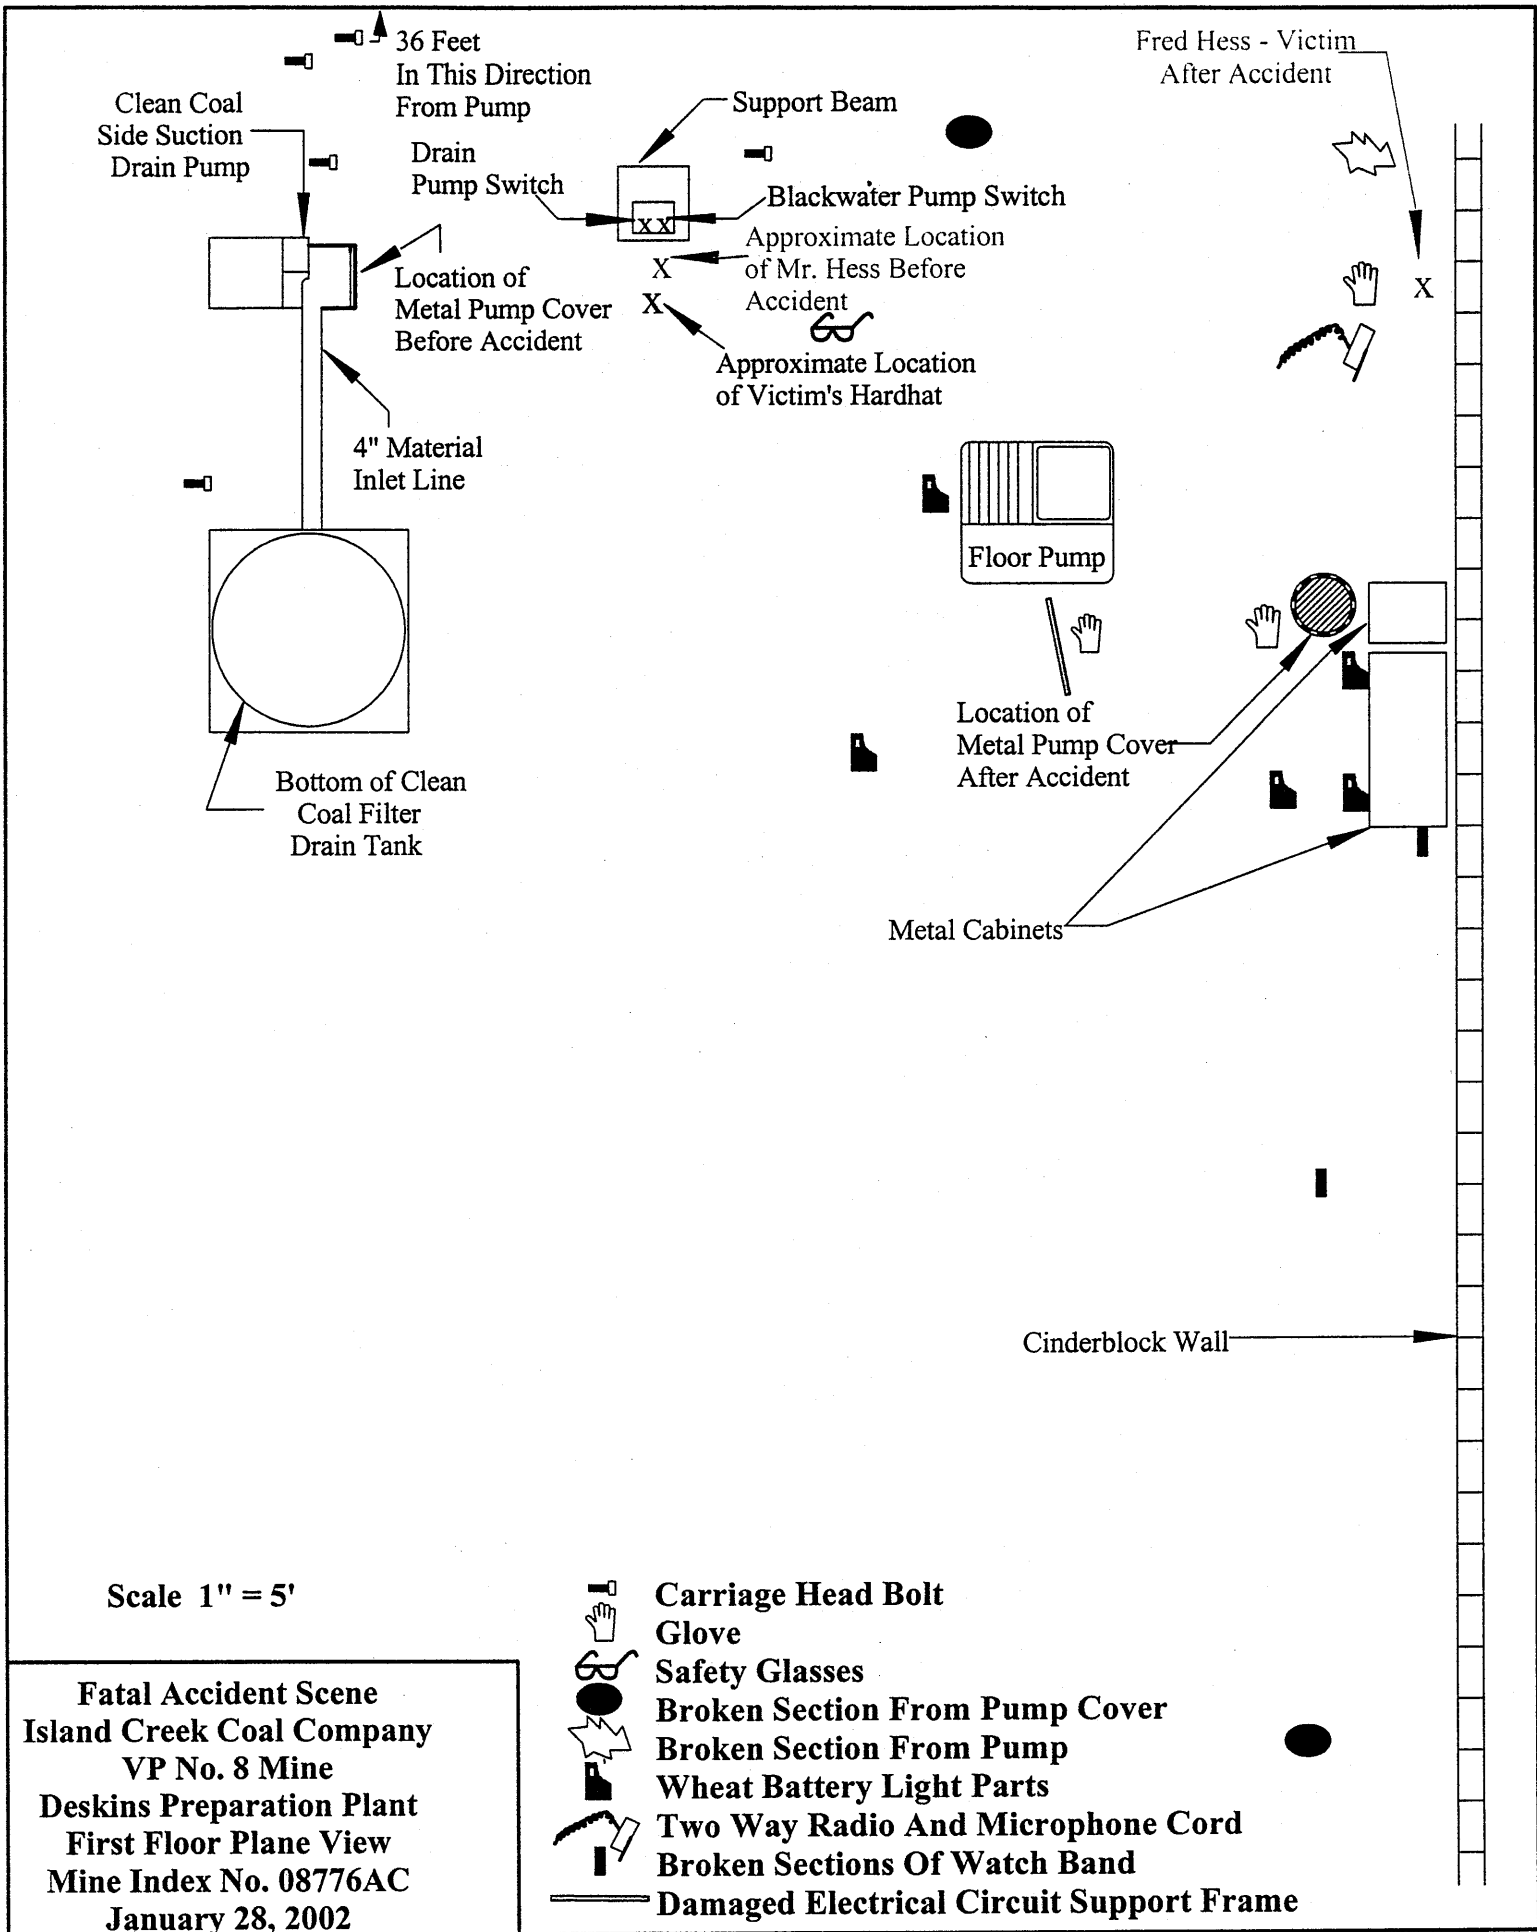
Fatal Accident Scene
Island Creek Coal Company
VP No. 8 Mine
Deskins Preparation Plant
Fine Coal Circuit
Mine Index No. 08776AC
January 28, 2002

1. The pump explosion accident occurred on Monday, January 28, 2002, at approximately 8:30 p.m. at the VP No. 8 Deskins Preparation Plant, near the control switch used to energize and de-energize the clean coal side suction drain pump.

3. The control switch used to energize and de-energize the drain pump was located approximately eight feet from the side and directly in line with the pump cover.

5. Five carriage head bolts used to secure the pump cover to the drain pump frame were observed on the plant floor at distances of three, four, six, eleven and thirty-six feet from the pump.

7. The drain pump cover measured 19.75 inches in diameter and was observed lying approximately 25 feet from the pump on the plant floor near a cinderblock wall.

8. Sections of metal that had broken from the drain pump cover were observed at the following locations: a section was found approximately forty-five feet and eleven inches from the pump near a side entrance doorway to the plant and a section was found approximately sixteen feet and five inches from the pump.

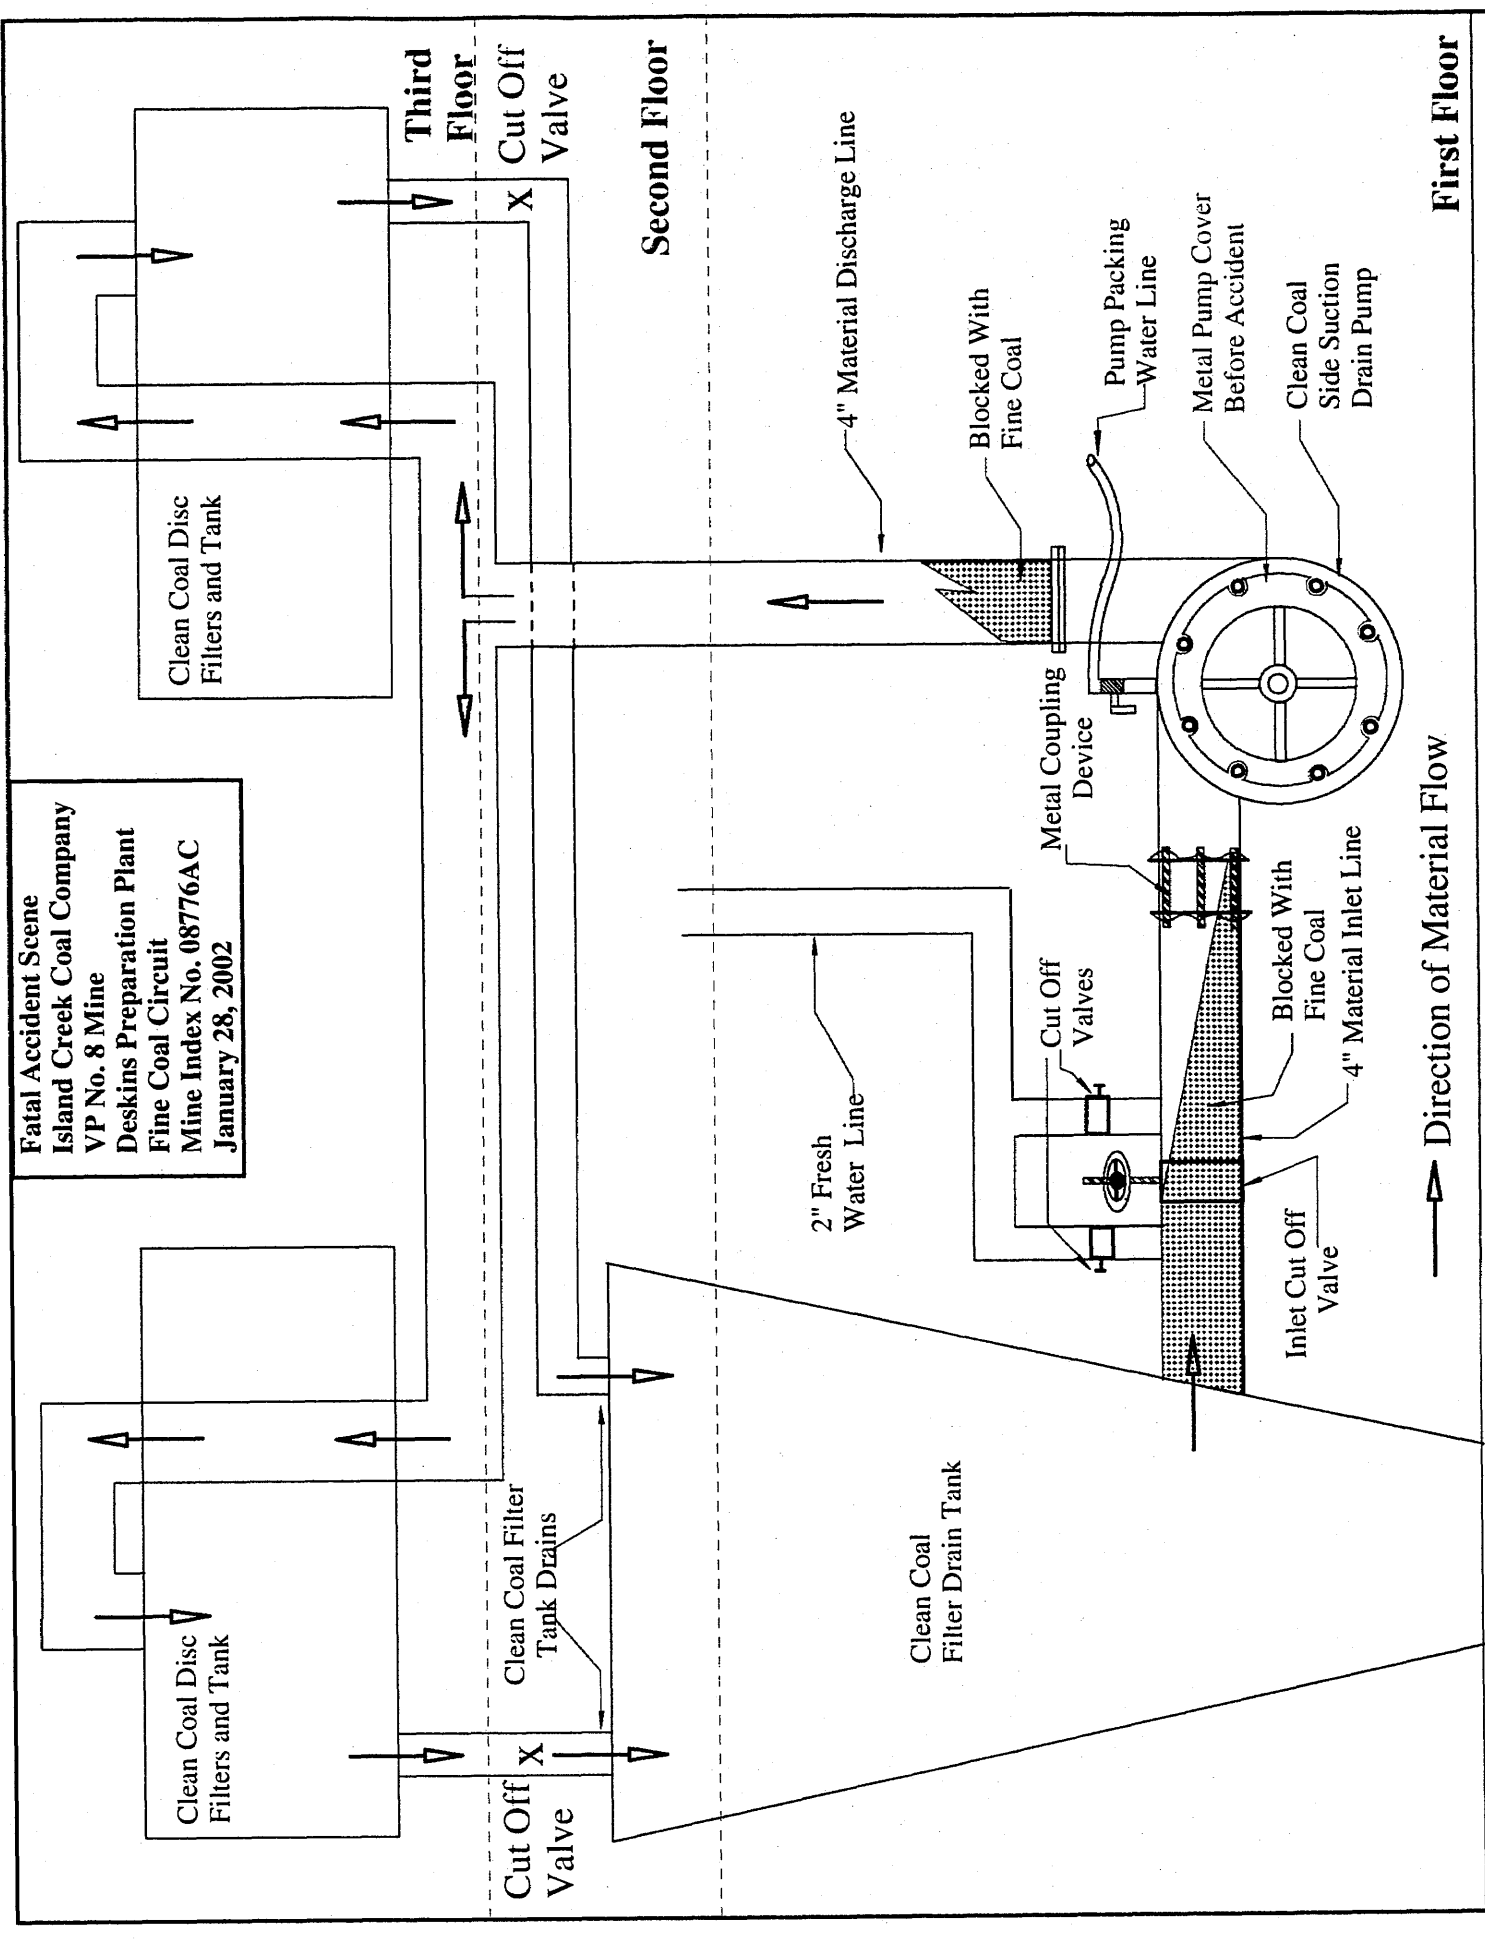
9. This drain pump is used to pump water slurry/fine coal (1/2 mm or less in size) from the clean coal filter drain tank, located on the first floor of the plant, to the clean coal disc filter tanks, which are located on the third floor of the plant. The clean coal disc filter tanks must be drained during each plant shut down and then must be refilled during the next plant start-up.
