Non-Injury Accident Investigation Report
Underground Coal Mine

Methane Ignition / Explosion Accident

June 17, 2015

Mill Branch Coal Corp.
Dorchester Mine
Mine Index No. 14698AB

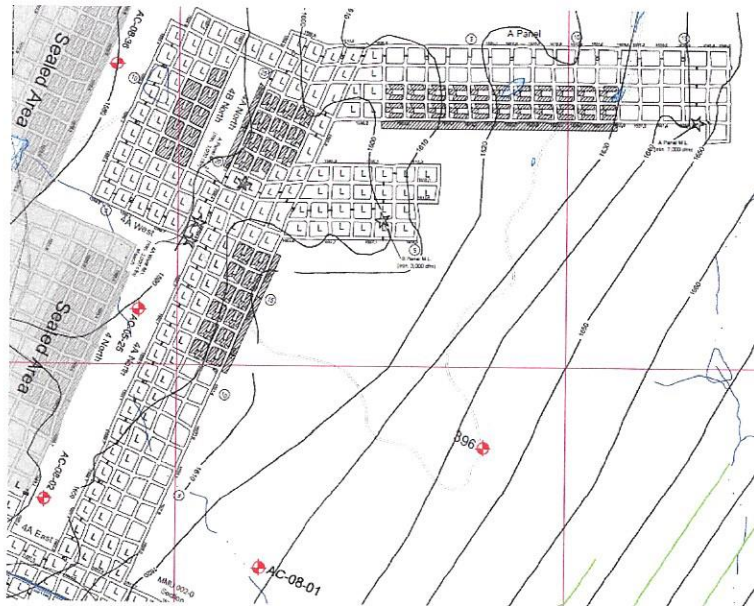
As shown in this map, the limited number of pillars extracted during retreat mining operations resulted in the extent of gob area being relatively small. The section of retreat mining on the 4A North panel started at crosscut No. 17, and mining had progressed outby to crosscut 11. Six lines of pillars and solid wall cuts had been mined on the 002 section prior to the accident. Providing and controlling adequate ventilation during retreat mining operations is difficult where excessive mining heights exists together with roof caving, which could occur as much as 20 feet above the 12+ feet high coal. Managing effective air flow through the gob is even more of a challenge when forced air ventilation is used.

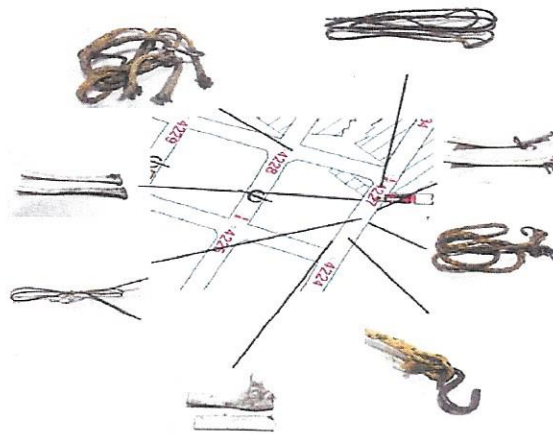
Items collected with their location depicted on the 002 section underlay map

Various items that had been exposed to heat were observed in the Nos. 4 and 5 entries outby the location of the MRS units and continuous mining machine on the 002 section.

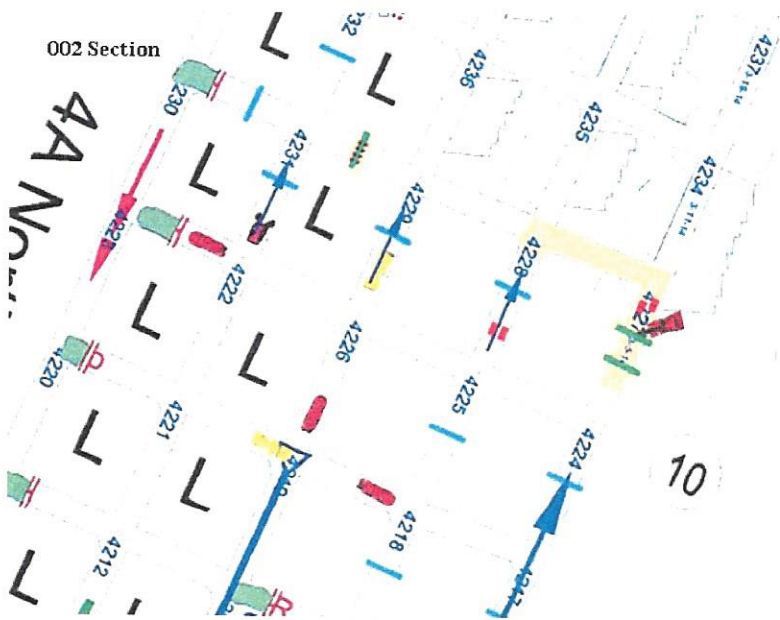
The highlighted area showed evidence of heat exposure extending from the location of the continuous mining machine depicted in the inby connecting crosscut between Nos. 4 and 5 entries and outby the location of the continuous mining machine in the No. 5 entry.

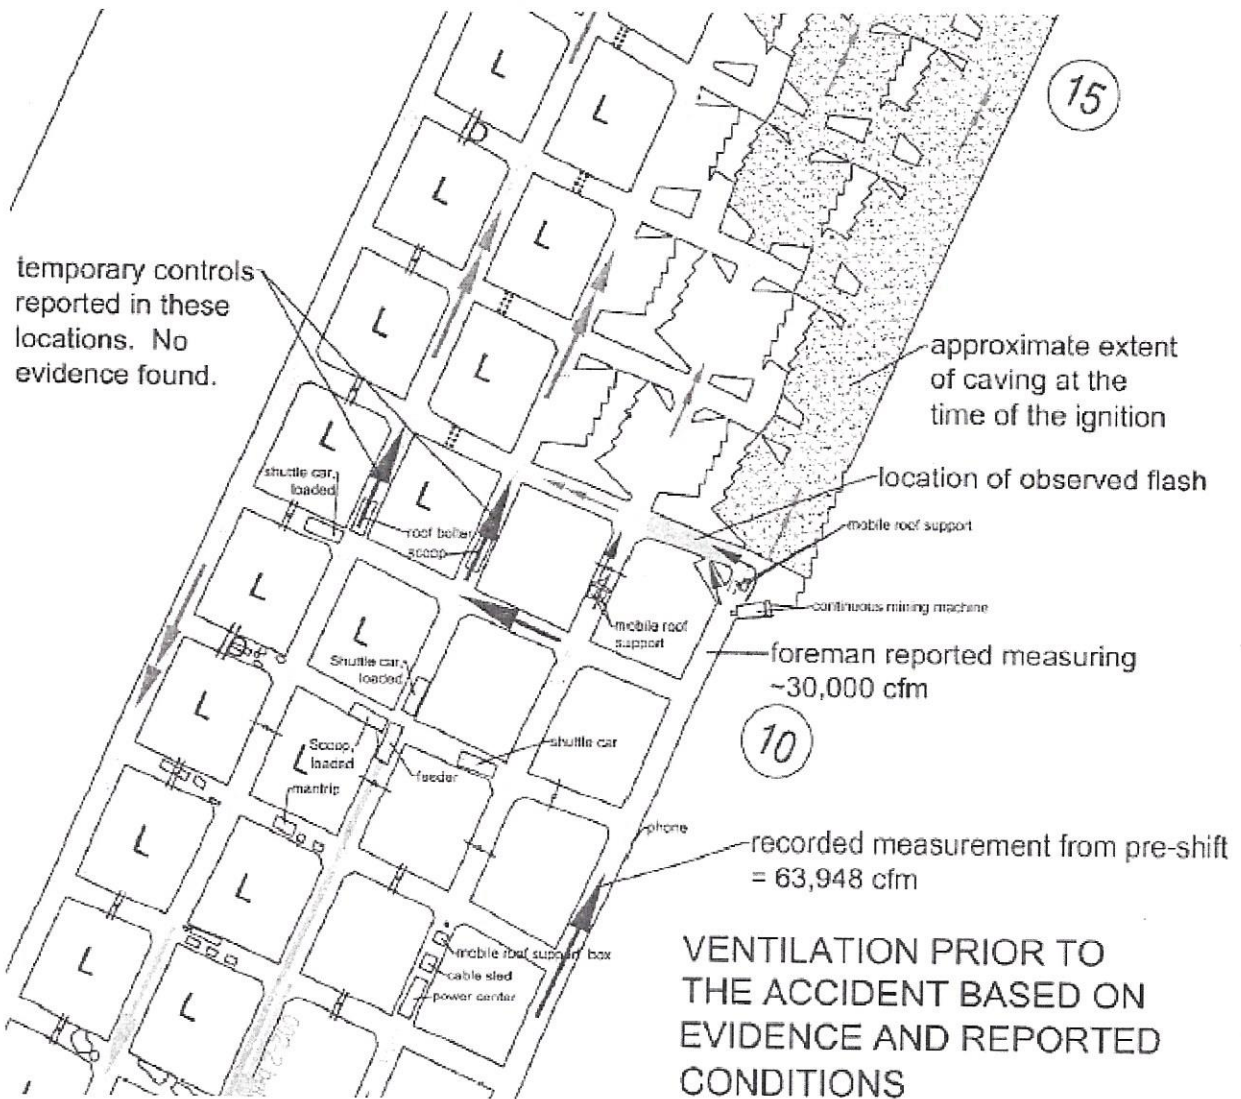
VENTILATION PRIOR TO THE ACCIDENT BASED ON EVIDENCE AND REPORTED CONDITIONS

The above illustration depicts 002 section face ventilation controls according to evidence, testimony, the location of the observed flash, and the approximate extend of caving in the No. 5 entry at the time of the ignition and subsequent explosion on June 17, 2015. A check curtain was found in the No. 4 entry blown against the MRS units. No evidence was found to indicate check curtains were installed in the Nos. 2 and 3 entries as indicated in Chandler’s testimony. If the check curtains were not installed in the Nos. 2 and 3 entries, a short circuit of airflow would have existed, which would have greatly reduced the air available for dilution of methane in the No. 5 entry working place. The mine records indicated 63,948 cfm was measured at the intake end of the pillar line during Chandler’s preshift examination of the 002 section for the oncoming shift conducted earlier in the shift prior to the explosion. The measurement was taken between crosscut Nos. 8 and 9. The measurement should have been taken between crosscut Nos. 9 and 10 in the intake entry furthest from the return air course immediately outby the first open crosscut

It is plausible that the gob area inby the MRS units in the No. 5 entry working place and particularly along the solid rib where mining had taken place was not well ventilated allowing explosive mixtures to accumulate. An ignition at the continuous mining machine could have propagated into the gob area inby the MRS units. It is possible, however, unlikely, that an accumulation of explosive mixtures in the pillared gob area was ignited by a roof fall given the minor amount of roof that fell immediately before the ignition occurred according to mine personnel.

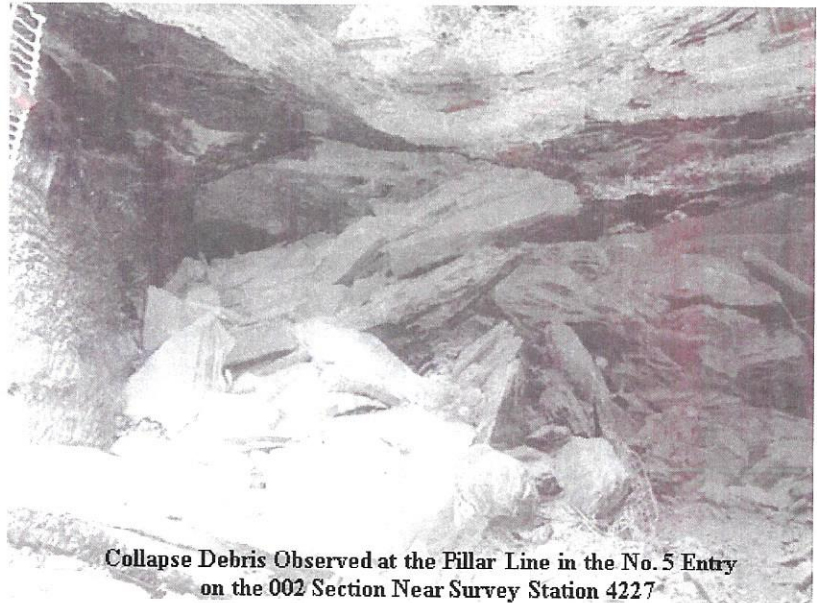
**Collapse Debris Observed at the Pillar Line in the No. 5 Entry
on the 002 Section Near Survey Station 4227**

8. A pillar fall in the gob area was observed inby the location of the two MRS units in the No. 5 entry working place. There was no pillar fall observed in the crosscut connecting the Nos. 4 and 5 entries located inby the location of the continuous mining machine. No significant pillar fall had occurred in the gob area of the No. 4 entry for three crosscuts inby and in the No. 3 entry for four crosscuts inby.

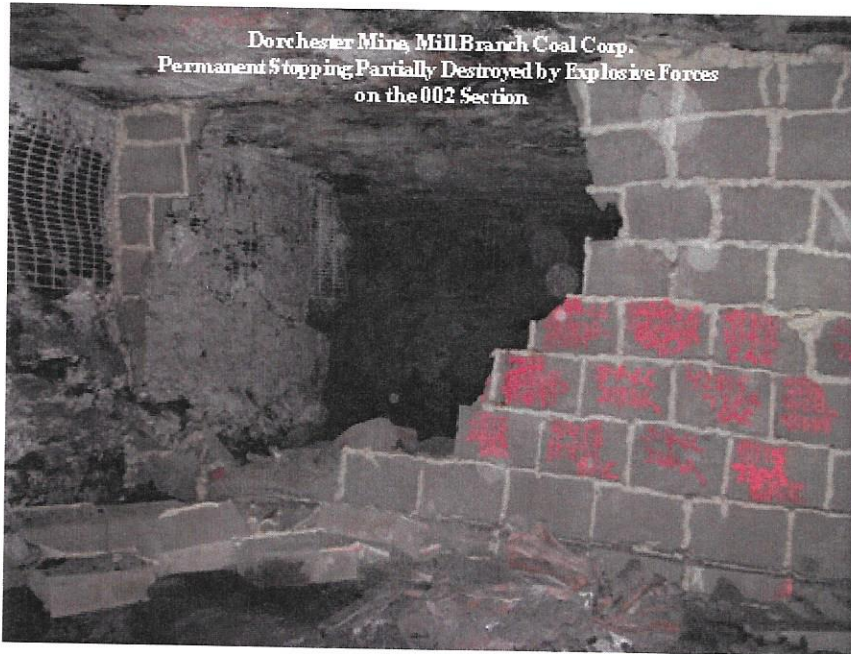
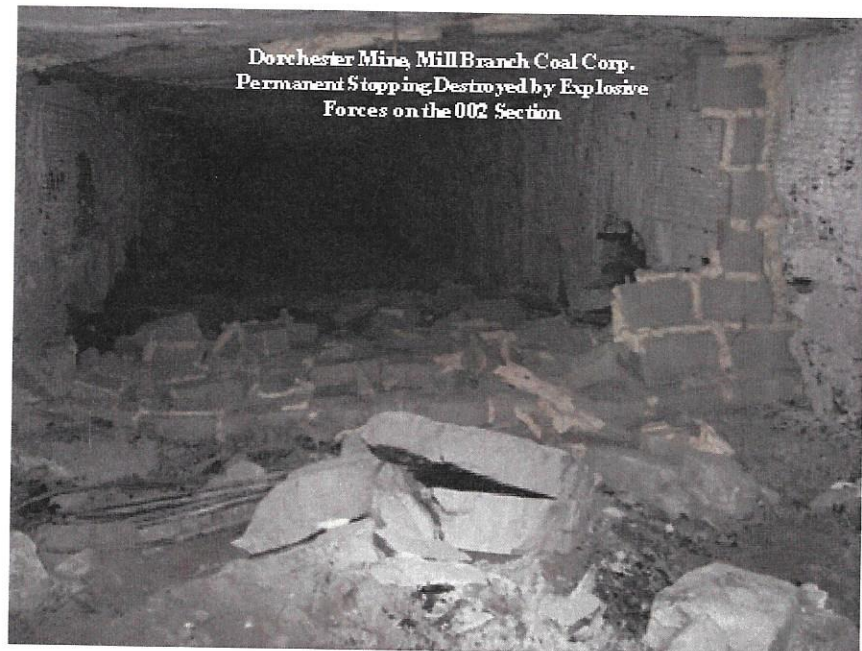
Appendix D

11. Most of the permanent stoppings on the 002 section were either damaged or destroyed starting outby in the 4A North Mains at survey station 3060 and extending through the 4A East area and extending inby on the 4A North section to survey station 4287. Fifty five (55) permanent stoppings were damaged or destroyed by the explosion (See Appendix D).
