INVESTIGATION REPORT
UNDERGROUND COAL MINE EXPLOSION

McClure No. 1 Mine

CLINCHFIELD COAL COMPANY

June 21, 1983

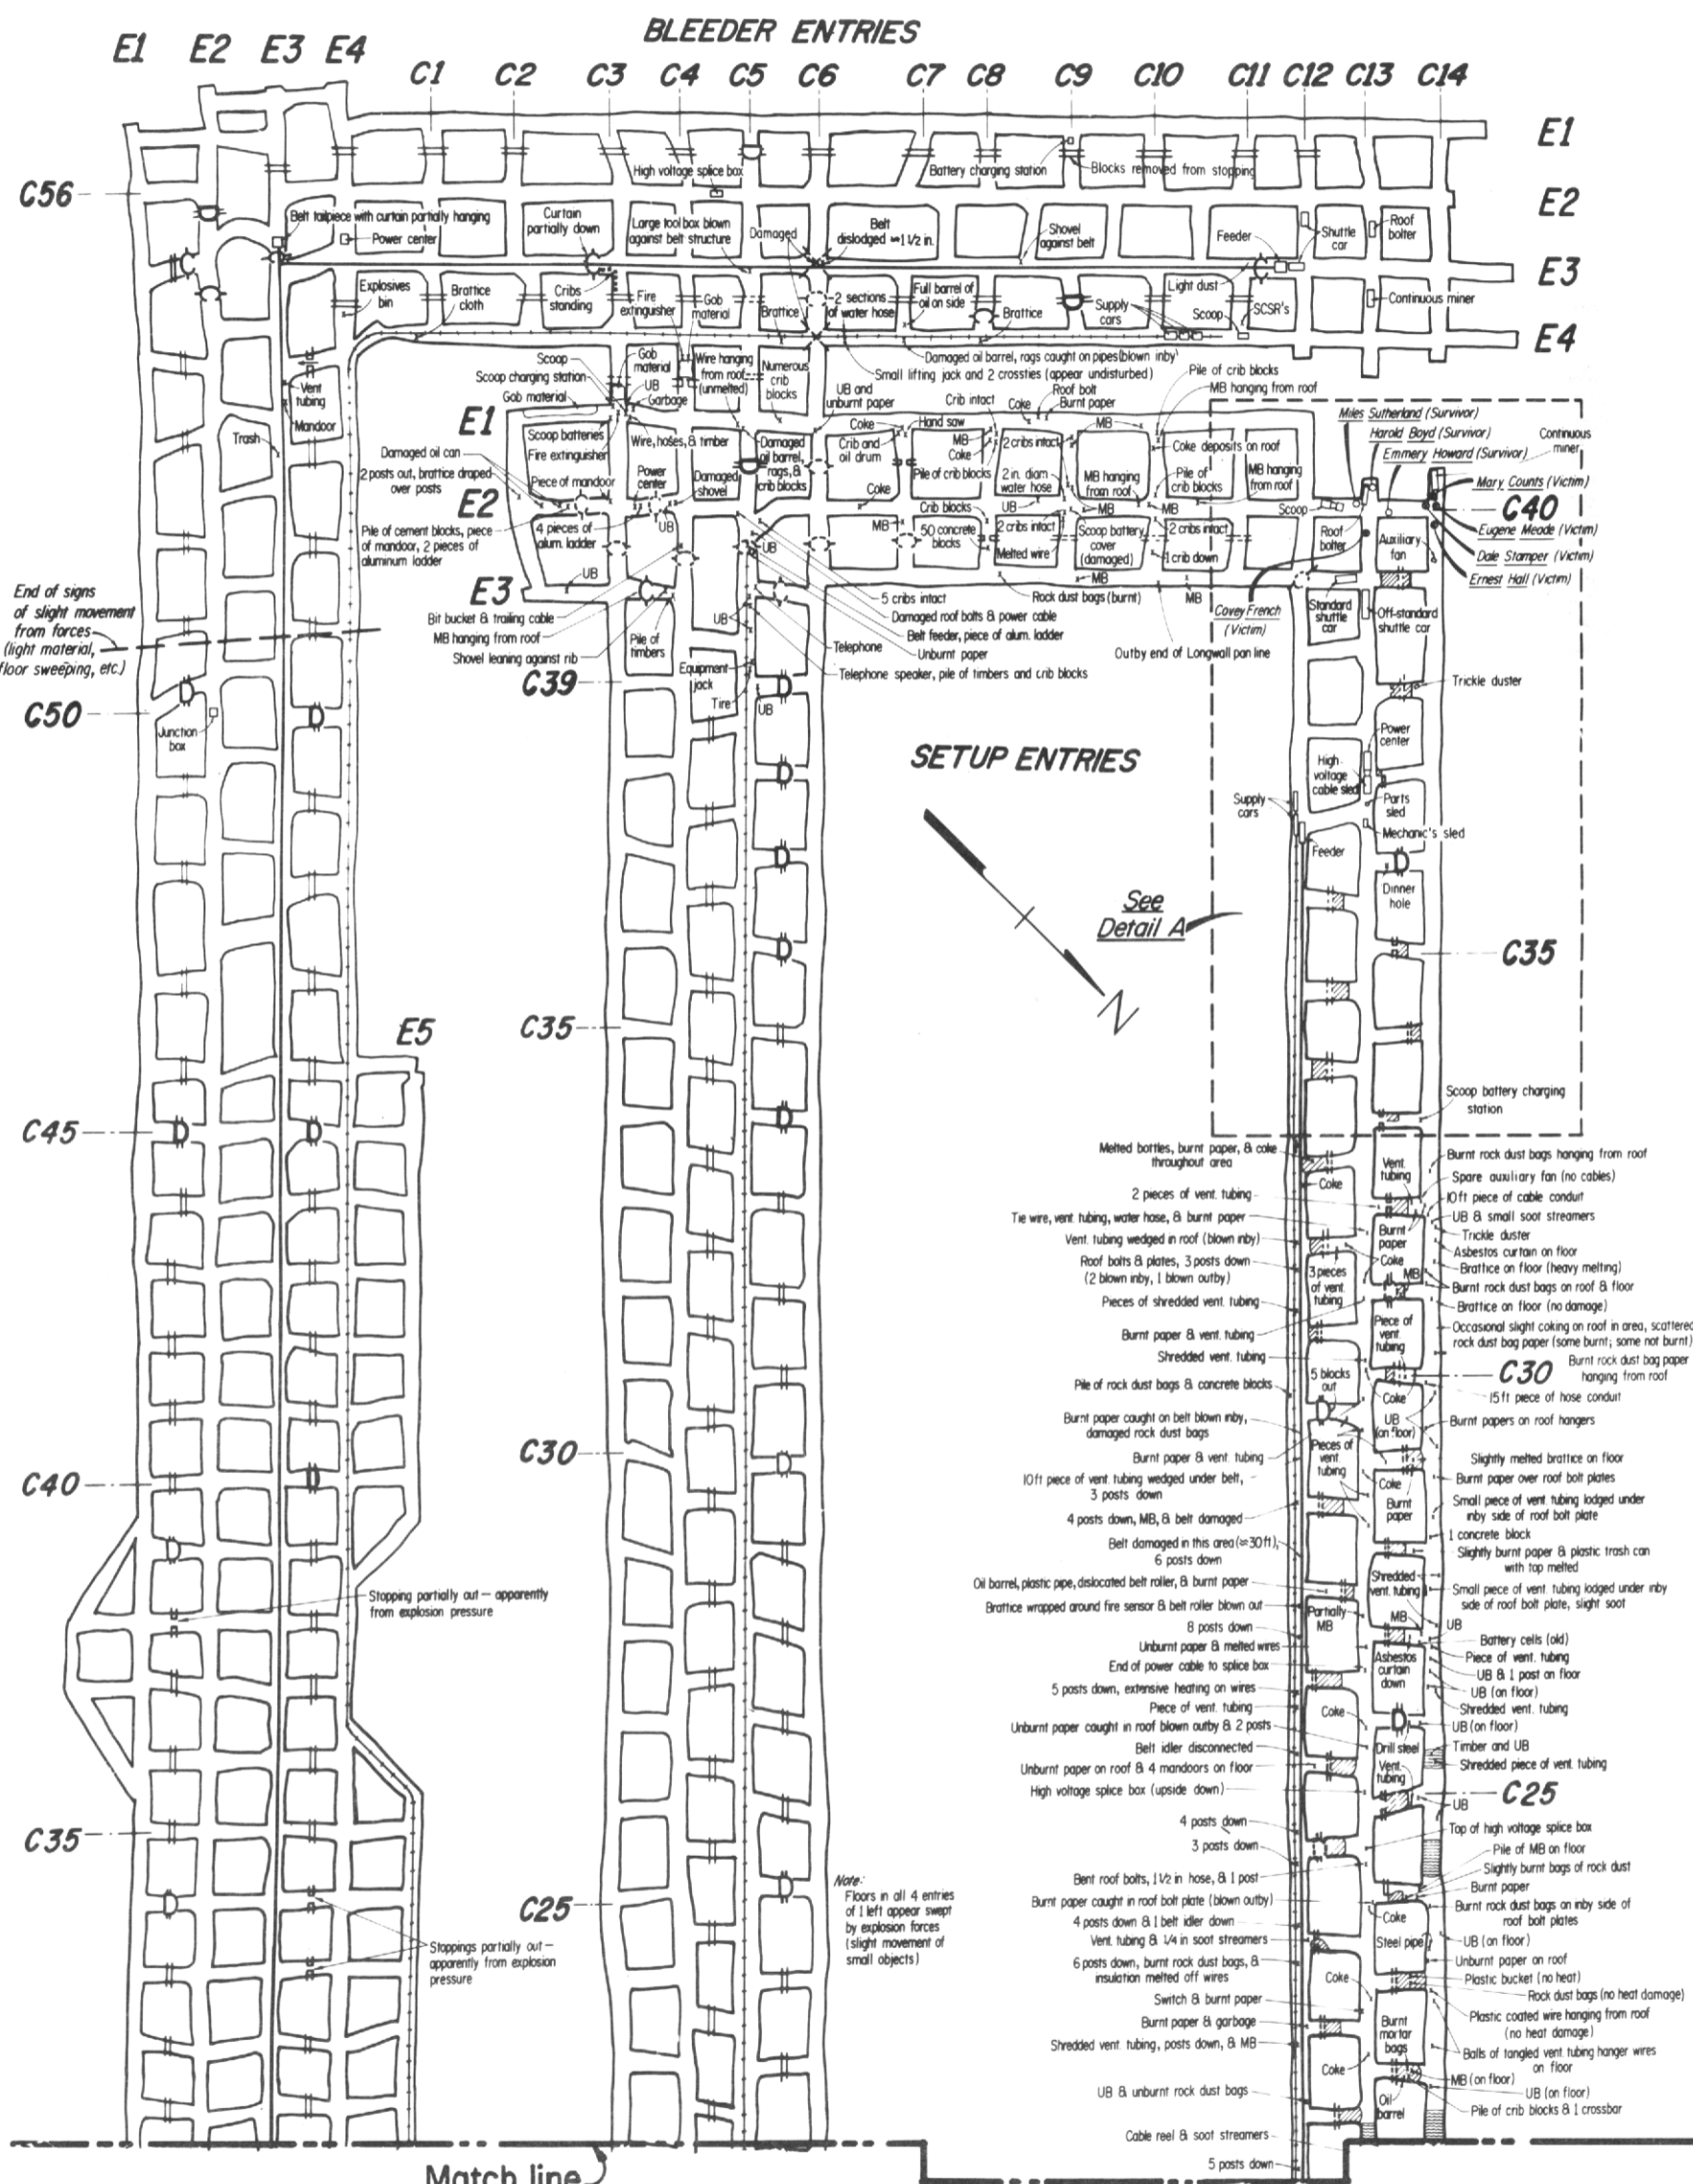
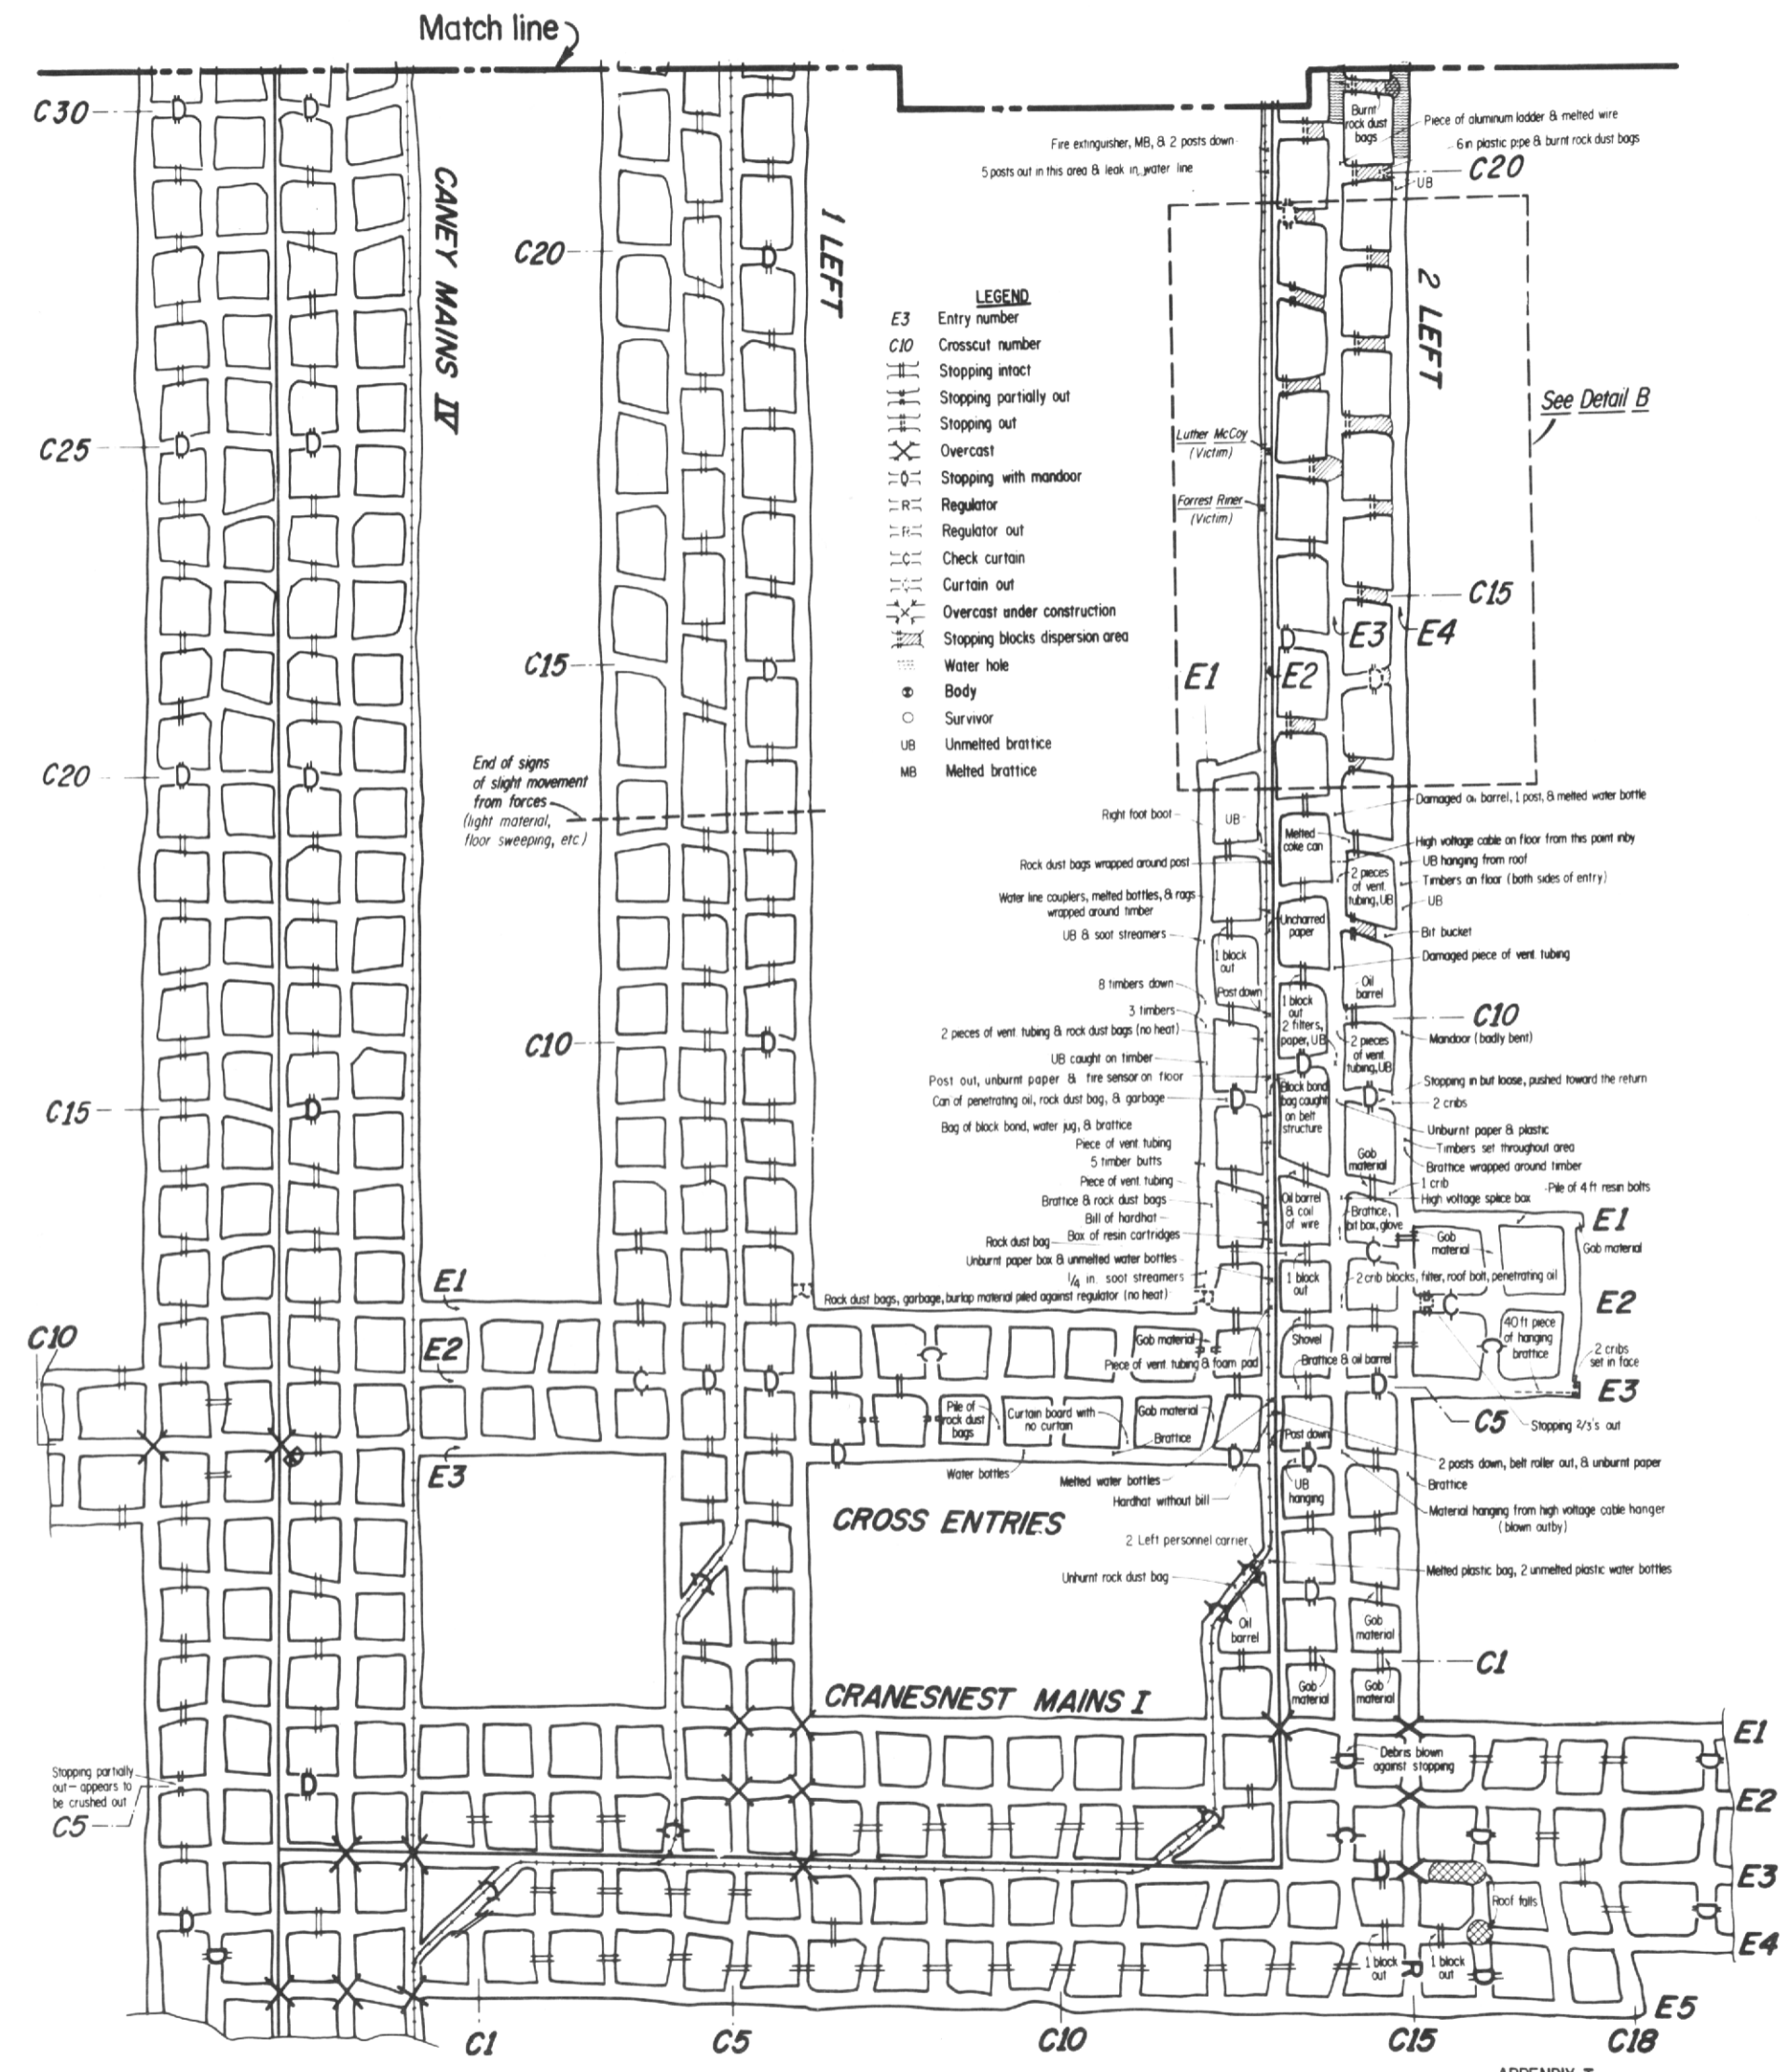
Map showing direction and extent of major forces, extent of flame, airflow directions and air quantities after explosion.

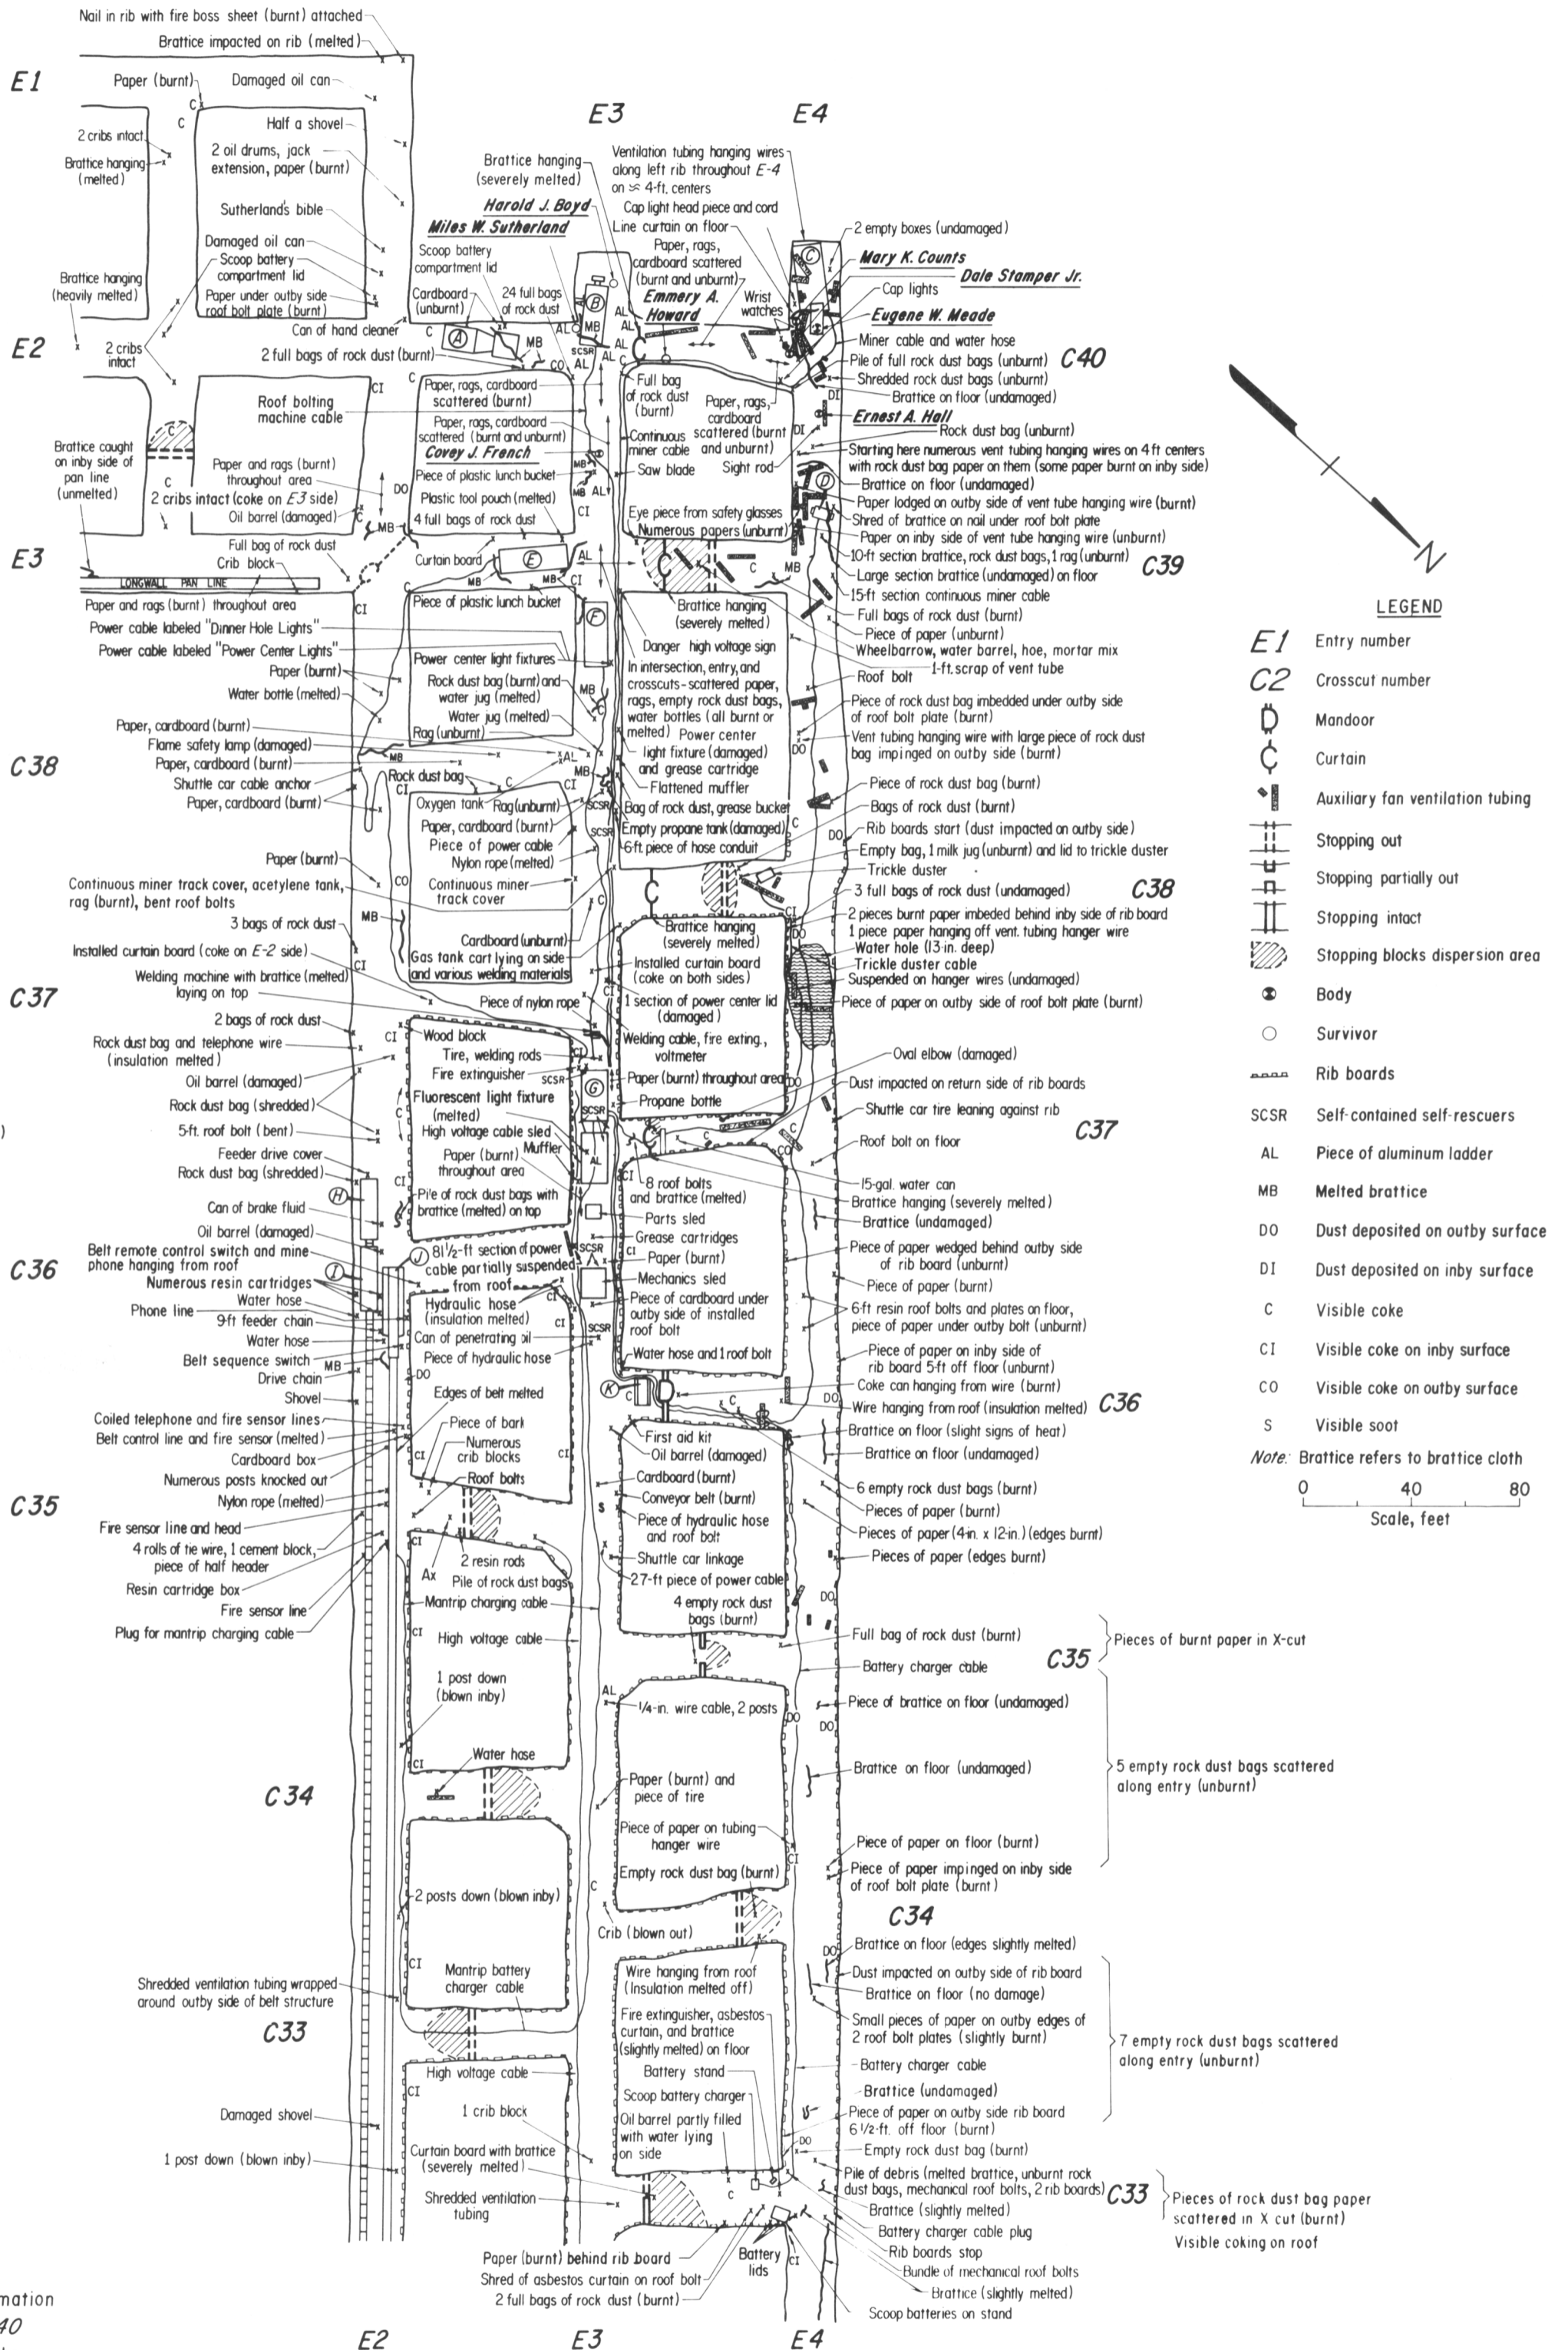
APPENDIX U

- ④ Scoop
 - Brattice (melted) in bucket and extends over hydraulic ram.
 - Paper (burnt) behind left front headlight.
 - On top
 Hand held drill
 Rock dust bag (burnt)
 Plastic rope (melted)
 Bundle of roof bolts
 Seat cushion (melted)
 - Lids from battery and motor compartment off

- ③ Continuous miner
 - On top of miner
 Numerous empty rock dust bags (undamaged)
 2 hemp pull ropes (undamaged)
 1 hammer
 3 full water bottles (undamaged)
 2 cans of spray lubricant
 1 sledge hammer
 1 ventilation tubing tee
 1 bit wrench
 2 10-ft sections of ventilation tubing
 - On floor around miner
 Numerous pieces of paper (undamaged)
 Numerous 10-ft sections of ventilation tubing (damaged and undamaged)
 Numerous pieces of various lengths of ventilation tubing (damaged and undamaged)

- ⑥ Power center
 - Inby cover blown off
 - Outby window broken

- ⑦ Dinner hole
 - Picnic table
 - Fluorescent light fixture, one end on table, one end hanging (damaged)
 - Garbage box
 - Several stopping blocks
 - Brattice hanging (melted)
 - Brattice on floor (melted)
 - Lunch pails on floor around table
 - Visible coke on roof

Mine map (Detail A) showing detailed information of 2 Left section between crosscuts 33 and 40 and the longwall setup entries gathered by the investigation team

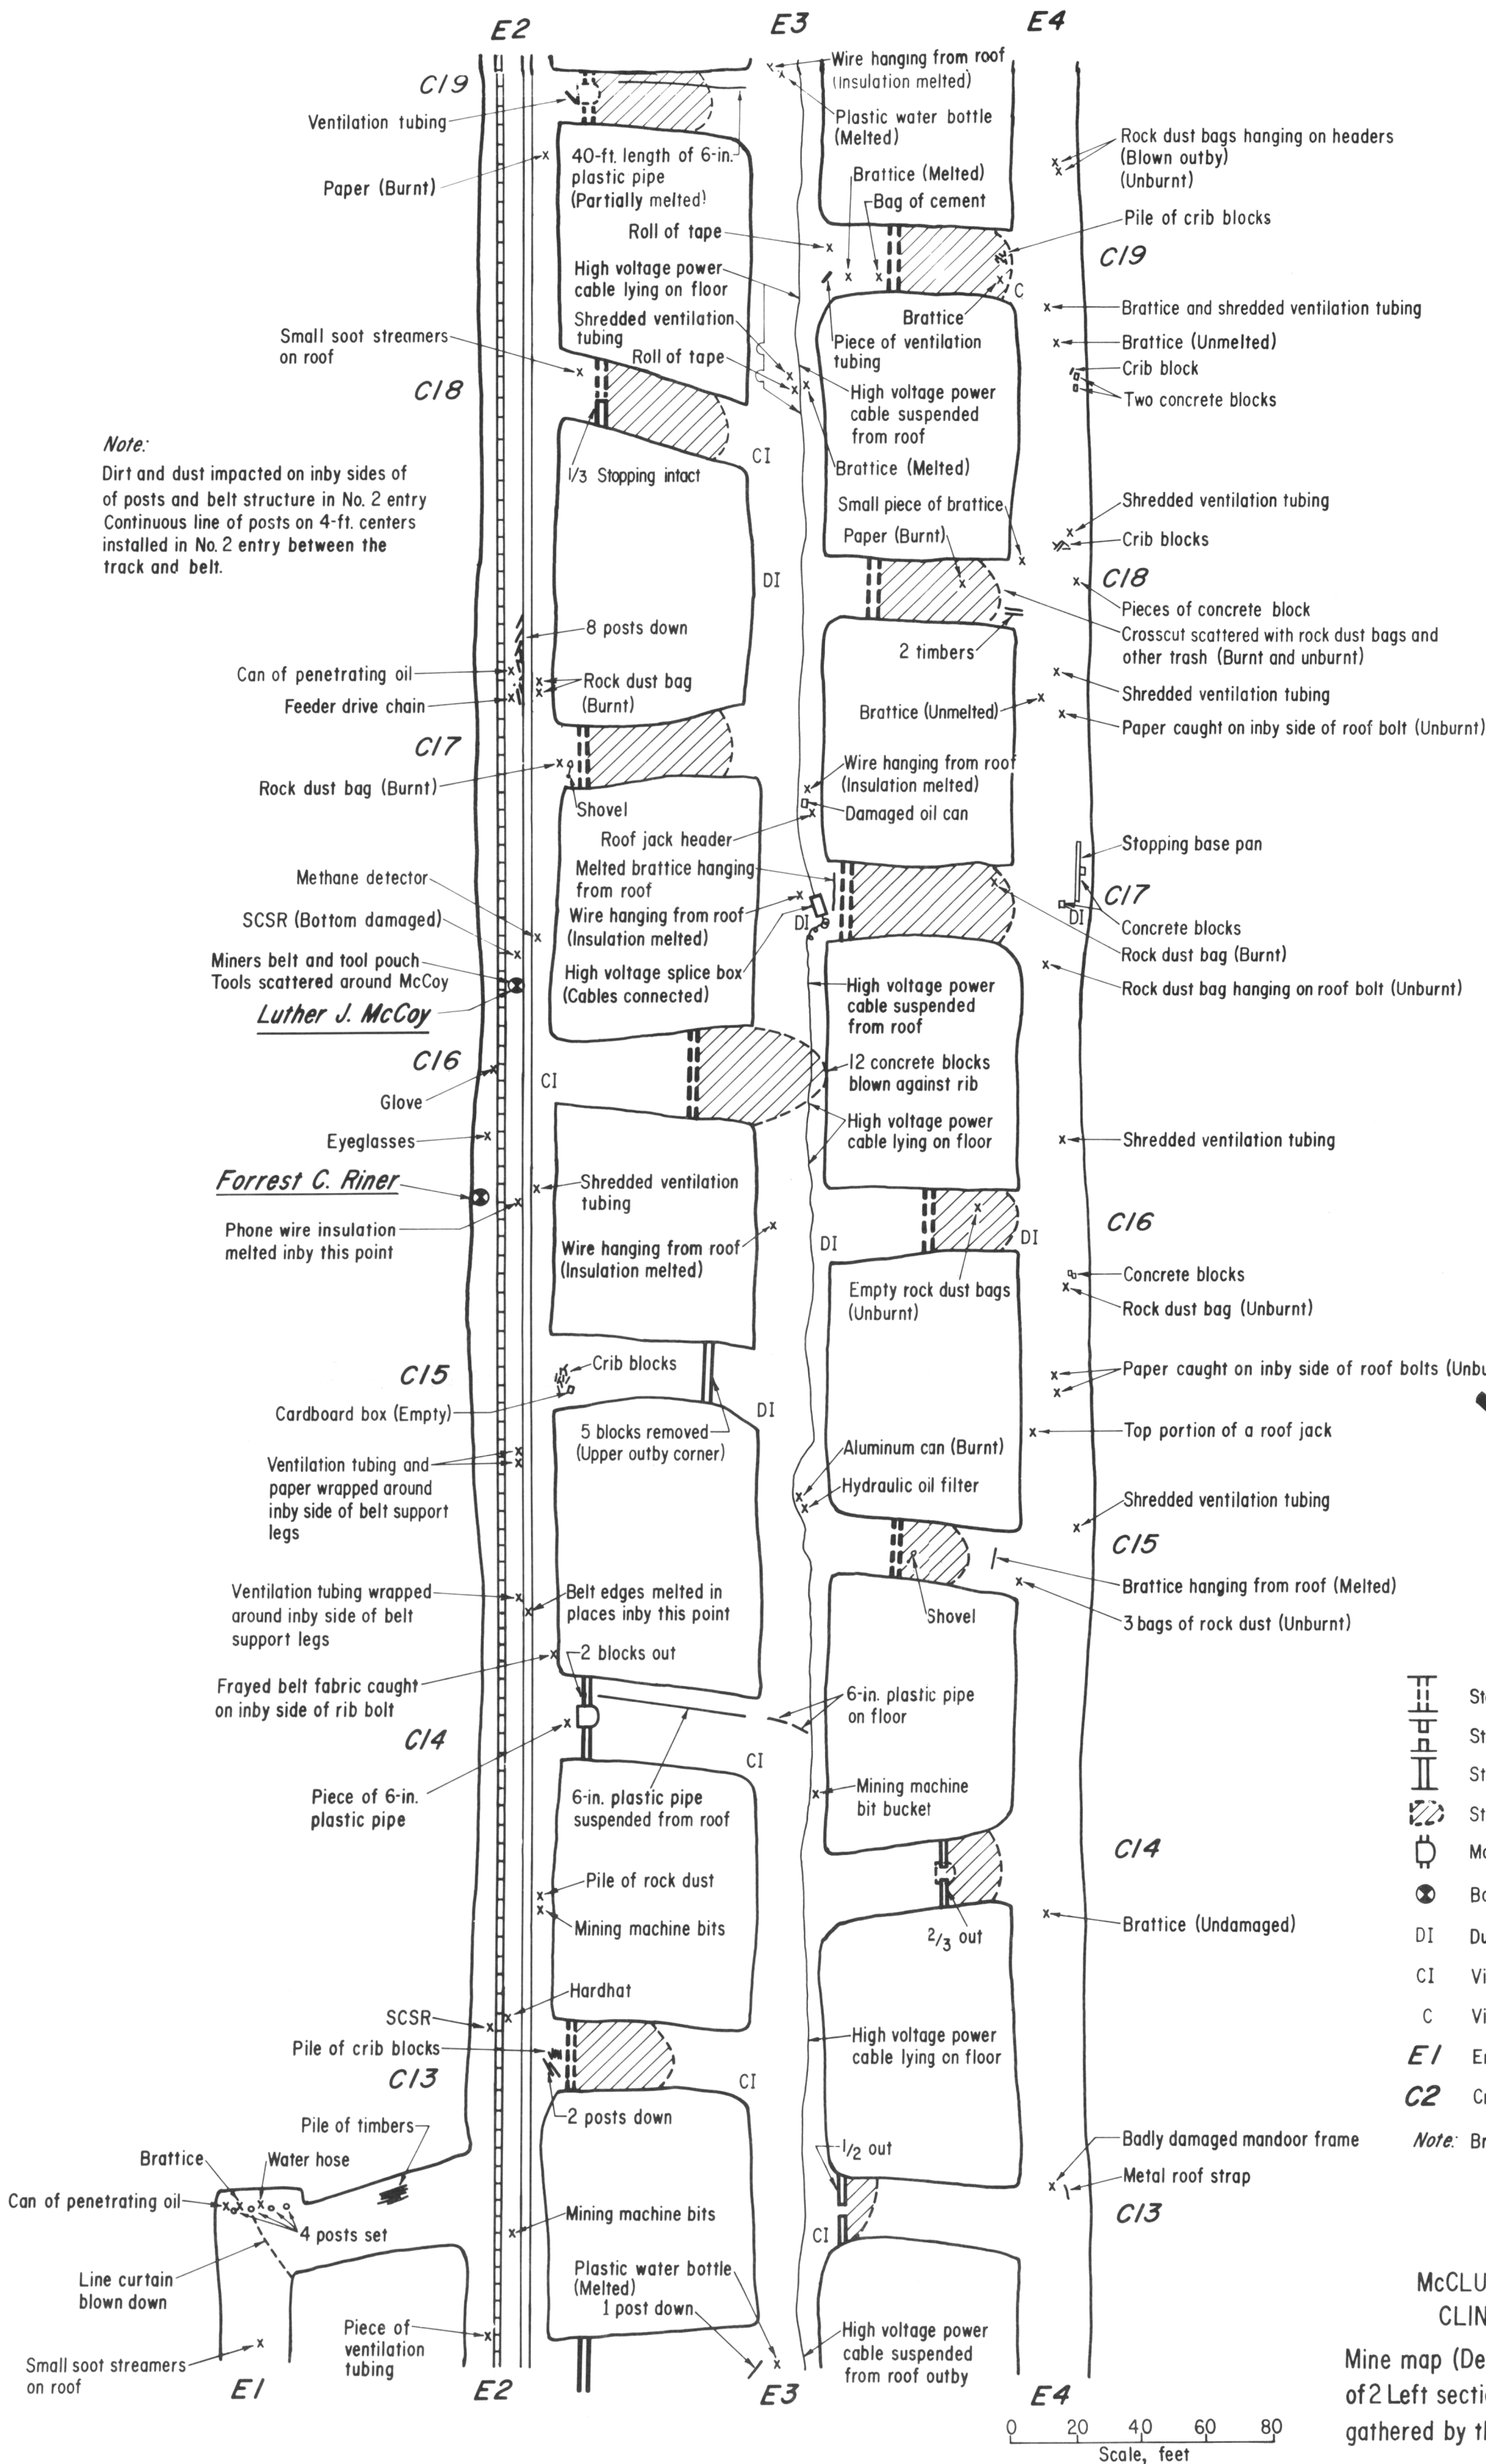
Note:
 Dirt and dust impacted on inby sides of posts and belt structure in No. 2 entry. Continuous line of posts on 4-ft. centers installed in No. 2 entry between the track and belt.
