Accident Investigation Report
Underground Coal Mine

Fall of Roof/Rib Material
Fatality Investigation Report
August 20, 2009

Big Laurel Mining Corporation
Mine No. 2
Mine Index No. 14744AA
Wise County, Virginia

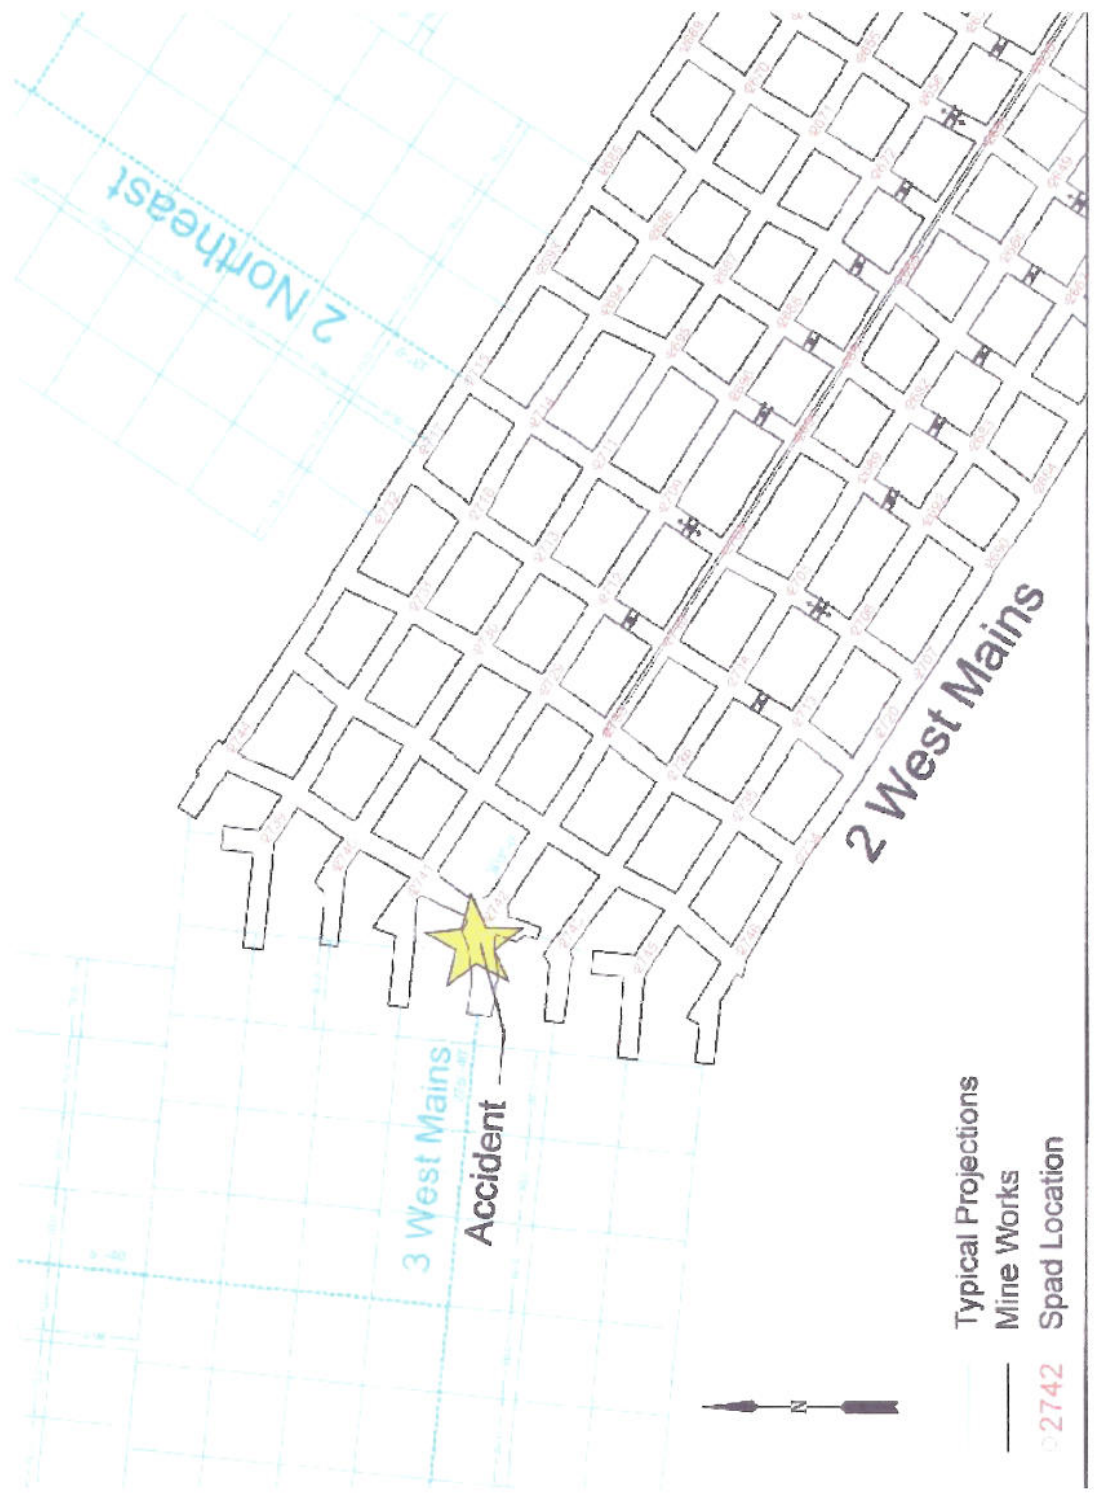
Typical Projections
Mine Works
2742 Spade Location

1. The fall of rib material accident occurred on August 20, 2009 at approximately 6:18 a.m. The accident occurred on the 2 West Mains-002 Section in the #4 Heading just inby the last open crosscut approximately 20 ft. inby survey station No. 2742.

9. The faces were driven up farther than they needed to be to turn the section on the new azimuth. When the turn was made in the intersection outby the face of #4 Entry, it created an excessively wide place. Entry width measured with a standard rule ranged from 23’ 5” up to 29’ 7” at the deepest point of the offset created by the overdriven face.
