# HAZARD ALERT LIVE TOMORROW

## Hoist Accident Safety Alert

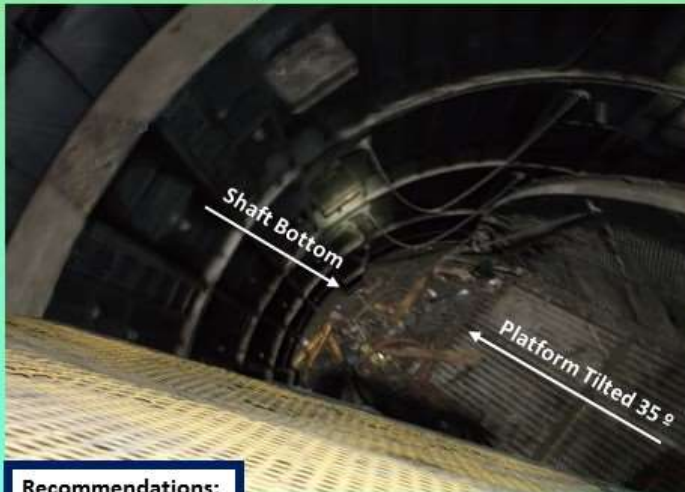
Platform Reenacted on Surface

On Friday, June 5, 2020, at 9:05 a.m., a hoist accident occurred at a shaft sinking operation in Buchanan County, Virginia. Two construction laborers and a crew leader were positioned on a work platform to be hoisted up to the next section of forms for a concrete pour inside the shaft. One end of the platform rigging was not attached properly to the hoist rope hook allowing the platform to tilt 36 degrees causing the two laborers to fall from the platform approximately 16 feet to the shaft bottom. The victims were not tied off with safety harness-lanyards while working from the elevated work platform. The victims were treated and transported to a local hospital where one individual was treated and released. The other victim was transferred to Johnson City Medical Center where he was admitted with multiple pelvic/hip fractures.

- ✓ Personnel riding conveyances must wear a full-body harness with a short, shock absorbing lanyard and be properly tied off to a designated anchor point.
- ✓ The location of the anchor point should be carefully selected to prevent the lanyard from becoming snagged or entangled when the conveyance is moving.
- ✓ All rigging for work deck platforms must be properly connected and secured to the hoist rope attachment. Rigging for below the hook lifting devices should be inspected before each use.
- ✓ Always stay alert and constantly aware of your surroundings.
