## Virginia Department of Mines, Minerals and Energy

## BED SECTION OVERTURNED DURING ASSEMBLY

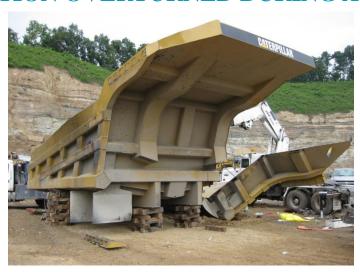
At approximately 9:00 a.m. on July 31, 2013, a miner was seriously injured when a bed section of a 785D haul truck overturned during assembly. The section had been placed upright on the ground and the lifting chains were disconnected to allow the boom truck to be repositioned. Two crib blocks were used to level/support the piece in order for it to stand upright. The victim was apparently moving to a safer location while the truck was being moved. He was located between the bed section and the boom truck. As the boom truck and lifting chains were being repositioned, the bed section overturned striking the victim and pinning his lower torso against the ground causing serious injuries.

- Always ensure that equipment and heavy items are secured in place before approaching or attempting any work.
- Always be aware of your body positioning to avoid pinch points and potential danger zones if something should go wrong.
- Two mobile cranes are recommended for truck body assembly. This
  will make it easier to position the sections and allow one crane to
  always be connected if the other crane has to be repositioned.
