SAFETY ALERT BULLETIN

SURFACE HAULAGE NEAR MISS

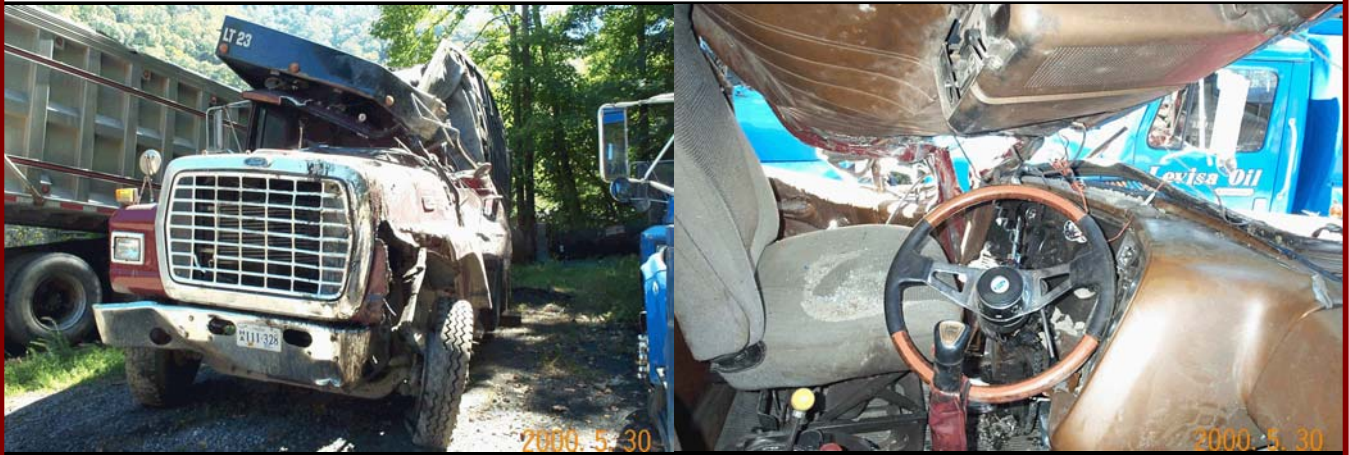
On September 20, 2004, at approximately 5:00 p.m., a contract coal truck driver was injured when his 1984 Ford tandem truck traveled out of control down an inclined mine haul road and overturned against the hillside. The driver stated the transmission came out of gear causing the operator to lose control of the vehicle. The injured miner was transported to Grundy General Hospital and then flown to Holston Valley Hospital. The injured miner received five broken ribs, a bruised lung and a bruised kidney. He had been employed by this contractor as a truck driver for three weeks and had ____ years experience operating coal trucks.

- Always conduct proper pre-operational checks on your equipment and report any deficiencies to the proper persons.
- Always keep your vehicle under control at all times.
- Never attempt to change gears while descending a grade in a loaded truck.
- Always remain in the confines of the vehicle, never attempt to jump from a moving vehicle.
