Within nine months (August 2022 to April 2023), two flyrock incidents occurred at Virginia mineral mines. Flyrock, defined as any uncontrolled material generated by a blast that was hazardous to persons or property not owned or controlled by the operator, represents a serious hazard to both mine employees and other persons who may be located at or near the mine. Fortunately, no one was seriously injured, though significant damage to property (vehicles and structures) did occur in each of these incidents.

Virginia Energy Mineral Mining Program  
900 Natural Resources Drive, Suite 400  
Charlottesville, VA 22903  
(434) 951-6310

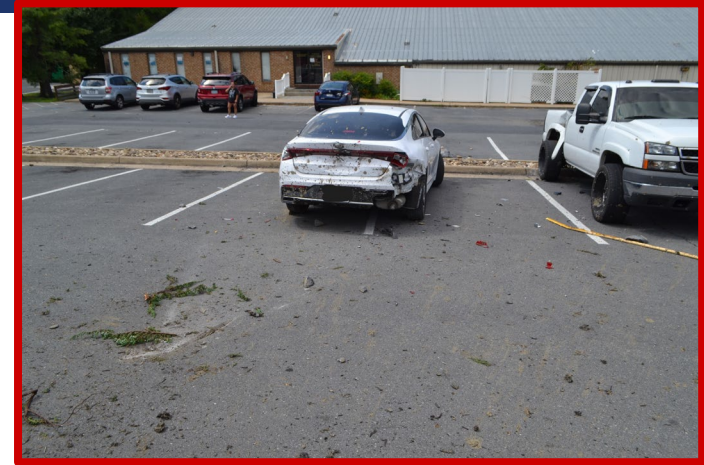
In August 2022, a production blast resulted in uncontrolled rock and mud leaving the quarry, resulting in injuries to nearby members of the public and damage to vehicles, a power line, parking lots and to a building located off the mine site. Virginia Energy's Mineral Mining team's investigation concluded there was insufficient burden along the free-face. The alignment of an adjacent angled borehole was not adequately taken in consideration when loading a face borehole that contained a geologic anomaly (i.e., a void and mud seam).

*Flyrock damaged vehicles and pavement - August 2022*

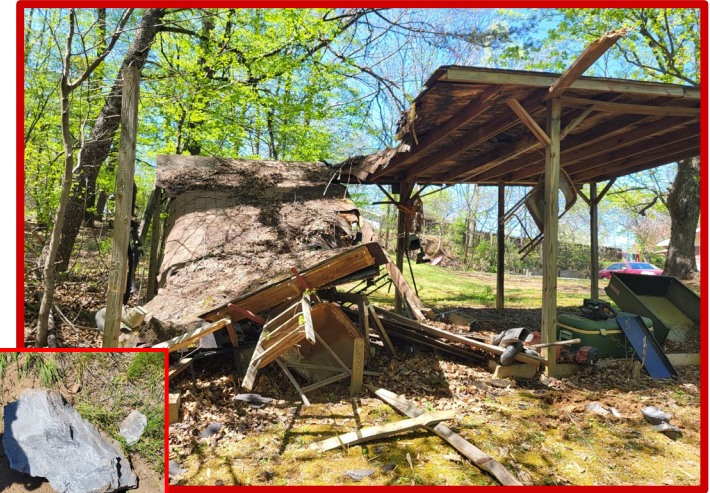
In an April 2023 flyrock incident, uncontrolled rock from a production blast traveled approximately 2,300 feet from the blast site. Virginia Energy's Mineral Mining program is currently investigating this incident, but preliminary conclusions from the investigation indicate the flyrock came from a lack of sufficient burden on the open corner of the shot.

*Flyrock damaged shed - April 2023*
