SAFETY ALERT: MINER SERIOUSLY INJURED **DISASSEMBLING A MODULAR TRENCH BOX**

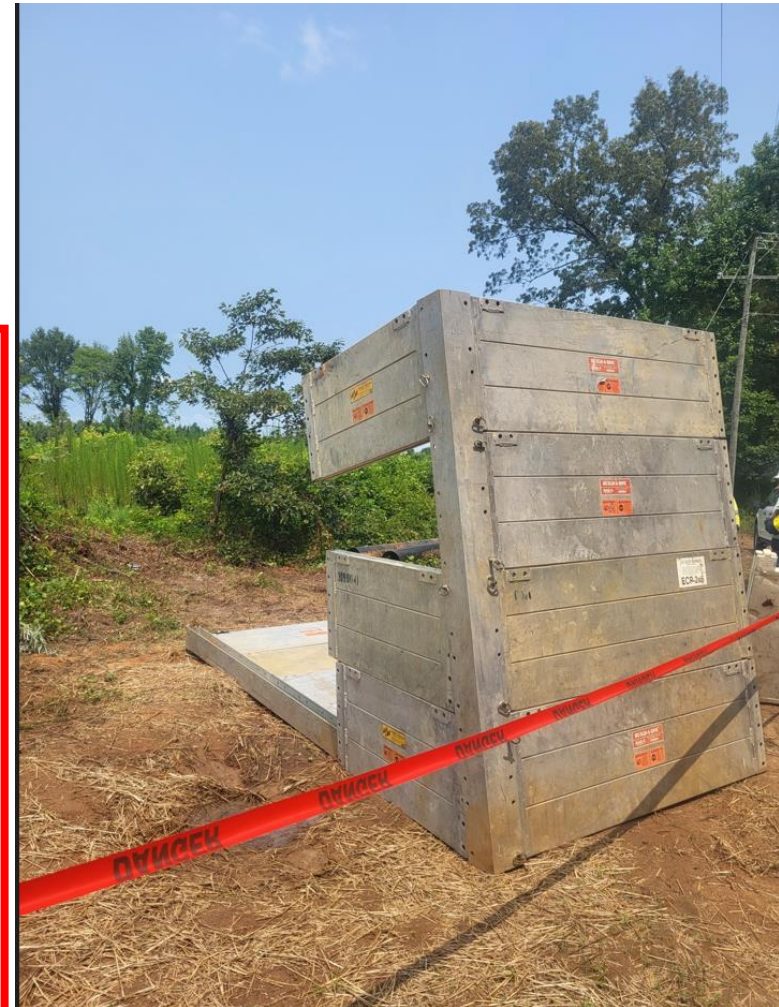
On 7/31/23, a 63-year-old miner with 26 years of experience was seriously injured while disassembling a modular trench box. During the disassembly process, one of the wall panels fell unexpectedly causing the miner to move quickly to avoid it. This quick movement resulted in a torn tendon in the miner's left knee that required surgery to repair.

Accident scene showing modular trench box being disassembled.

- Miners should be tasked trained on the maintenance and use of all equipment prior to its use.
- Task training should review manufacturer's safe operations instructions including assembly and disassembly where applicable.
- Care should be taken that all parts remain stable or blocked against hazardous motion while disassembling equipment.
- Maintain enough fasteners in place to ensure stability until controlled movement can be ensured.
- Lifting aids are recommended when necessary to ensure the stability of partially disassembled equipment.
