SAFETY ALERT BULLETIN

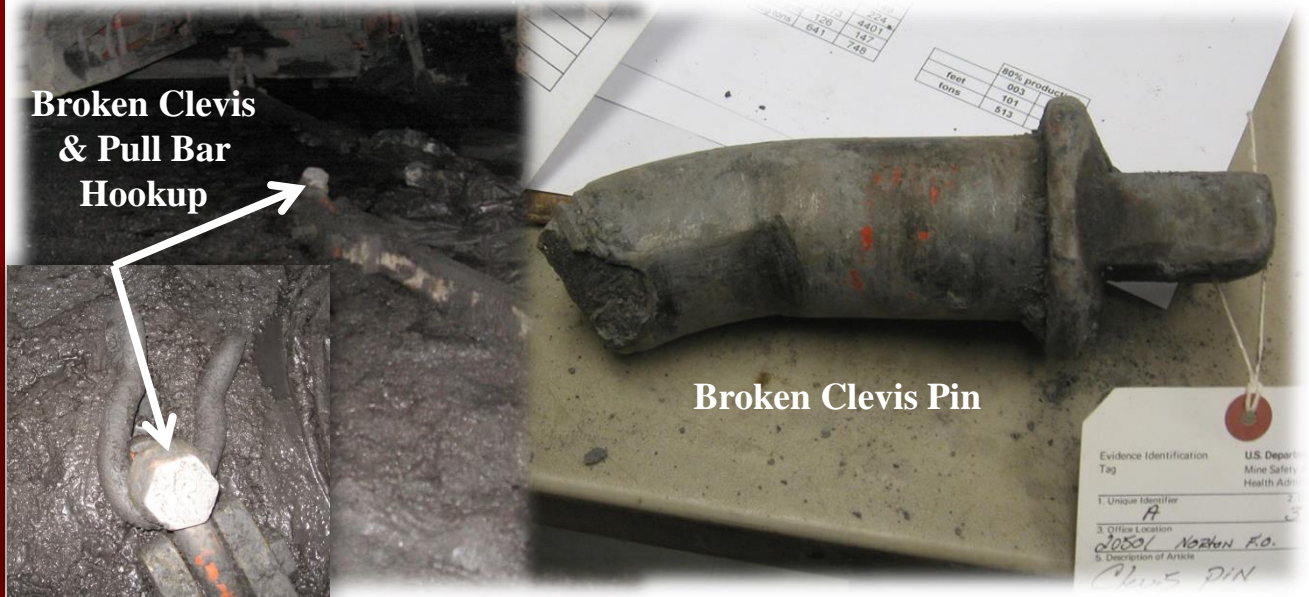
At approximately 4:45 A.M. on March 13, 2015 a serious personal injury occurred on a retreat mining section of an underground mine located in Dickenson County, VA. The victim, who was working as a contractor at this mine, was injured when he was struck by a pin from a hydraulic retriever that was being used to remove a continuous miner from a pillar fall. The threaded pin broke in a 51 millimeter clevis while the retriever was under pressure and struck the injured person in the left shoulder and collar bone area. The clevis and link bars had been covered with ventilation curtains prior to pulling. Four (4) clevises and one (1) link bar was broken prior to the accident. The victim sustained bruising to his left shoulder and collar bone area and also bruising to his lung with the development of an air pocket.

- **Only the minimum amount of employees needed for retrieval work should be allowed in the area.**
- Clevises and link bars should be inspected thoroughly and defective equipment replaced immediately.
- Precaution should be taken to make sure everyone is in a safe location when pressurized retrieval work is being conducted.
