SERIOUS INJURY ACCIDENT: May 2008 Miner Struck By Service Truck

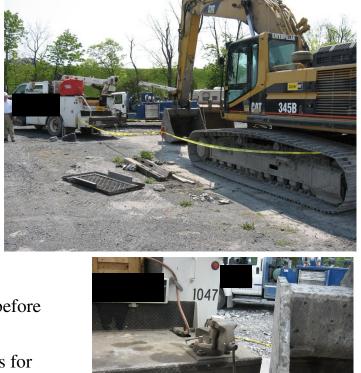
Accident scene

An assistant mechanic employed by a mine company was seriously injured when he was struck by a contractor's service truck as it was backing up. The injured worker and the contractor mechanic were preparing to remove the stick section, and its associated hydraulics, from a Caterpillar 345B excavator for repairs. After observing the mine mechanic collecting tools from his own truck, the contractor began backing his service truck into position next to the excavator bucket. Thinking the contractor was going to stop approximately ten feet from the bucket, the miner entered the work area and began loosening the keeper bolts on the hydraulic lines going to the bucket. The rear bumper of the service truck struck the miner pinching his left pelvic area between the bumper and the excavator bucket. The victim was transported to a hospital where he was treated for a complete fracture to his left pelvic bone.

This accident occurred due to a lack of communication between the victim and the contractor mechanic. The victim disregarded the service truck's audible back-up alarm and placed himself in an unsafe position. To avoid the occurrence of a similar accident, DMM recommends the following:

Pinch point between the bumper and bucket.

- Workers must be aware of the dangers in working around mobile equipment and the importance of staying alert to what is going on around them.
- Workers must establish eye contact with operators prior to moving around mobile equipment.
- Equipment operators must be certain that all persons are in the clear before starting or moving mobile equipment as required by DMM regulation.
- Remind all workers of their responsibility to examine their work areas for unsafe conditions prior to starting work and frequently thereafter.
