DMM Safety Alert: Driller Struck By Drill Steel

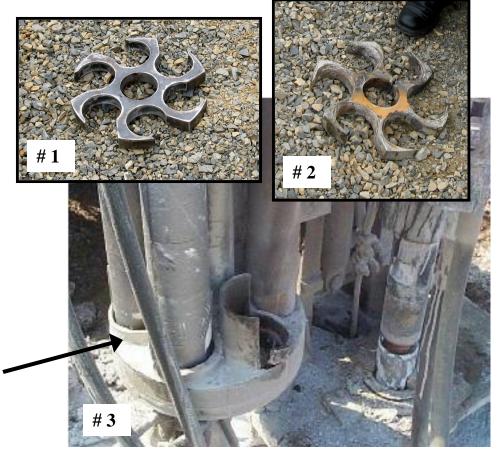
• Photographs #1 and #2 at right show the "spider hook" assembly that supports the drill steel at the top of the carousel on the Gill "Beetle" drill. Photograph #1 shows a new part while photograph #2 shows the worn piece from the drill involved in the 2009 accident. Wear and tear on this part was a contributing factor in the 2001 accident as well. Mine operators and drillers should regularly inspect this part to monitor wear and replace it per the recommendations of the manufacturer.

• Photograph #3 shows the bottom of the Gill "Beetle" carousel involved in the 2001 accident. Note the rings or "cups" holding the steel in place. Drill cuttings and other debris may collect in these cups allowing the steel to slip out. Mine operators and drillers should ensure these cups are kept clean.

• Regardless of the brand or type of drill utilized, drillers must inspect drilling equipment prior to use and report safety defects to the certified mine foreman (**4VAC25-40-950**). Also, prior to moving drills, the mast must be lowered to a safe position and tools and other equipment must be secured (**4VAC25-40-1010**).
