INVESTIGATION REPORT
UNDERGROUND COAL MINE EXPLOSION

McClure No. 1 Mine

CLINCHFIELD COAL COMPANY

June 21, 1983

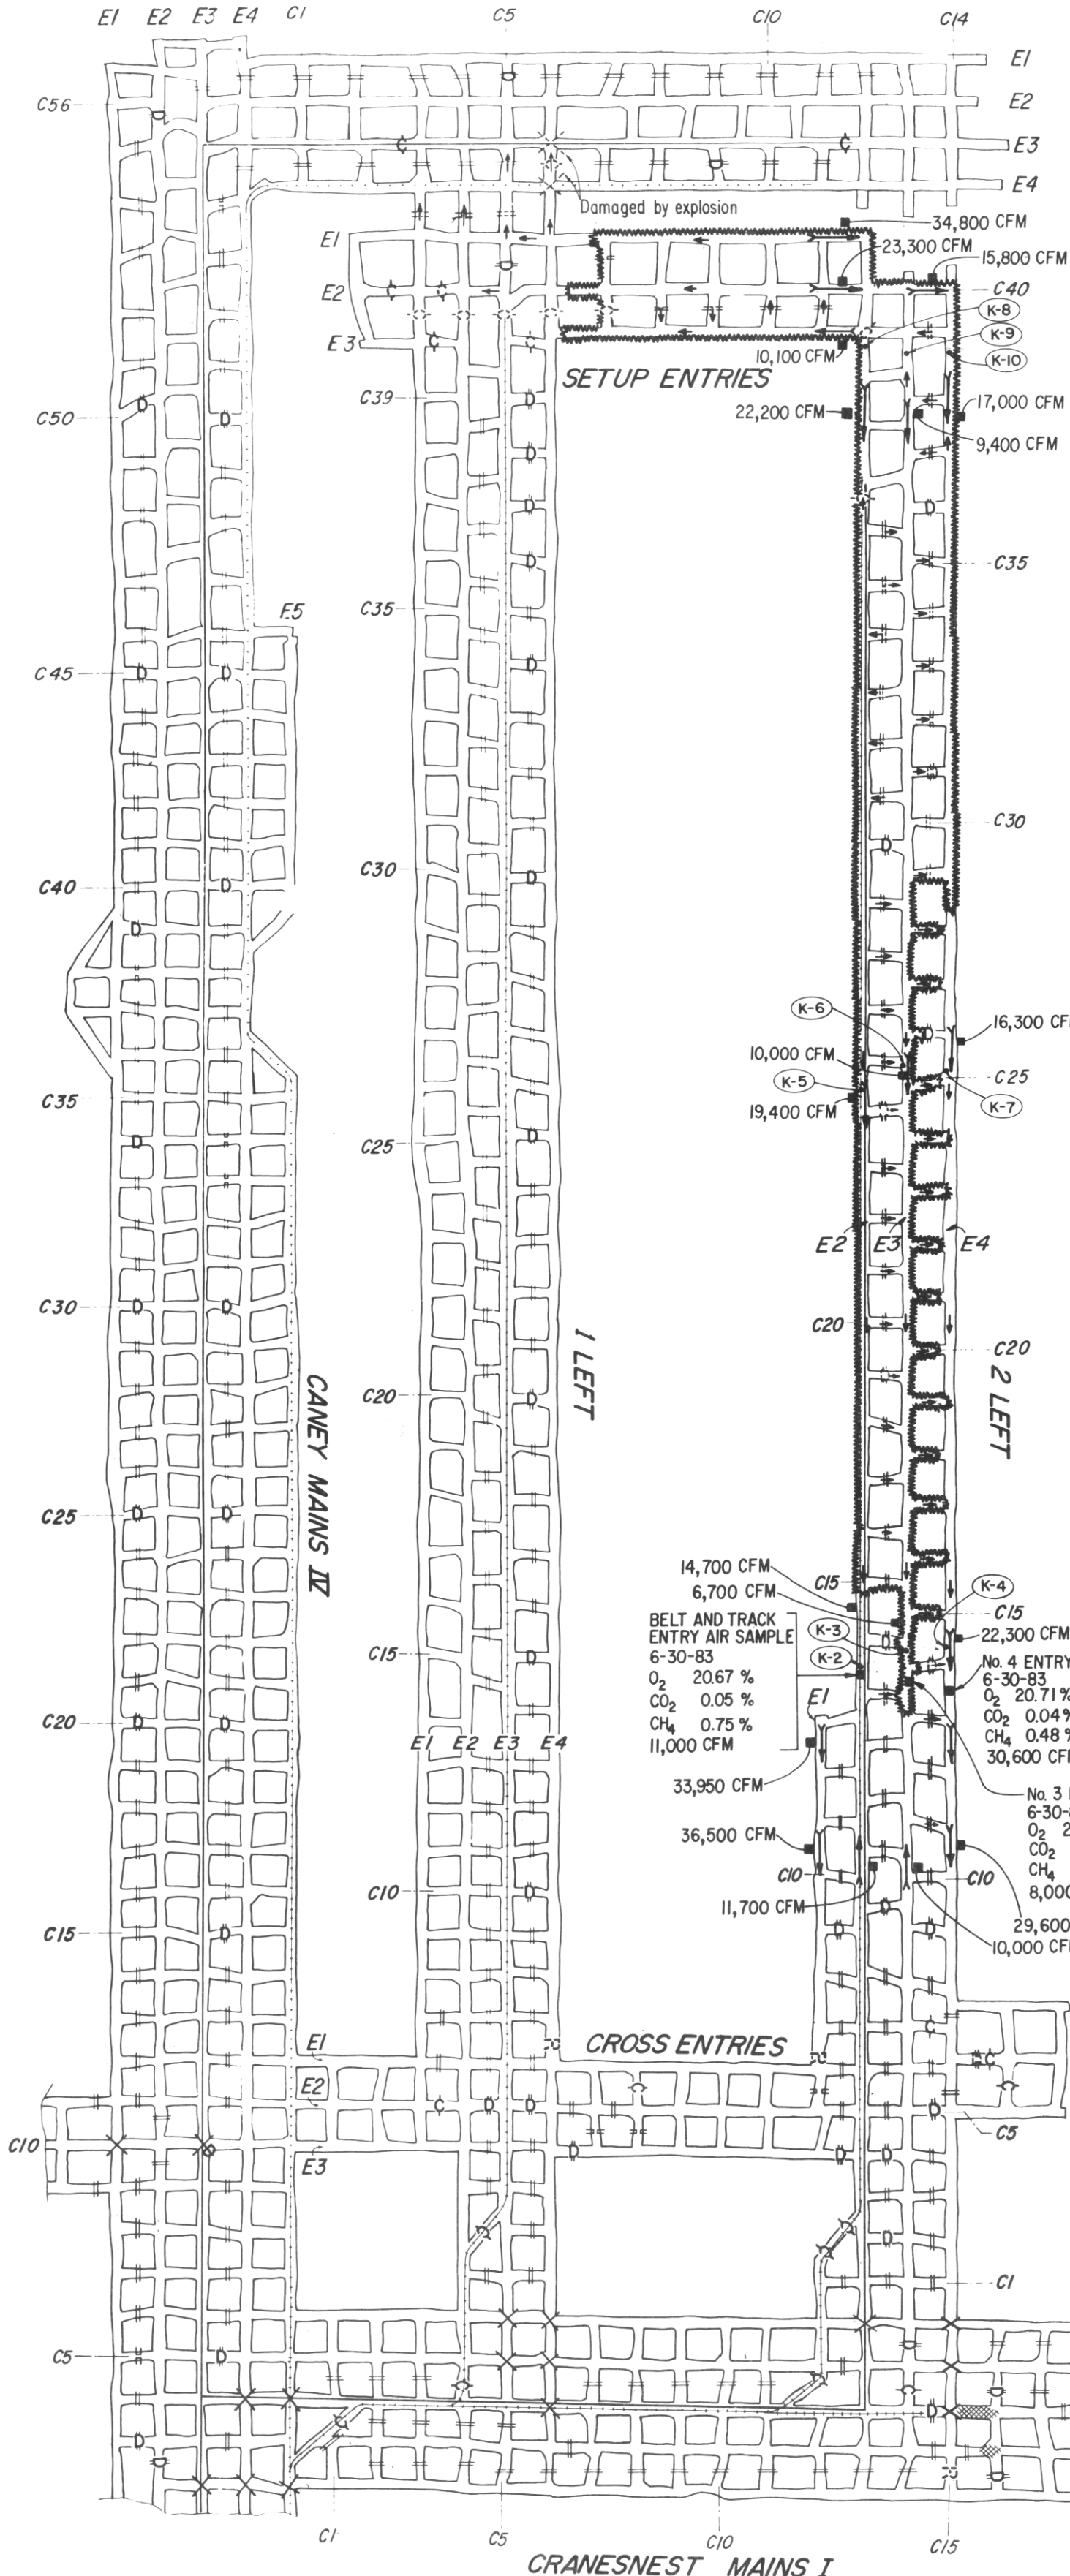
Note: Air readings taken 7-15-83 (except as otherwise noted) during a ventilation survey conducted by MSHA district personnel July 15, 18, 19, 20, 1983 in conjunction with the investigation.

Location of monitoring stations, average methane concentrations, balanced air quantities, average methane quantities from pressure-air quantity study conducted 7-11 to 16, 1983
