Electrical Safety AR Training Updated 2012

Division of Mineral Mining

Electrical Safety

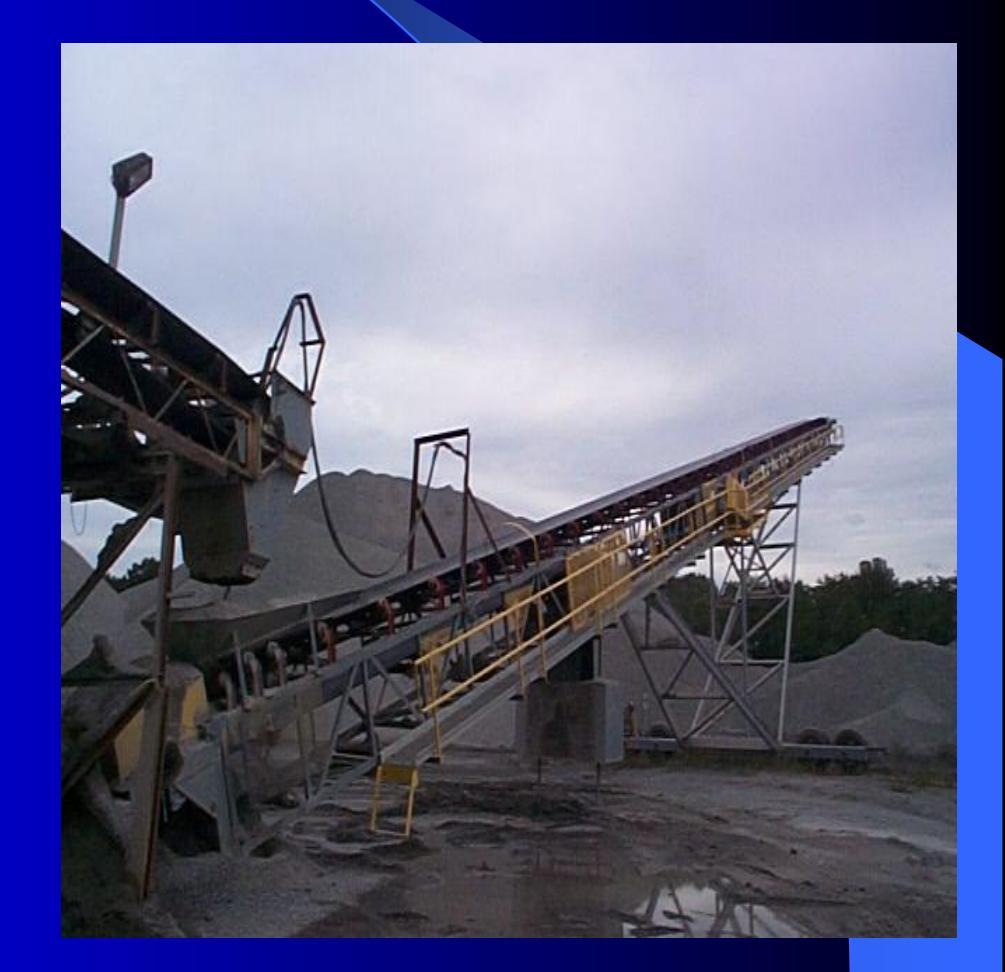
Electrical Conductors

Power wires and cables shall have adequate current carrying capacity and shall be protected from mechanical injury (4VAC25-40-2050, MSHA 56.12004).

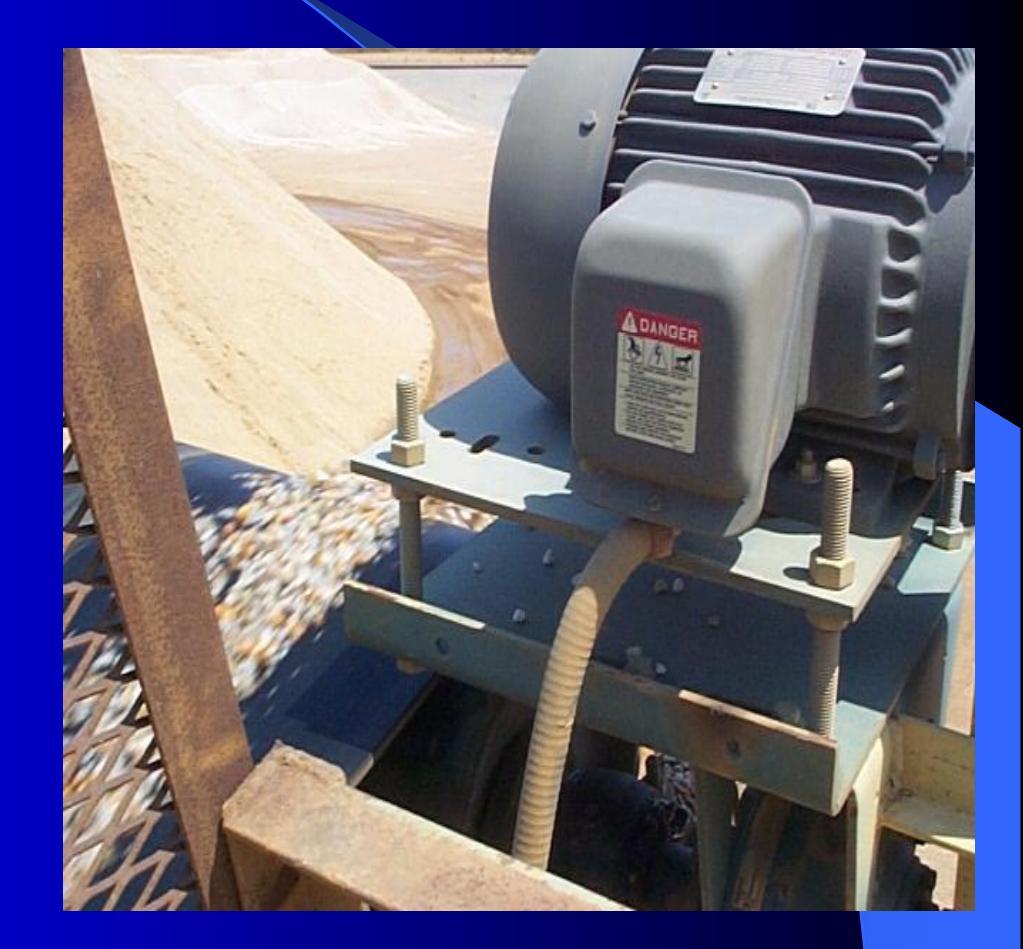
Inspection and Cover Plates

Cover plates must be securely in place except during testing or repair (4VAC25-40-2290, MSHA 56.12032).

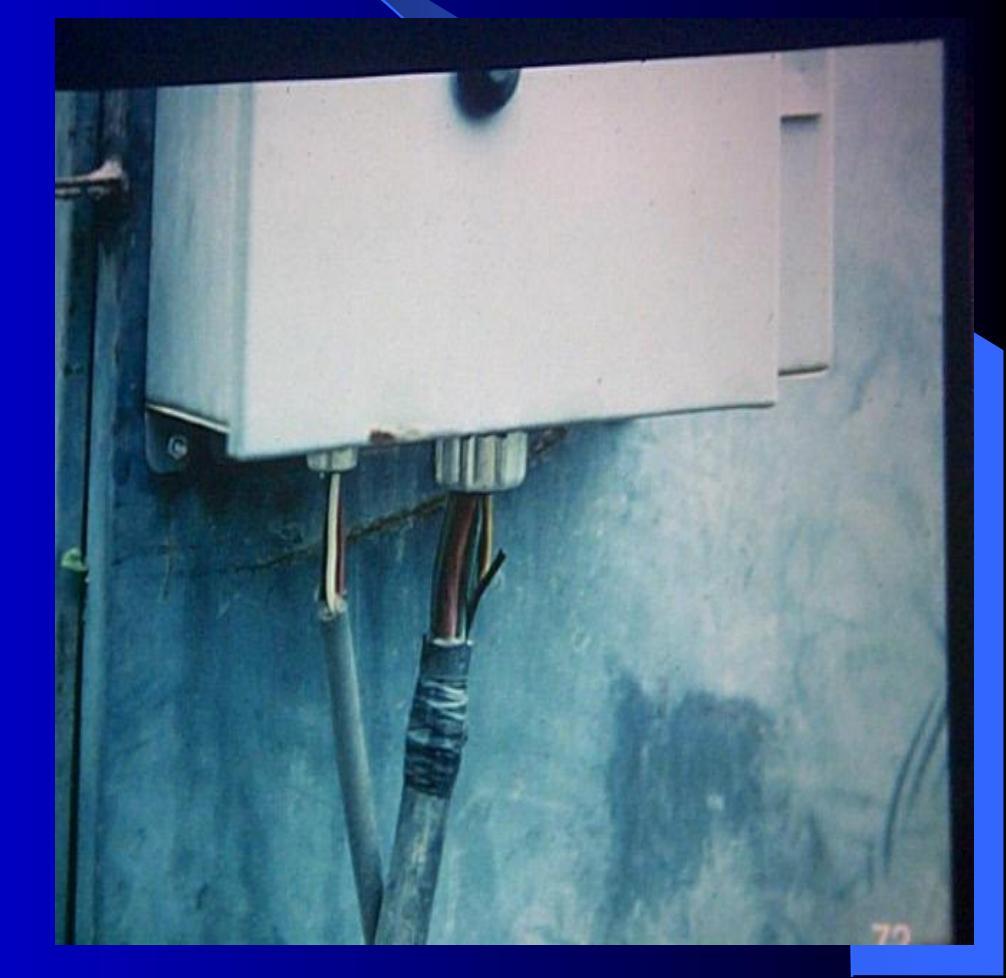
Insulation and Fittings for Power Wires and Cables

• Power wires & cables must be adequately insulated where they pass into/out of electrical compartments. For example, wire insulation must be secured in the insulated bushing (4VAC25-40-2090, MSHA 56.12008).

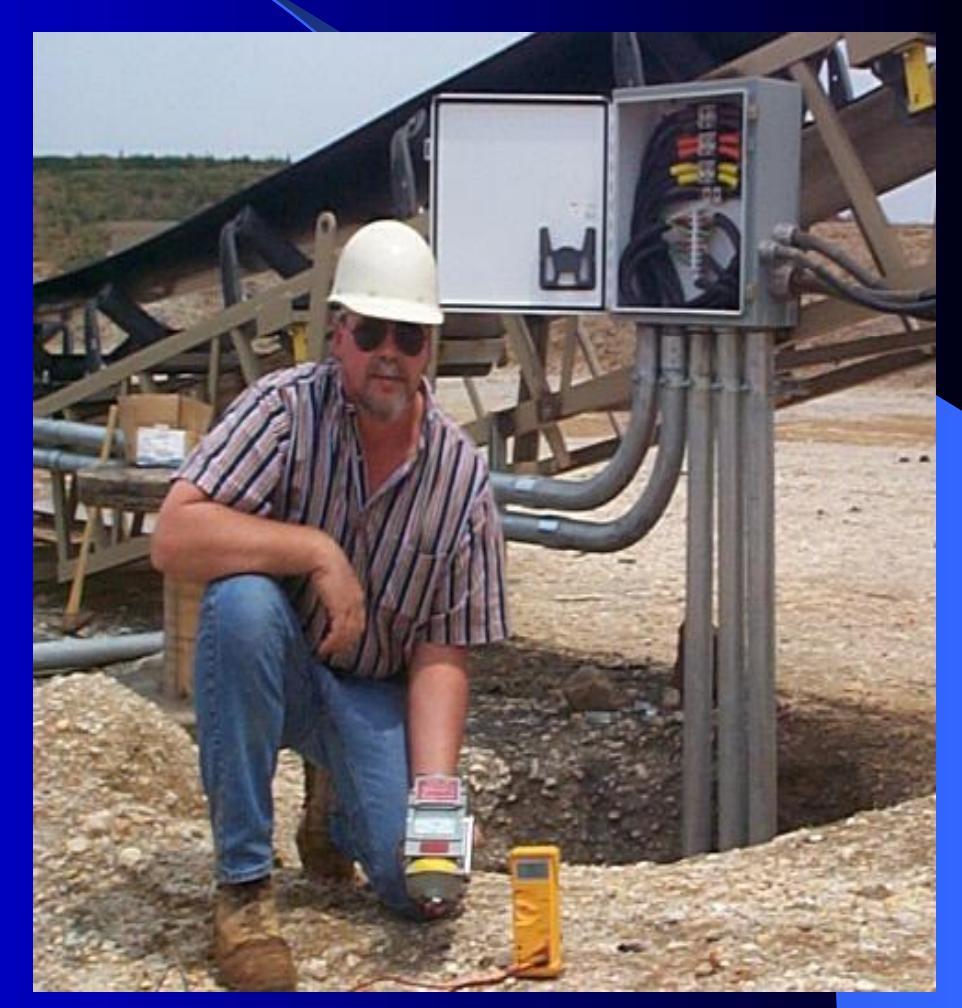
Testing of Grounding Systems

Continuity and resistance of grounding systems shall be tested immediately after installation, repair, and modification.These tests shall be conducted annually thereafter with record kept 4VAC25-40-2250, MSHA 56.12028.

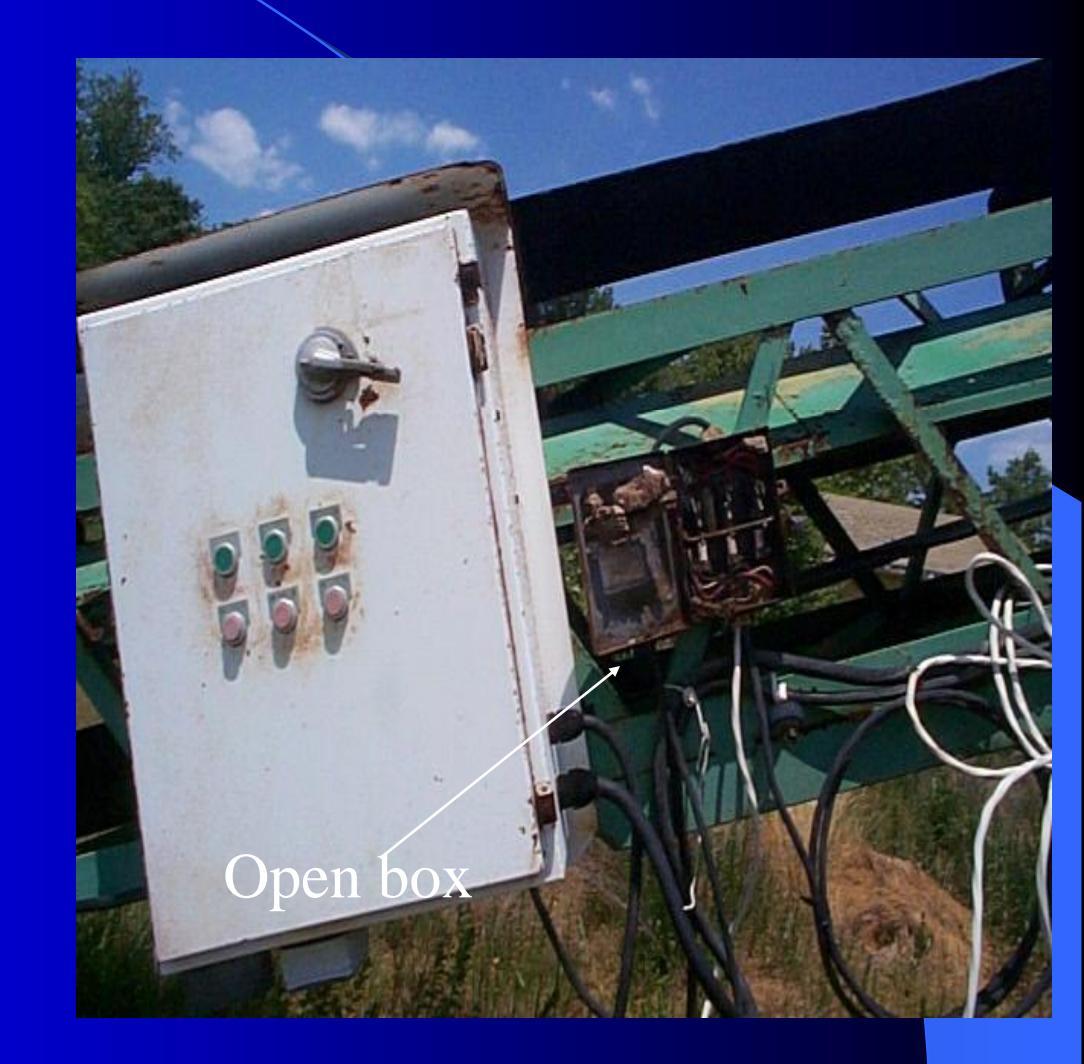
Dangerous Electrical Conditions

- Electrical equipment & wiring must be inspected periodically by a "competent person" to ensure safe operating conditions.
- Potentially dangerous conditions must be corrected prior to energizing. 4VAC25-40-2270, MSHA 56.12030.

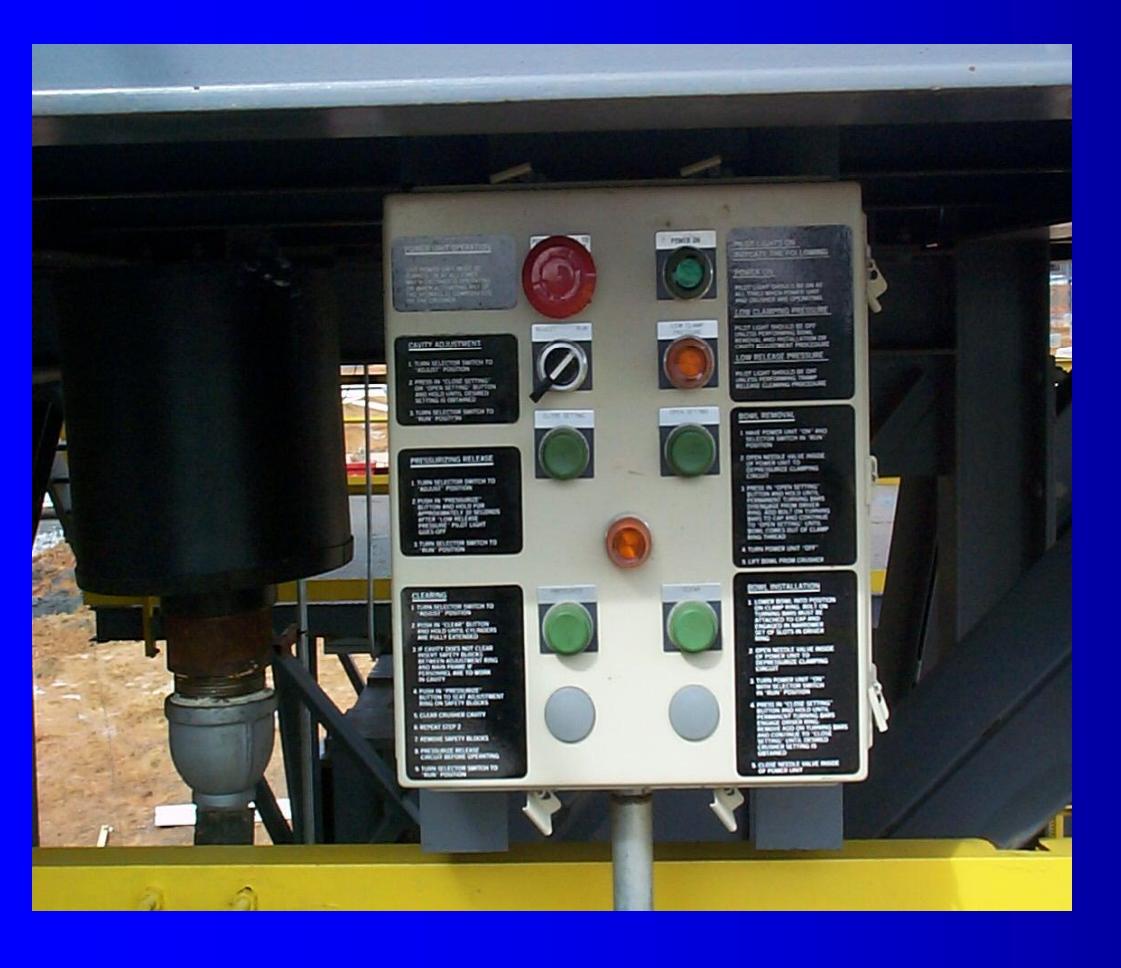
Labeling of Switches

Principal power switches shall be labeled to show which units they control.

Where location of the switch makes its identification readily apparent, labeling is not required.
4VAC25-40-2160
MSHA 56.12018

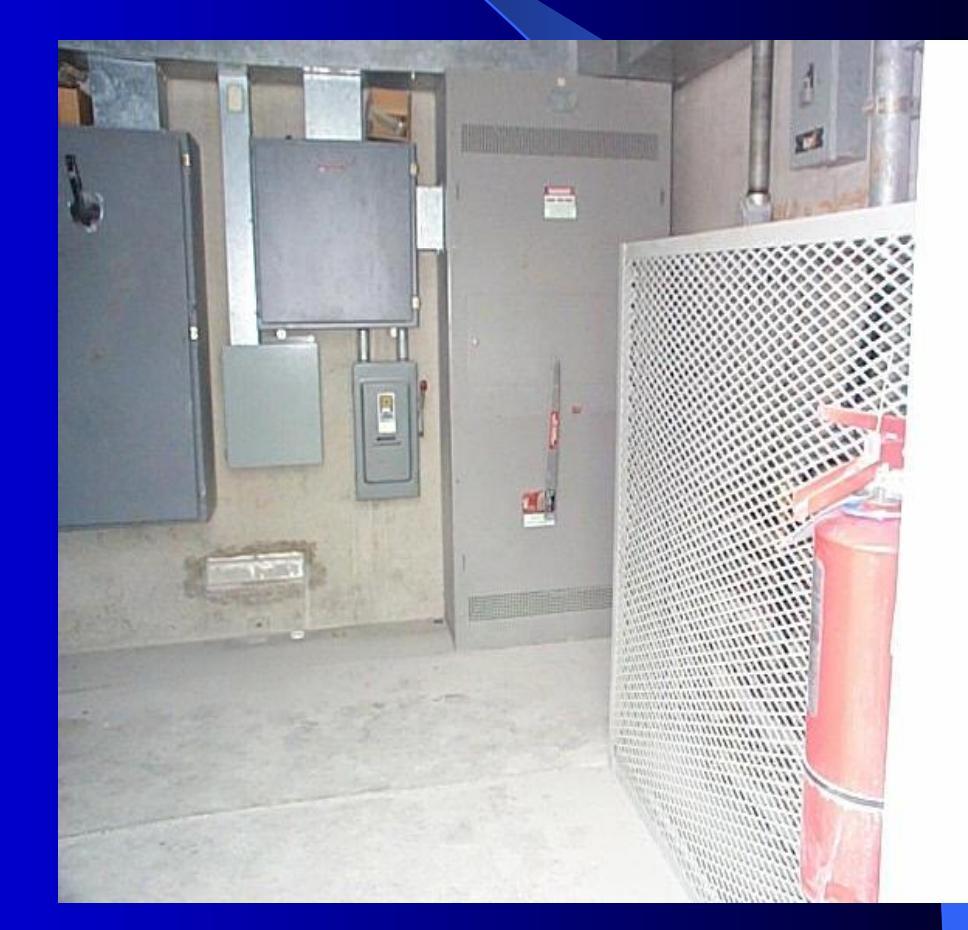
Electrical Switches & Controls 4VAC25-40-2030

Electrical circuits and equipment must be provided with acceptable and properly installed switches or controls.

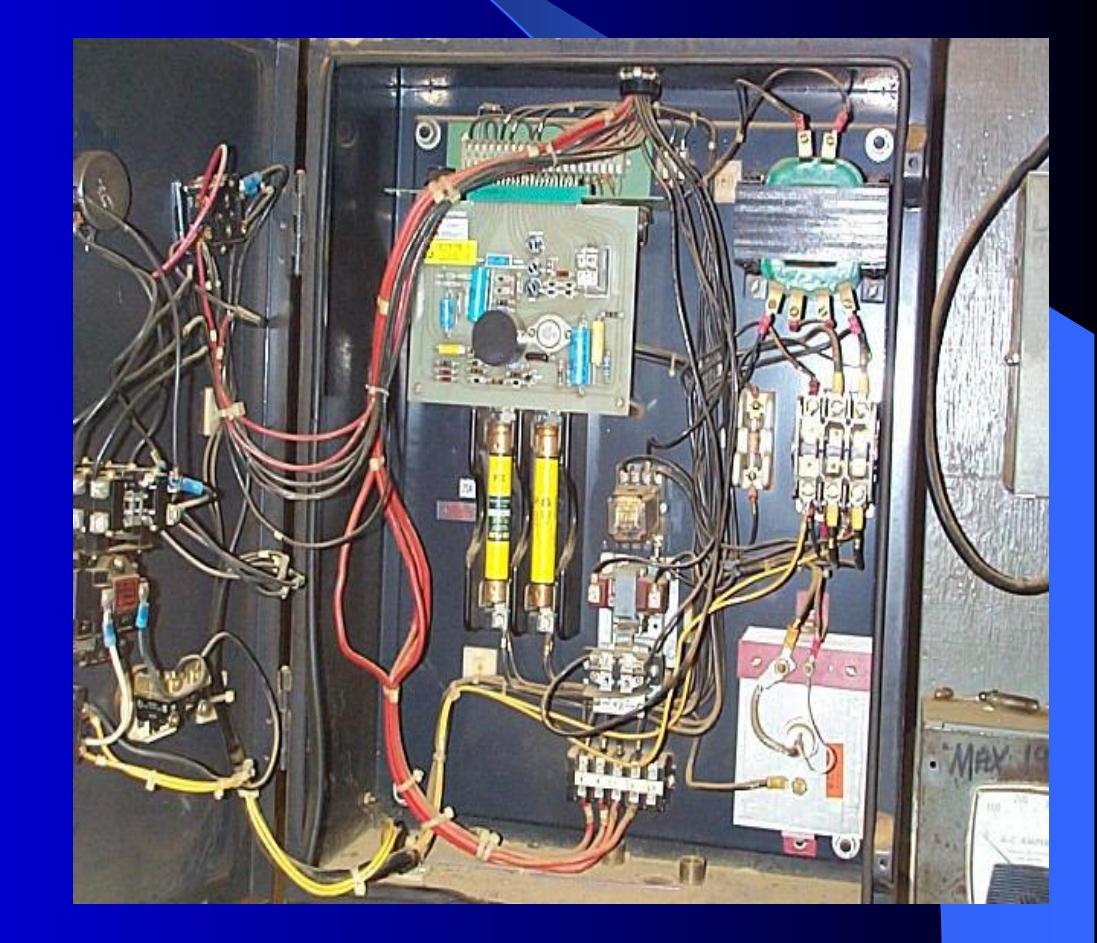
Electrical Control Box 4VAC25-40-2370

Operating controls must be installed so that they can be operated without danger of contact with energized conductors (e.g., behind access doors).

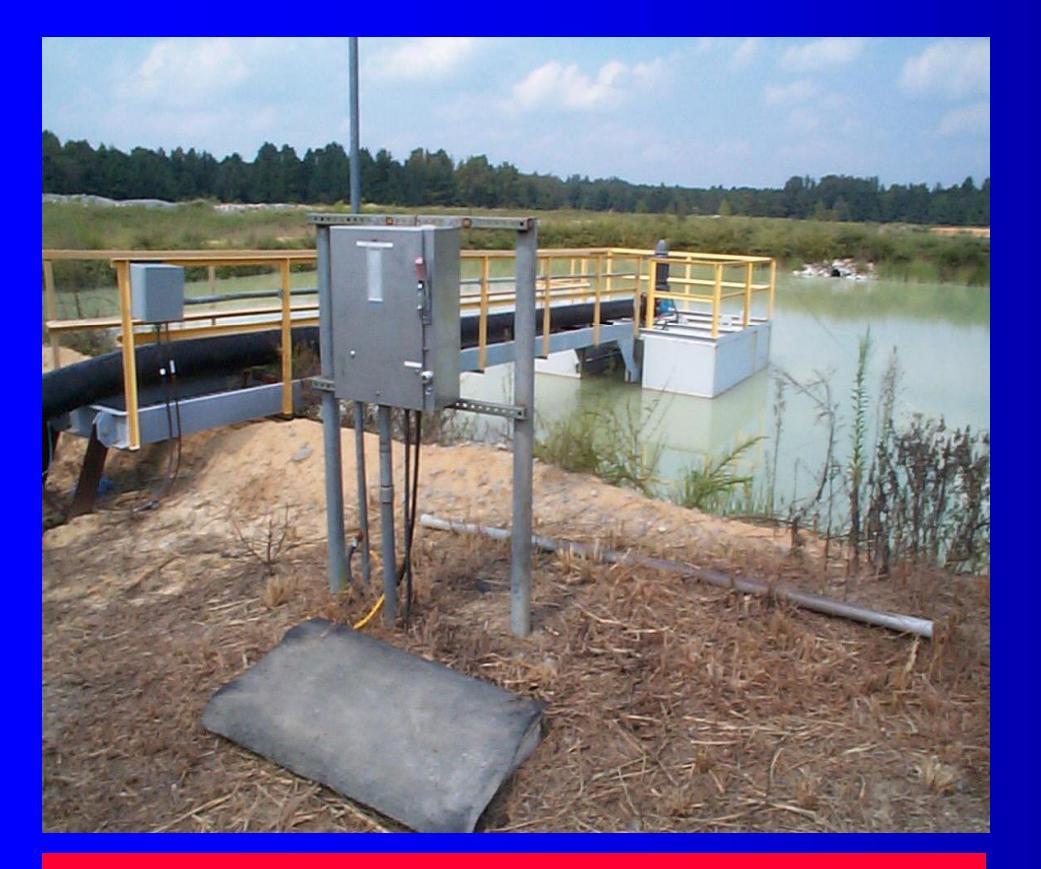
Nonconductive Electrical Safety Mats 4 VAC 25-40-2180

Conveyor belting is not acceptable !!

- Dry, wooden platforms, insulating mats, or other nonconductive material shall be kept in place at all switchboards and power control switches.
- Metal plates may be used where they are kept at the same potential as the grounded, metal noncurrent carrying parts of the power switch.

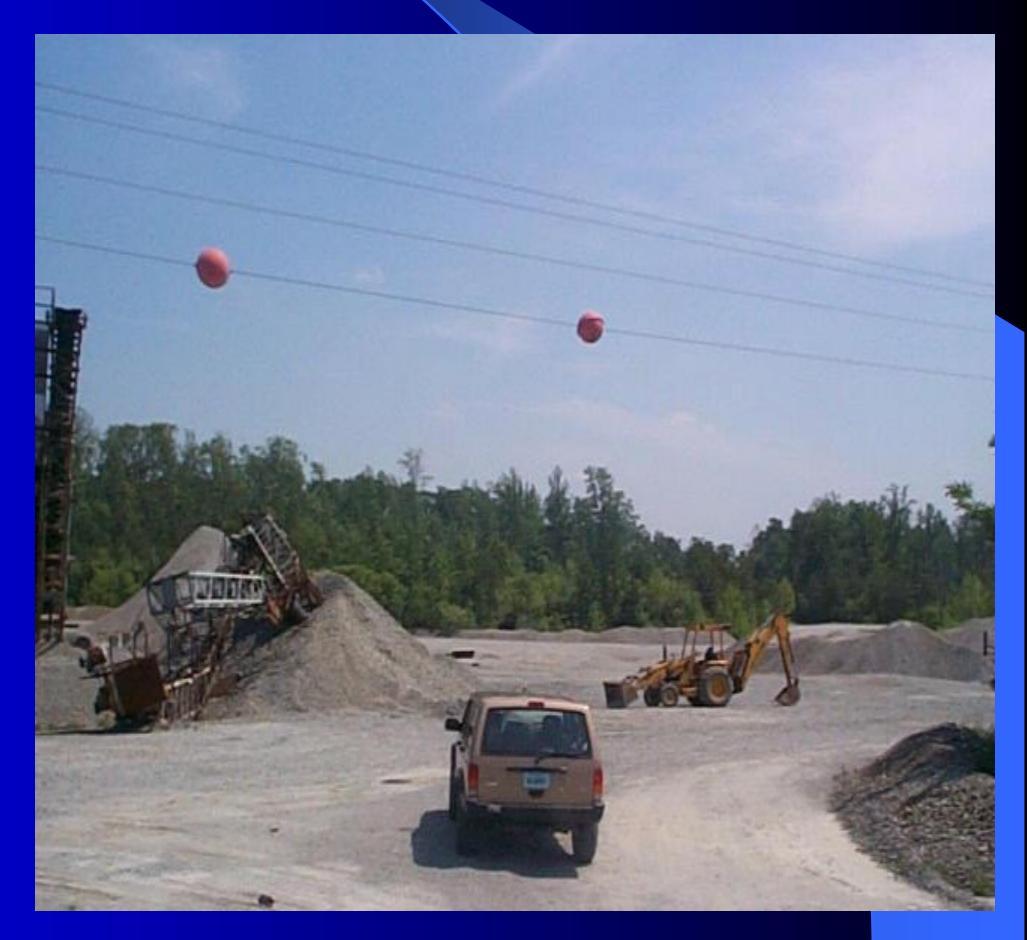
Power Line Clearance 4VAC25-40-2500

• If the clearance between mobile equipment and energized overhead power lines is less than 10-feet, the lines must be de-energized or a warning sign posted or other precautionary measures must be taken (e.g., lines marked, etc.).

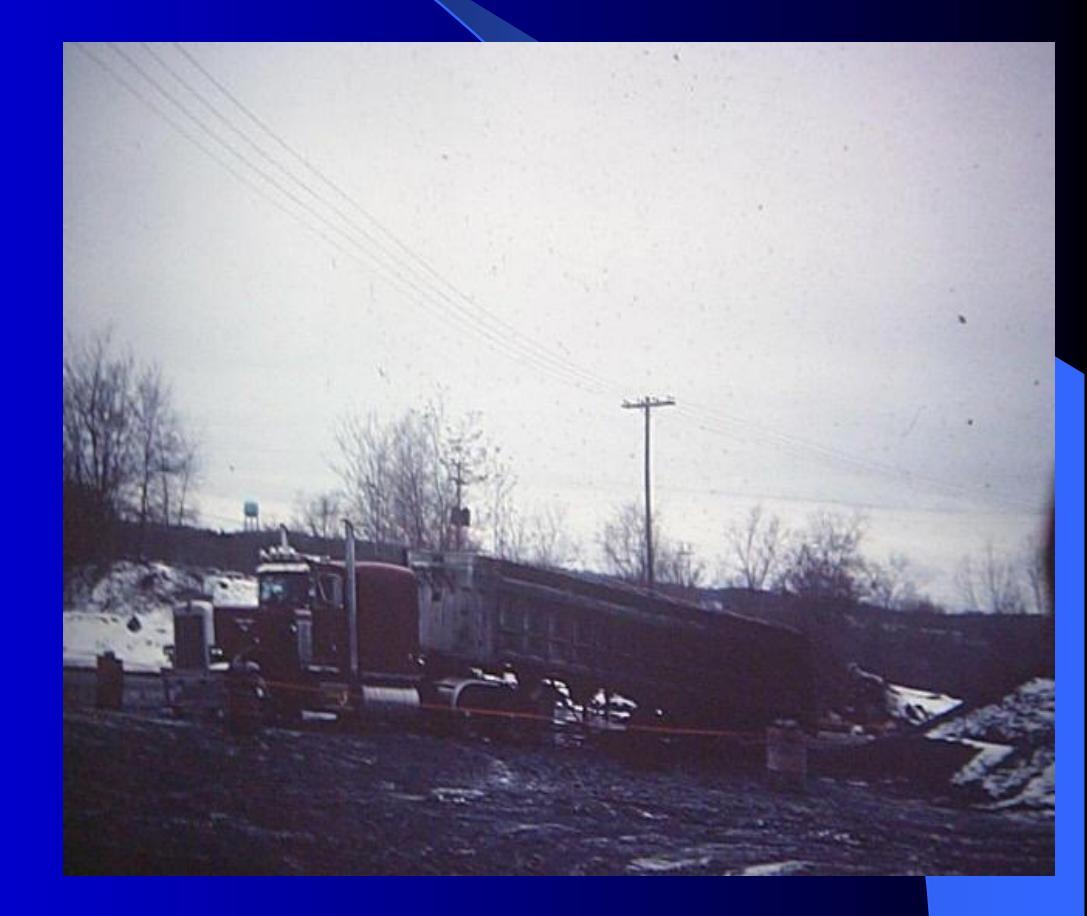
Fatal Trucker Accident

Victim was electrocuted when he raised his truck bed without first checking for overhead power lines.

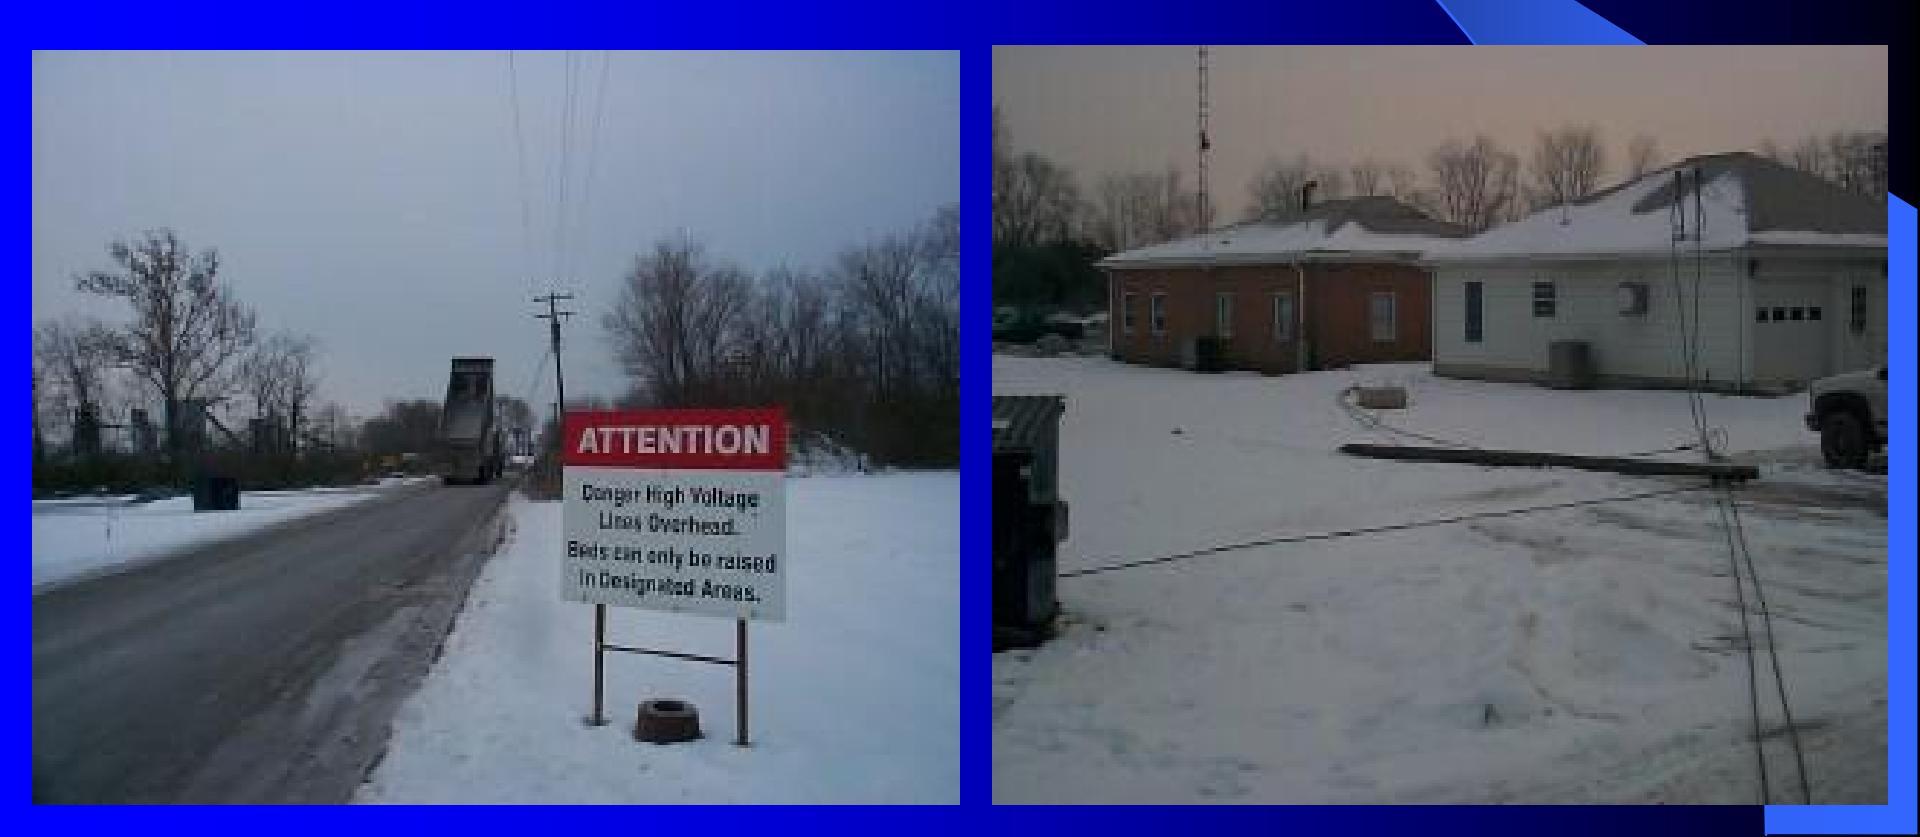
Overhead Line Incident December 10, 2002

A quarry customer truck driver raised the bed of his truck into energized (240-volts) power lines located alongside a public road that fronts a portion of the mining operation. The driver was attempting to clear material from the bed of the moving truck prior to being loaded with a limestone product. The certified mine foreman on duty at the mine instructed the driver to remain in the truck until the power company de-energized the damaged lines.

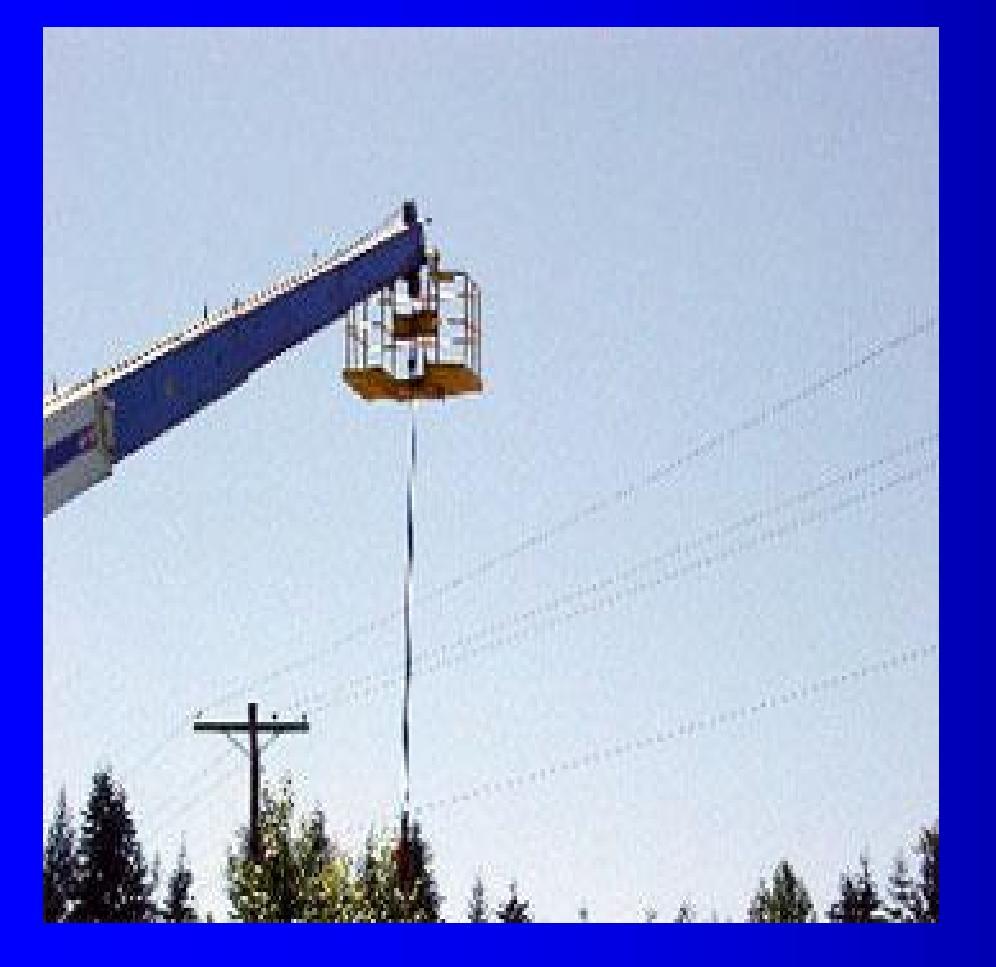
Electrical Fatality July 22, 2003

• Boom of crane struck energized 7200 volt overhead power line while moving a section of a conveyor at a sand and gravel operation. The victim was steadying the section as it was being lowered to the ground.

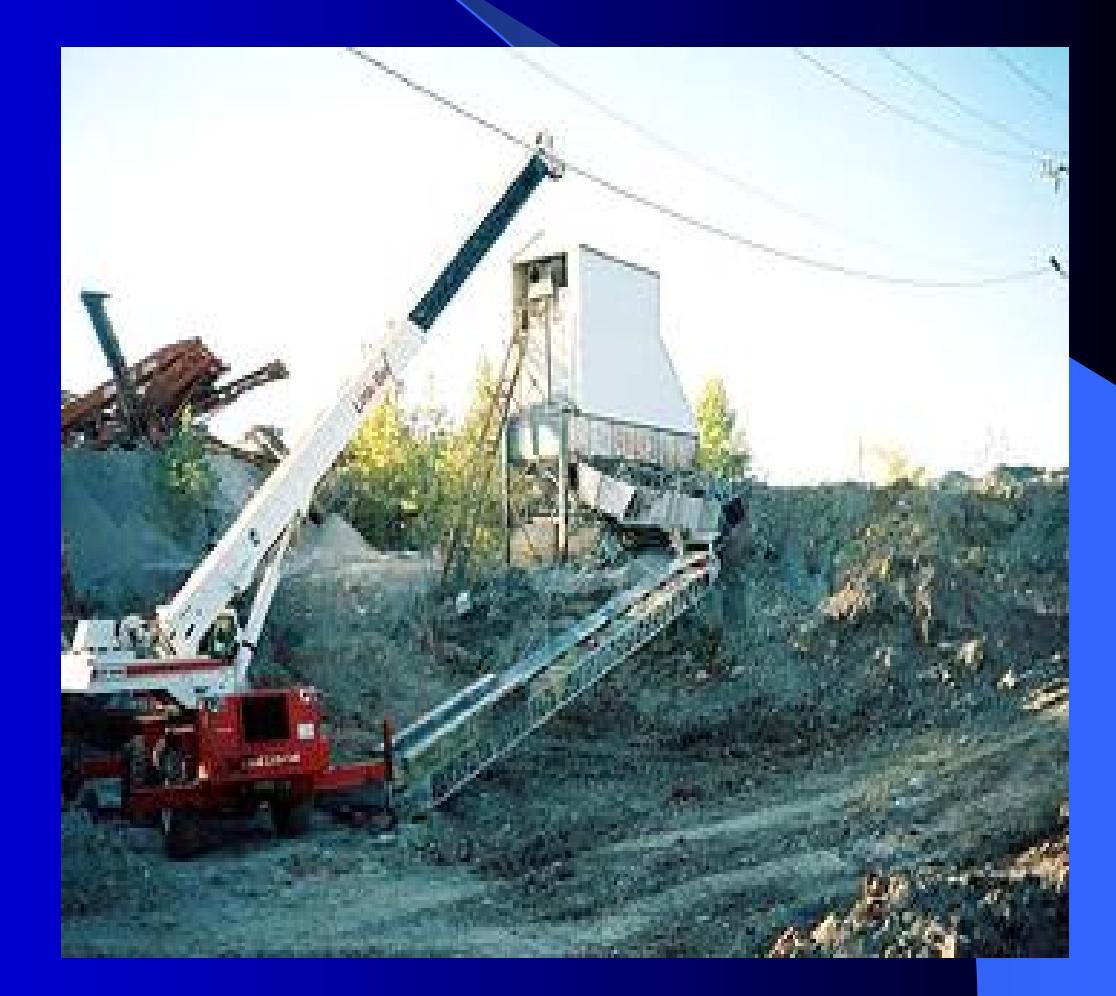
Electrical Fatal October 15, 2004

• A 4 man crew was positioning a conveyor. The victim had both hands on the conveyor when the crane hoist cable contacted a highvoltage power line.

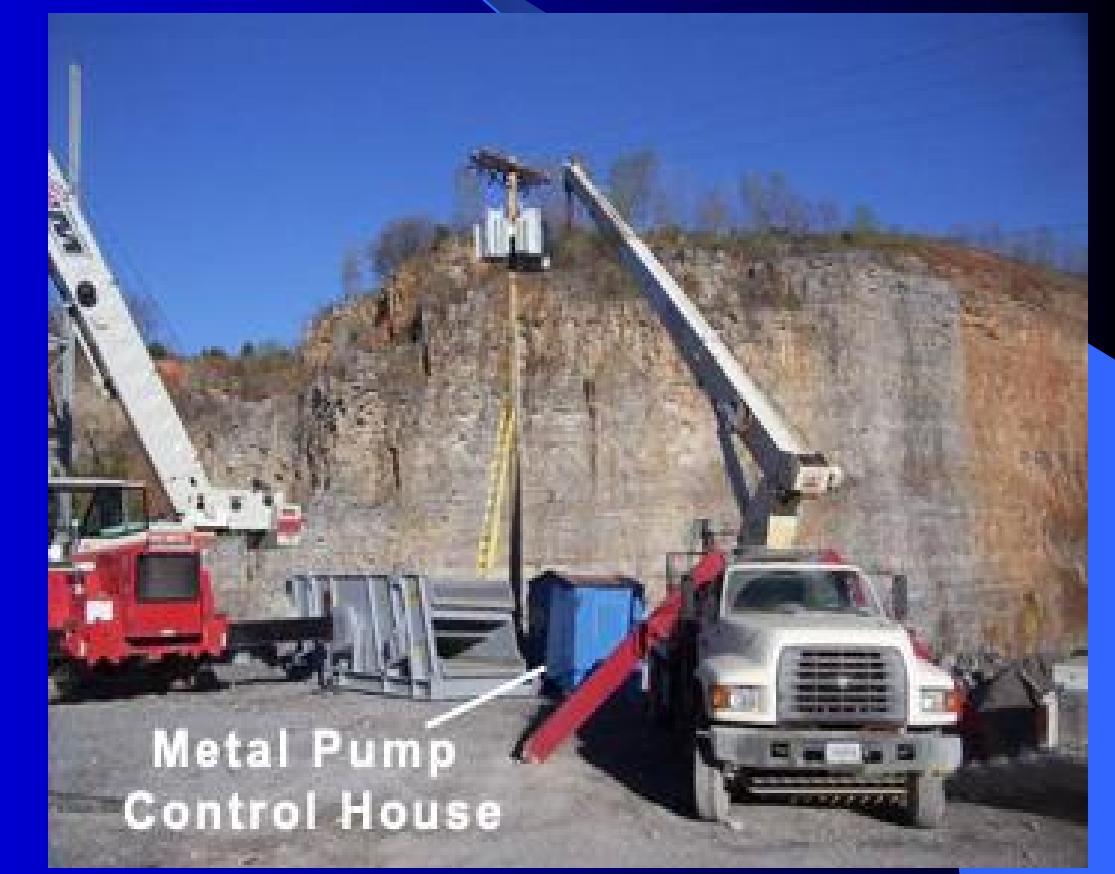
Electrical Fatal April 3, 2006

• A metal pump control house was being set into position. The victim was standing on the ground touching the suspended control house when the crane boom contacted the energized overhead power line.

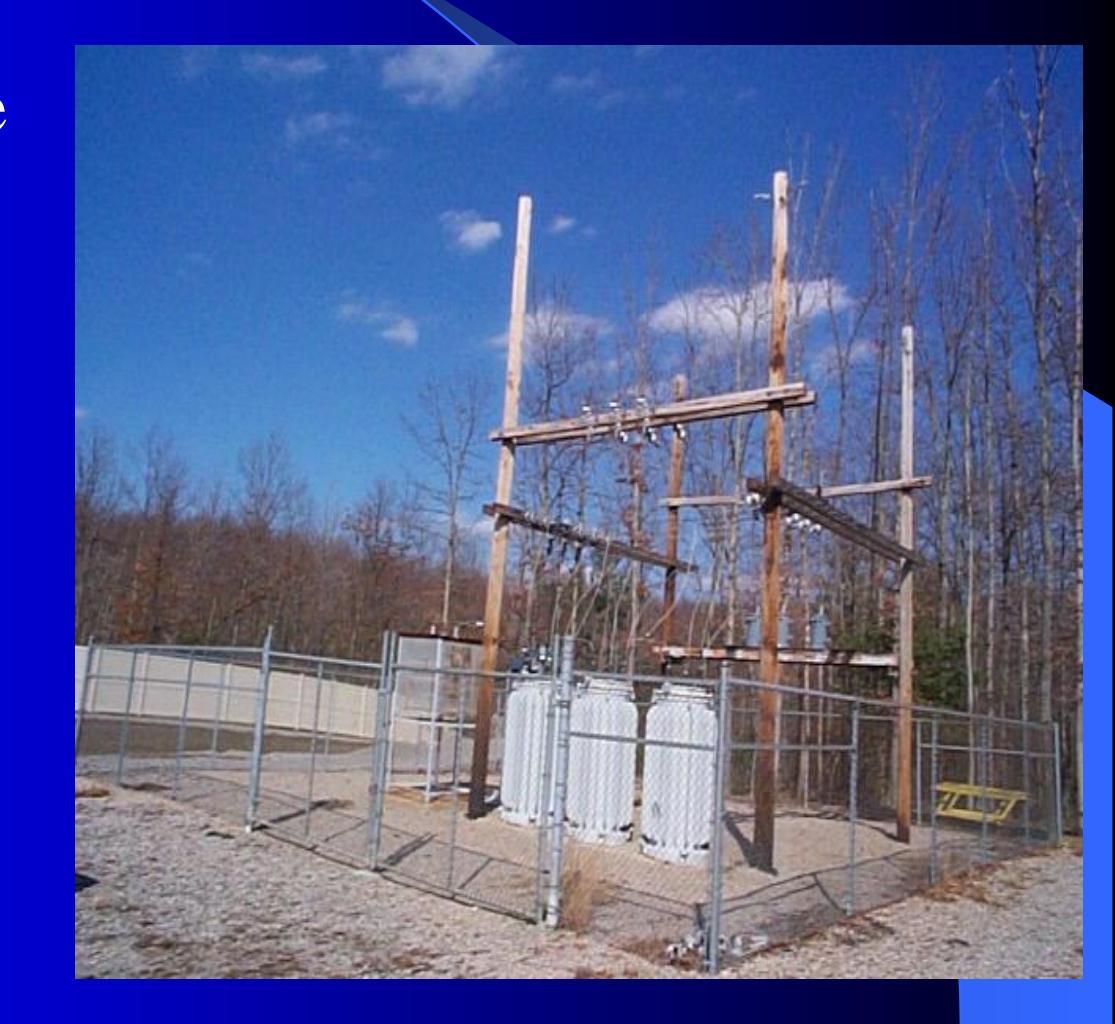
Open Transformers 4VAC25-40-2460

- Surrounded by a fence at least six feet (6-ft) high, with at least three feet (3-ft) of clearance between energized parts, casings, or wiring.
- Kept securely locked.
- Posted with warning/ danger signs.

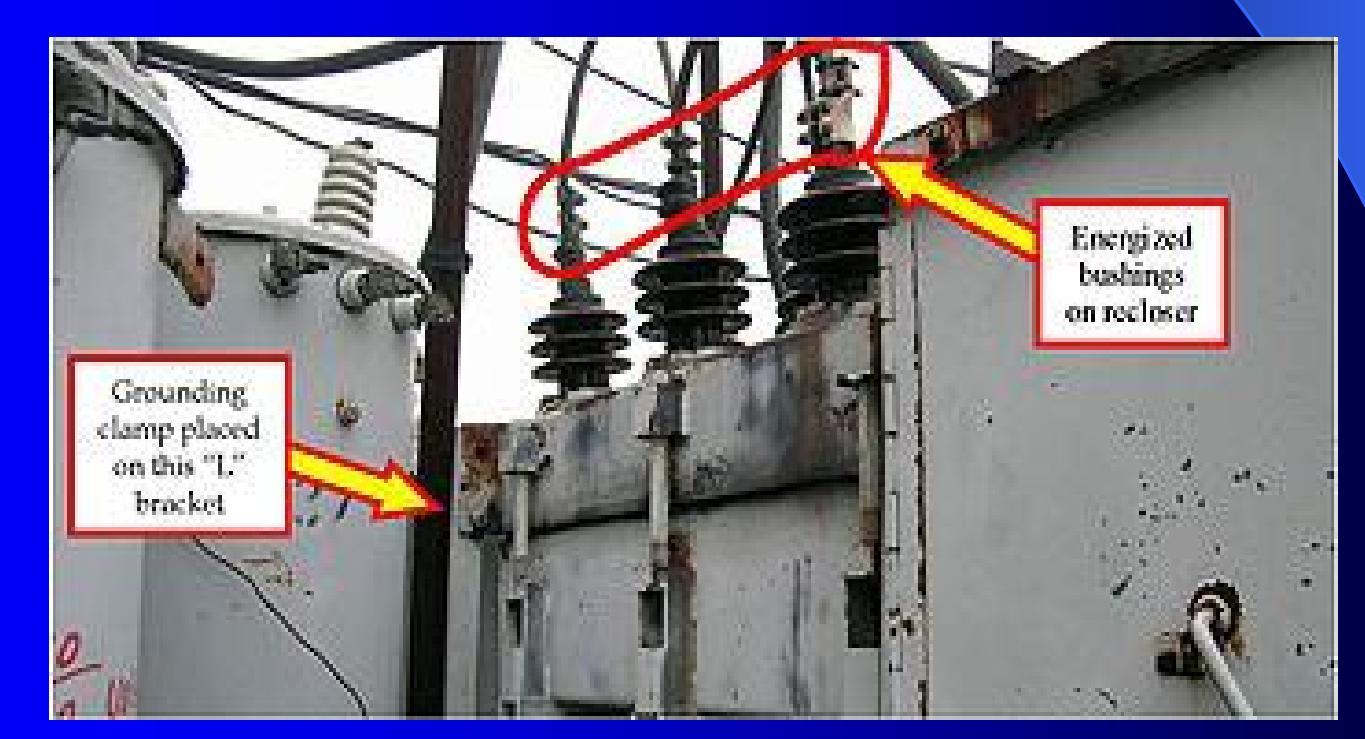
Fatality In Virginia October 23, 2004

The victim and 2 helpers were installing transformers in a substation. The victim was severely burned, and later died, from a high energy arc that occurred while he was working on the transformer. The transformers were energized while grounding clamps were being connected.

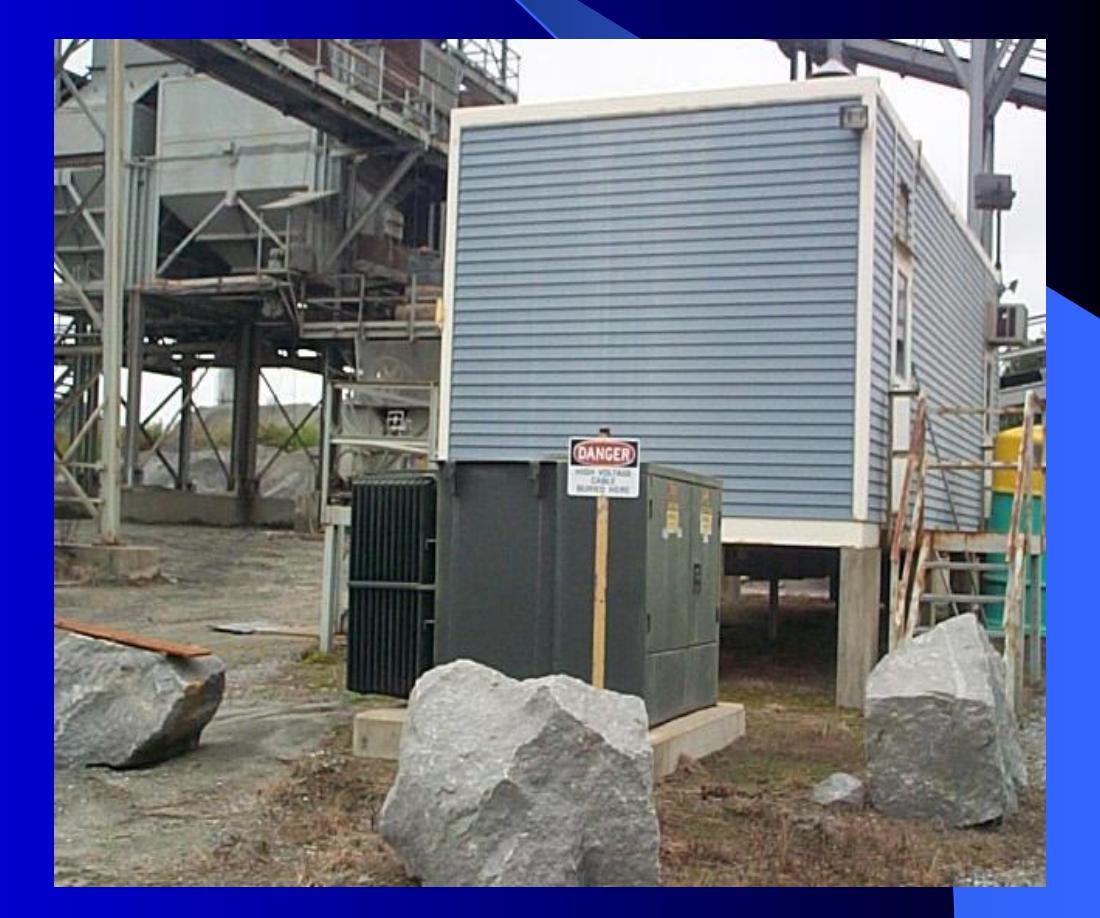
Enclosed Transformers 4VAC25-40-2460

• Totally enclosed.

• Protected location.

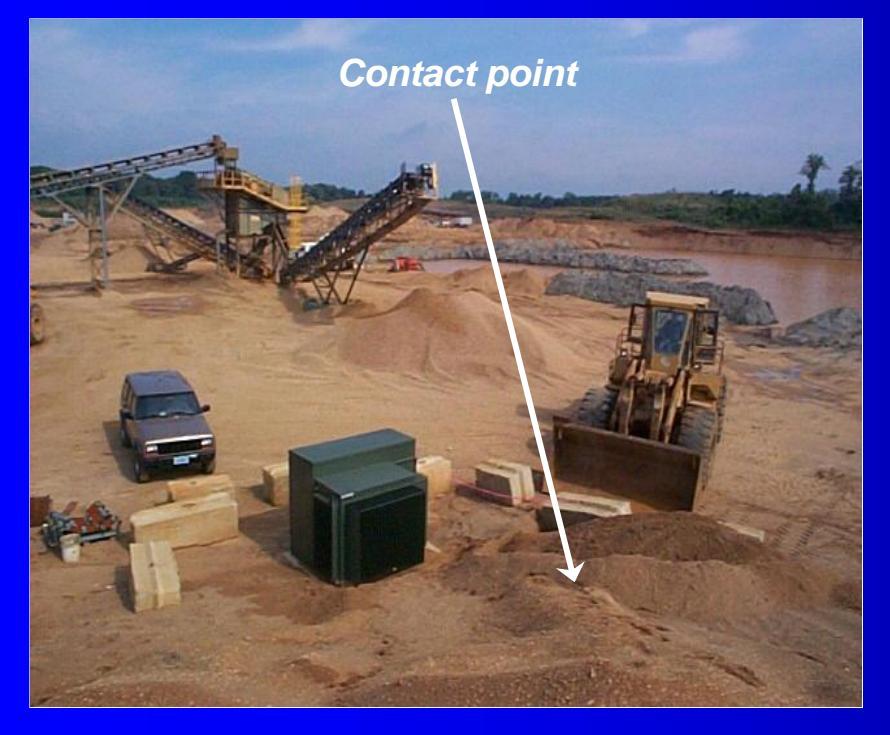
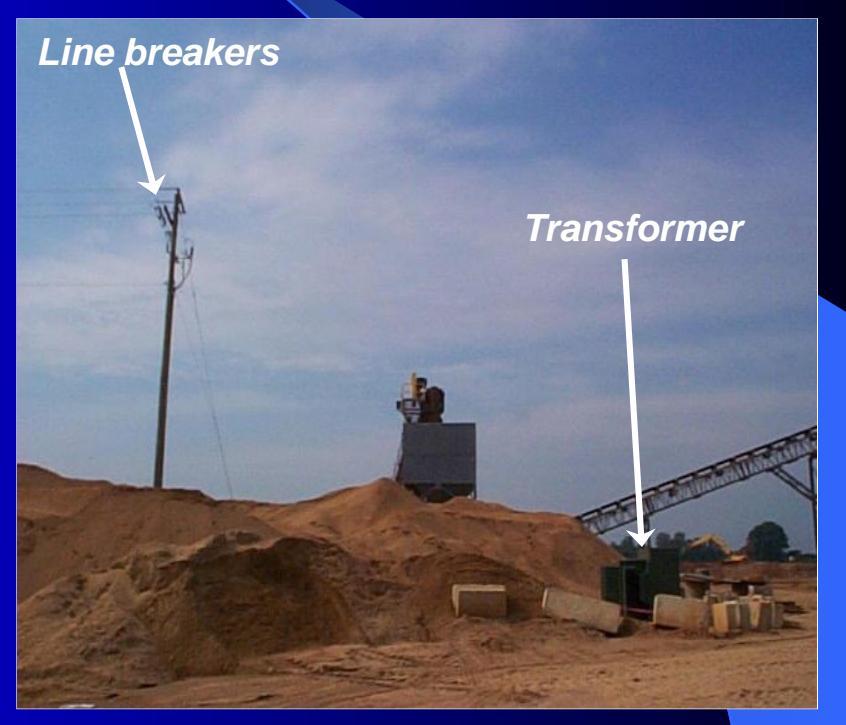
Accident Investigation: Electrical Accident May 22, 2001

A mine worker operating a front-end loader struck and cut buried high voltage (34,000 volts) power lines feeding a totally enclosed transformer located on a concrete pad. The worker was attempting to remove accumulated sand around the barricaded transformer prior to thunderstorms forecast for the region. The bucket of the front-end loader struck & cut the buried wires which then tripped the breakers on a nearby power line pole. Luckily, the worker was not injured.

RECOMMENDATION: Always contact "Miss Utility" to identify and mark location of buried utility lines prior to digging by hand or use of mobile equipment; failure to locate & mark buried lines could result in personal injury, penalties, and disruption of plant production/operation.

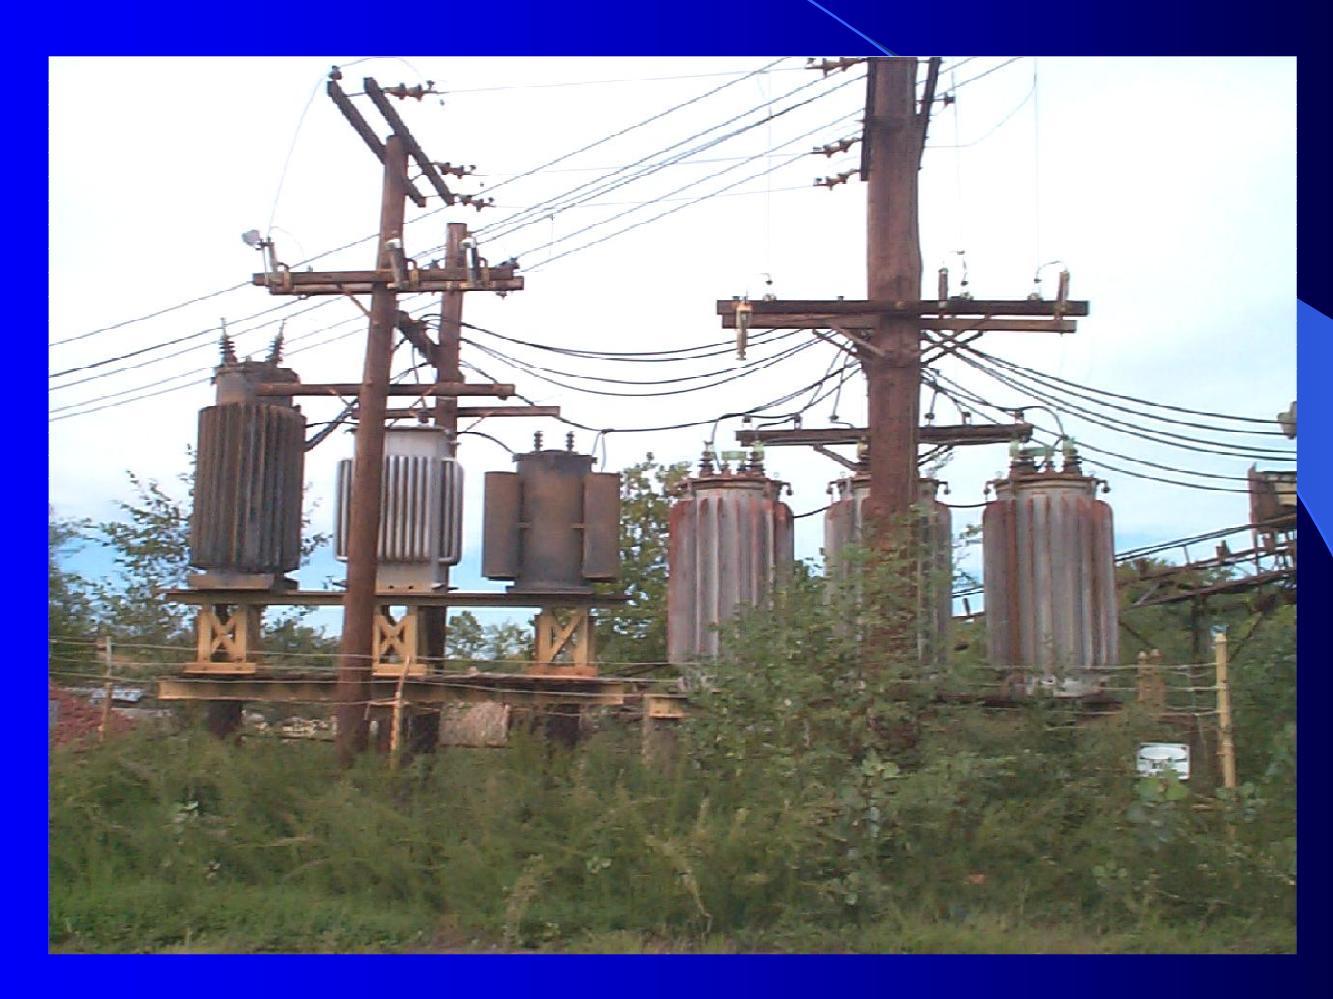
Elevated Transformers 4VAC25-40-2460

Mounted at least 8 feet above the ground
