Electrical Safety AR Training Updated 2012

Division of Mineral Mining

Electrical Safety

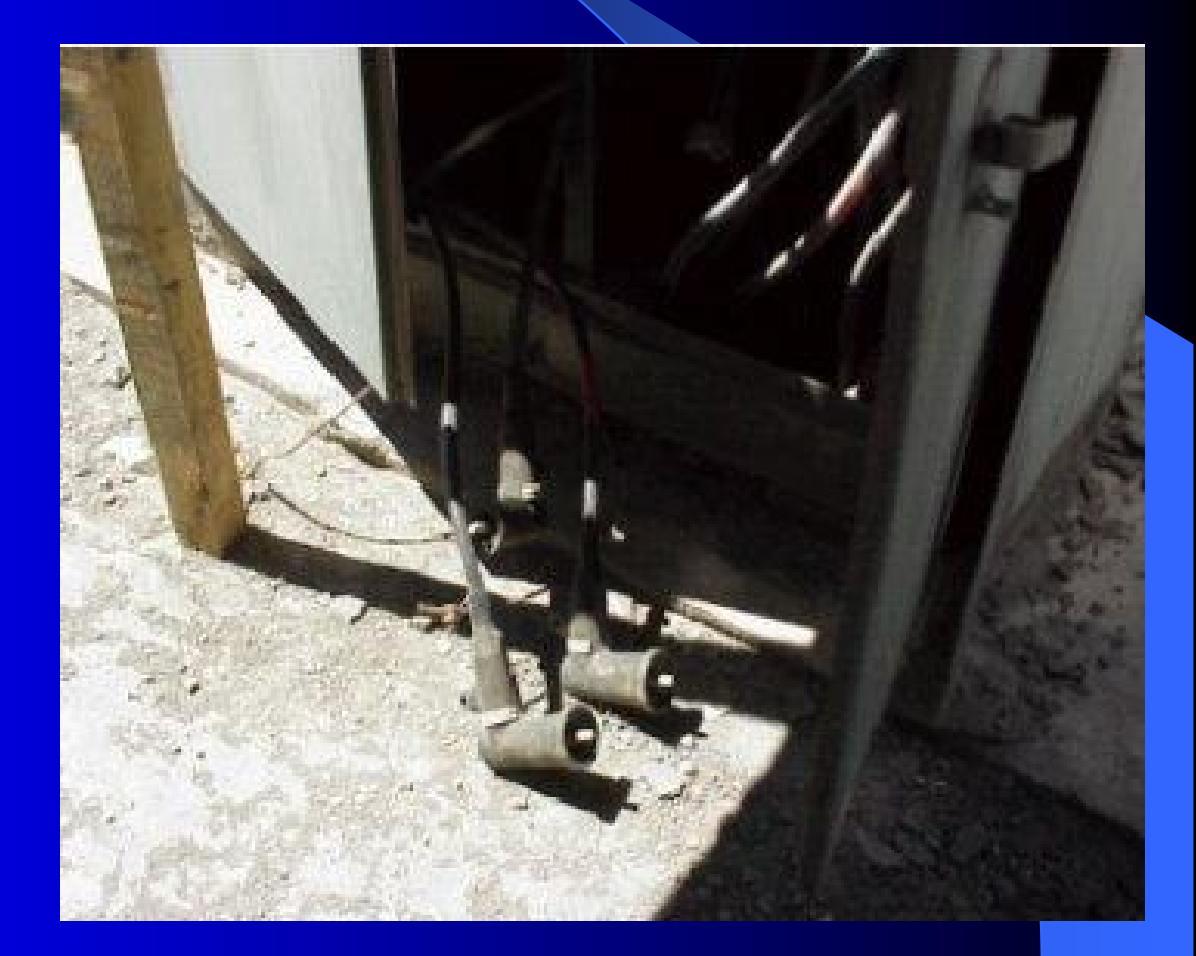
Electrical Fatality July 1, 1999

Victim came in contact with a 4160 volt electric circuit while replacing a transformer. Three leads supplying power to the transformer were disconnected, but, still energized!

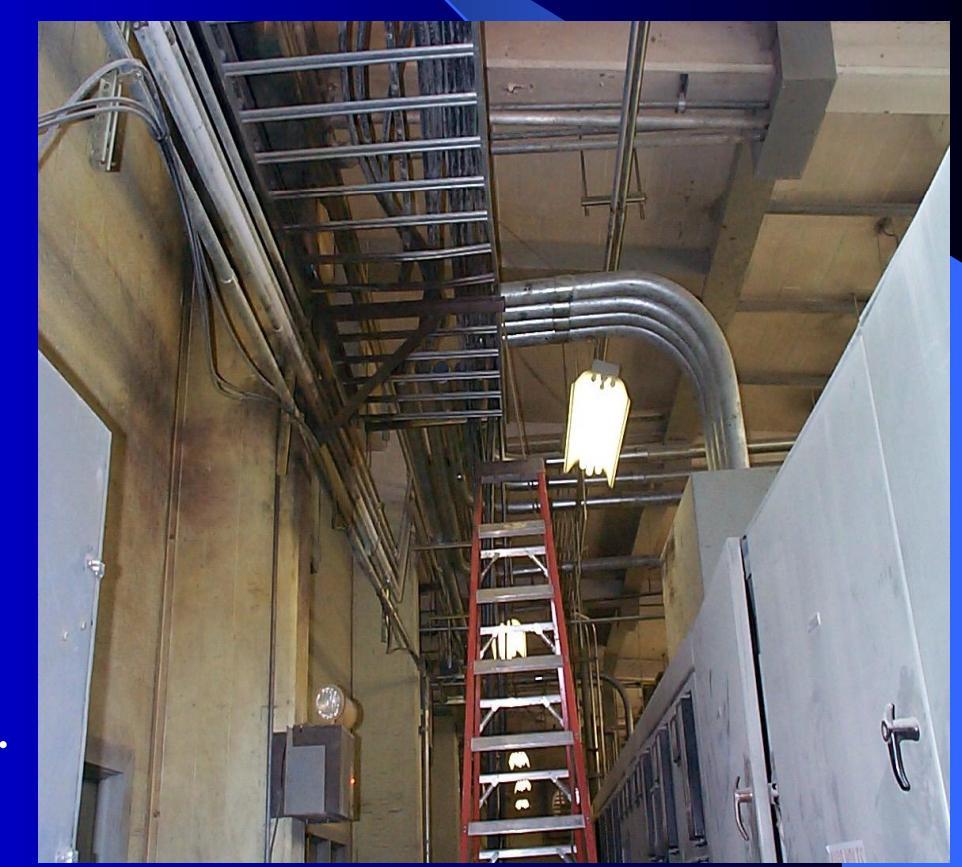
Electrician Helper Burned February 21, 2000

- Victim failed to de-energize, lock-out, and tag-out the circuit (4VAC25-40-2140).
- Victim not adequately supervised by a certified electrician (4VAC25-40-2015).
- Dangerous condition not corrected (4VAC25-40-2270).

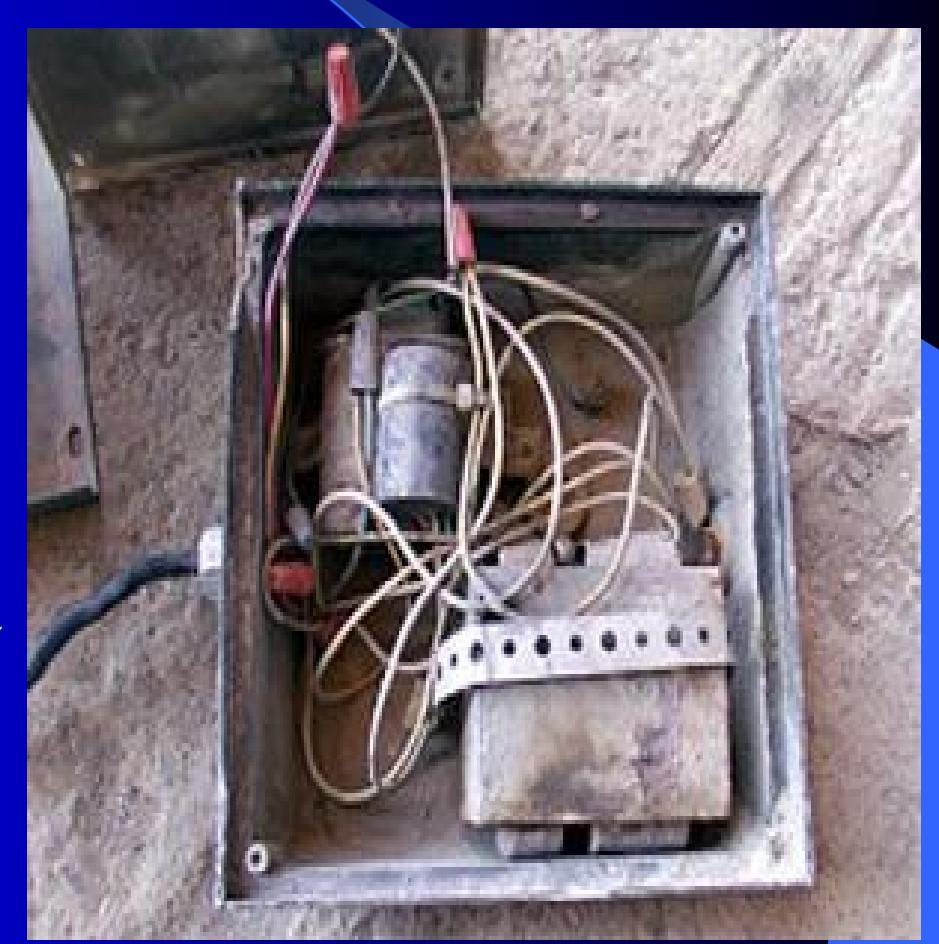
Electrical Fatality August 17, 2002

• Victim was electrocuted when he contacted a 480 volt cable and junction box in the process of moving them.

• Issues involved included using fuses and breakers of a proper type and size and ensuring proper grounding of metal enclosures.

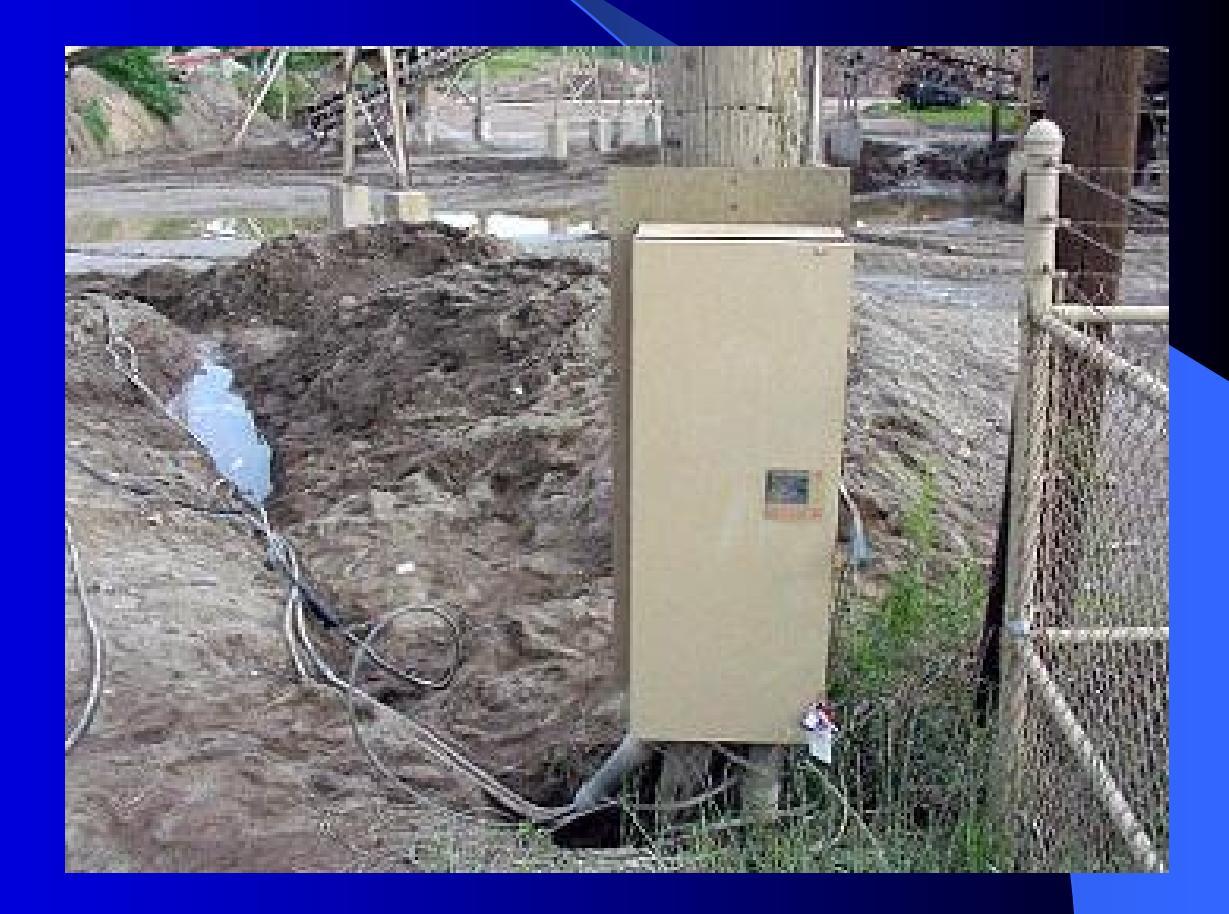
Electrical Fatality May 21, 2003

The victim was in the process of making a splice in a 480 volt power cable. While removing the insulation, he contacted a live conductor.

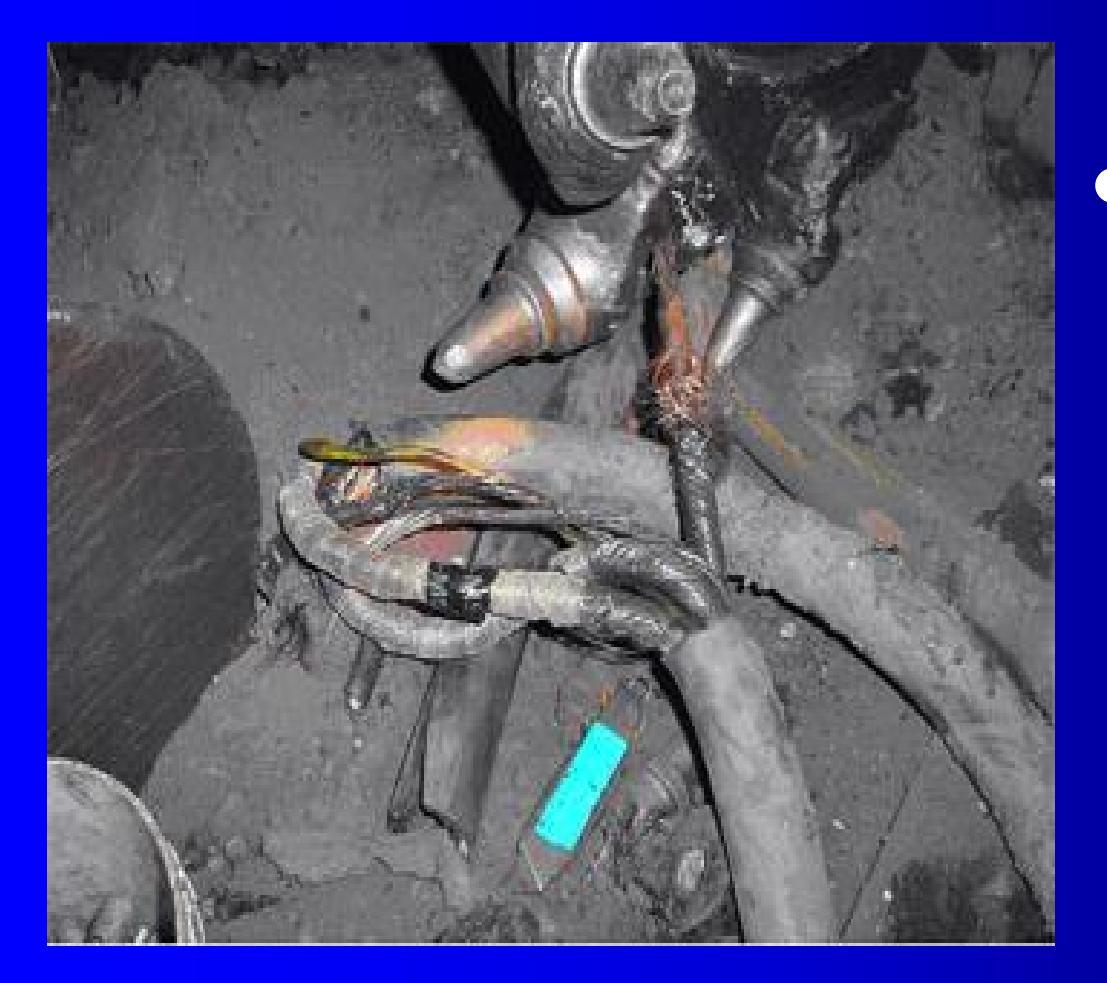
Electrical Fatality February 5, 2004

The victim was splicing a power cable during a mine-wide power outage. The power was restored to the cable before he finished, resulting in a fatal electrical shock.

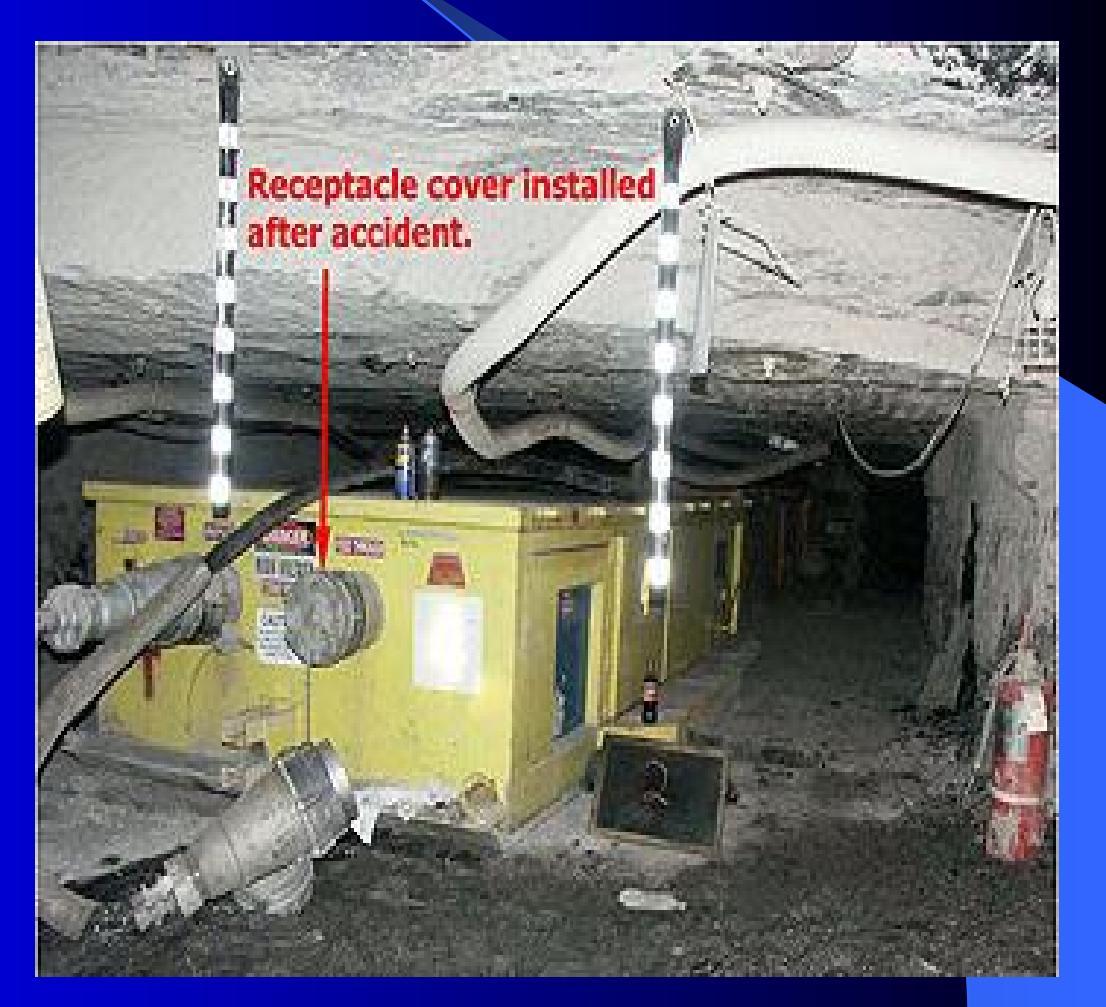
Fatality In Virginia September 24, 2004

- Victim suffered an electrical shock when he apparently contacted an energized receptacle.
- Proper identification of switches and use of proper testing equipment were factors as well as failure to lockout.

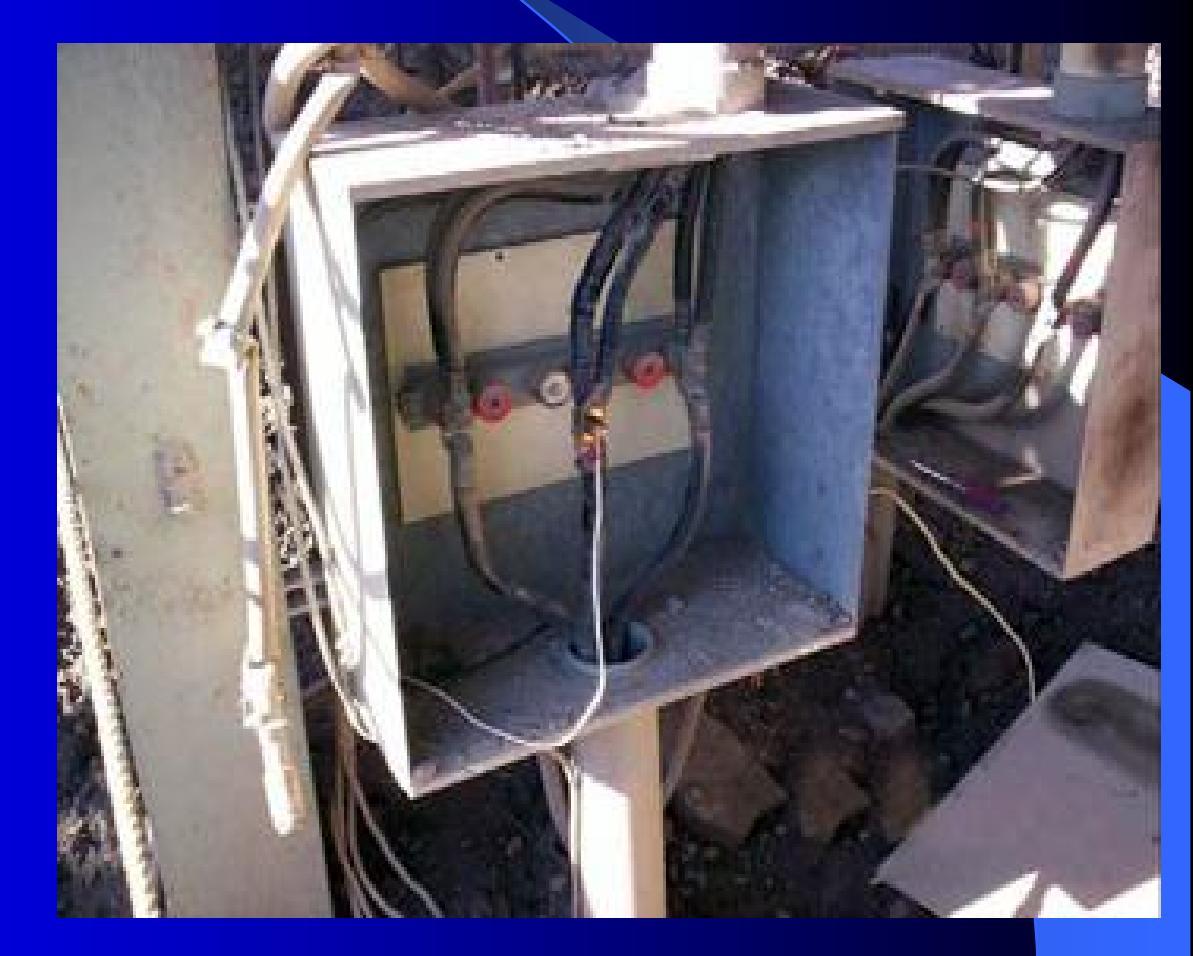
Electrical Fatality March 28, 2005

• The victim was performing repairs inside an electrical box when he contacted an energized component.

• Proper identification of circuits and use of testing equipment were factors as well as poor lockout practices.

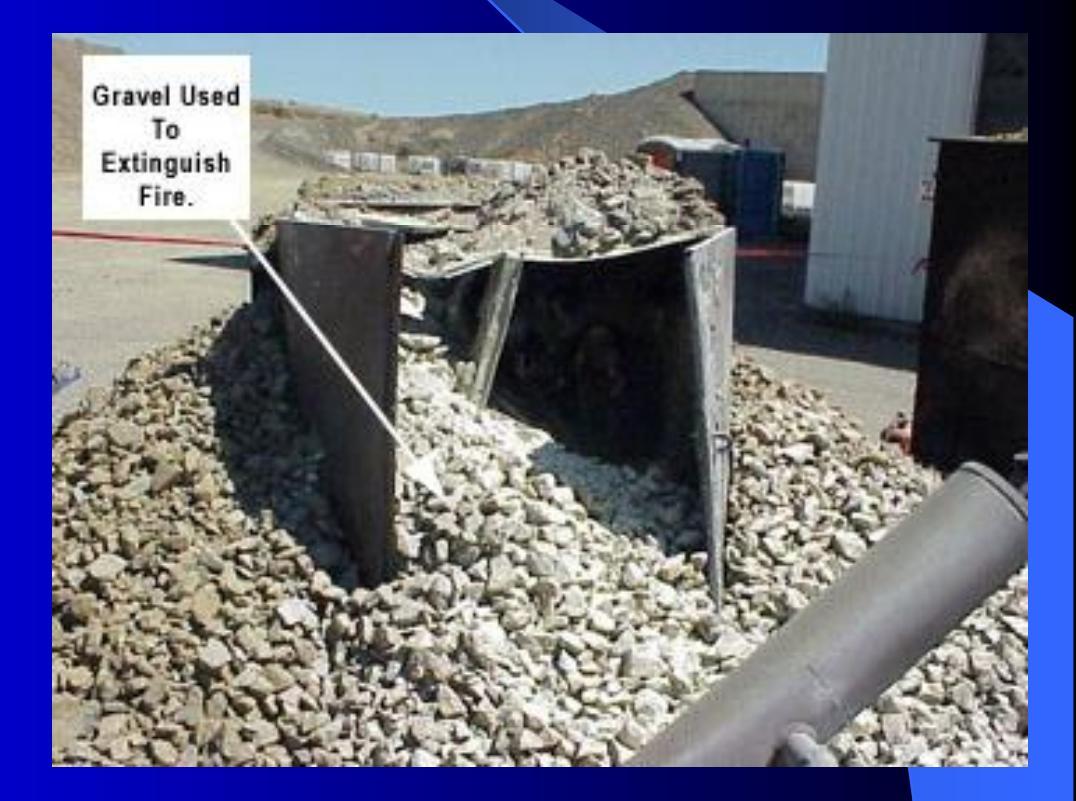
Electrical Fatality May 23, 2005

- The victim was working near an energized high voltage conductor when apparently an arc flash occurred.
- Proper identification of circuits, use of testing equipment and use of proper PPE were factors as well as poor lockout procedures.

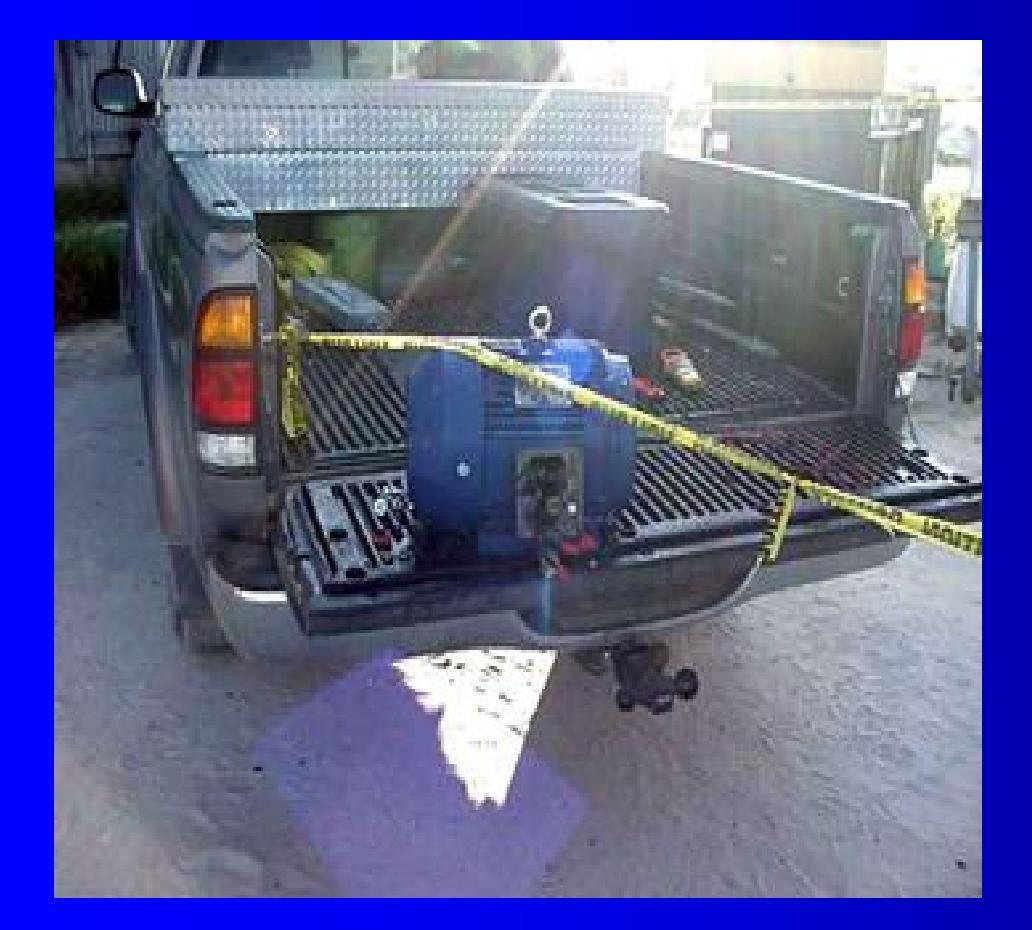
Electrical Fatality May 19, 2006

• A 77 year old contract electrician with 50 years of experience was checking an electrical motor and contacted an energized conductor.

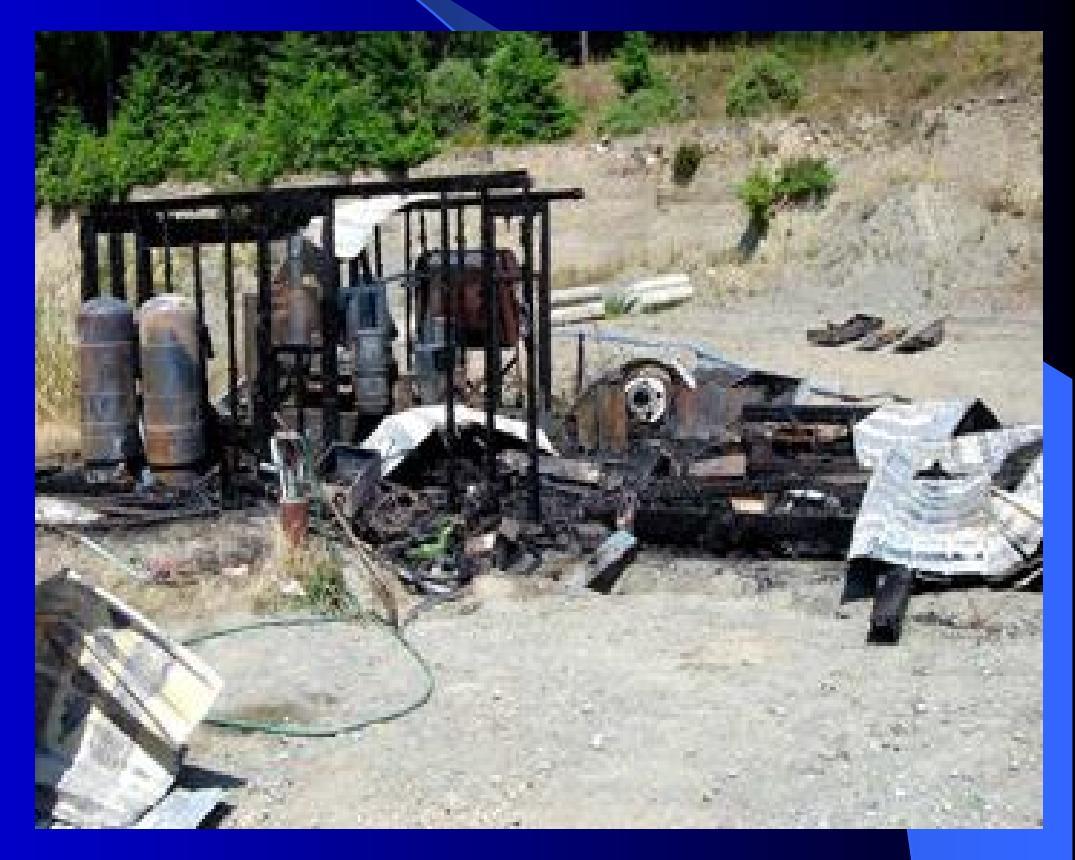
Electrical Fatality June 21, 2006

• A 75 year old contractor electrician was fatally injured when he contacted energized conductors while installing an electrical circuit.

• The building where the electrician was working subsequently caught fire and burned down before the primary circuit could be deenergized.

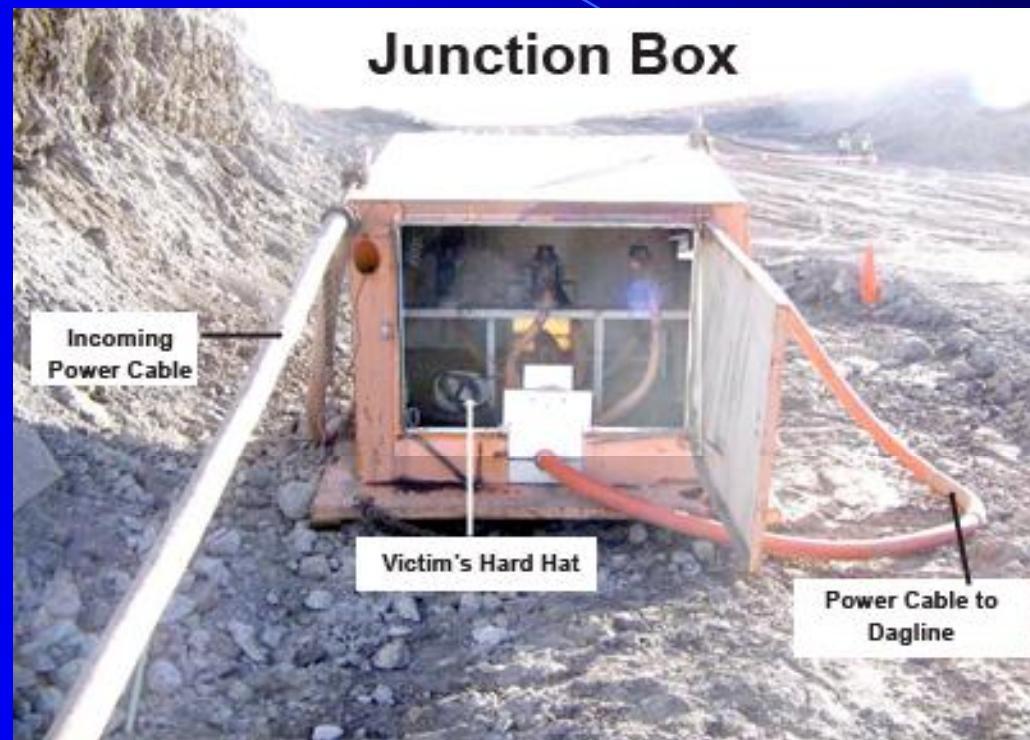
Coal Fatality October 23, 2006

An electrician was fatally injured while troubleshooting the trailing cable for an electrically powered dragline. The victim was working at a junction box that supplied power to the dragline when he contacted two 23,000 volt energized phases in the box. *Incoming power to the box had been disconnected and locked out by the victim*. A diesel powered generator on the dragline was started causing 480 volts to back feed, energizing the phases.

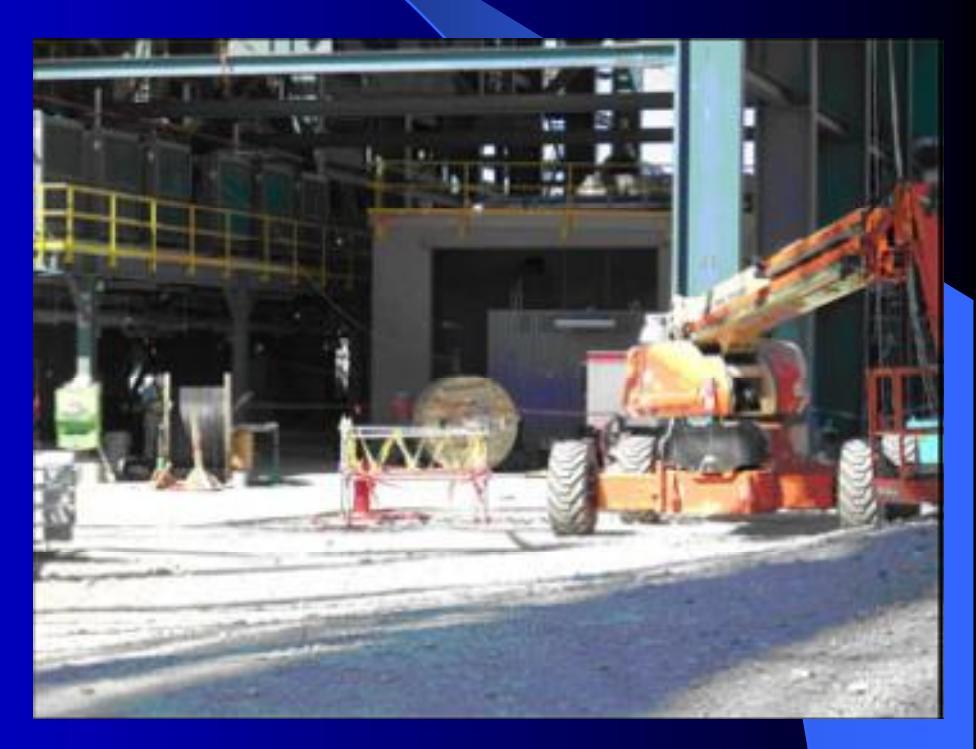
Electrical Fatality Accident, Sept. 14, 2007 Victim Died, July 7, 2008

- With the switchgear in the "on" position, the victim opened an enclosure to make an adjustment.
- As he reached into the cabinet, his hand contacted the energized fuse block sending current through him and out his other hand, which was in contact with the cabinet door, to ground.

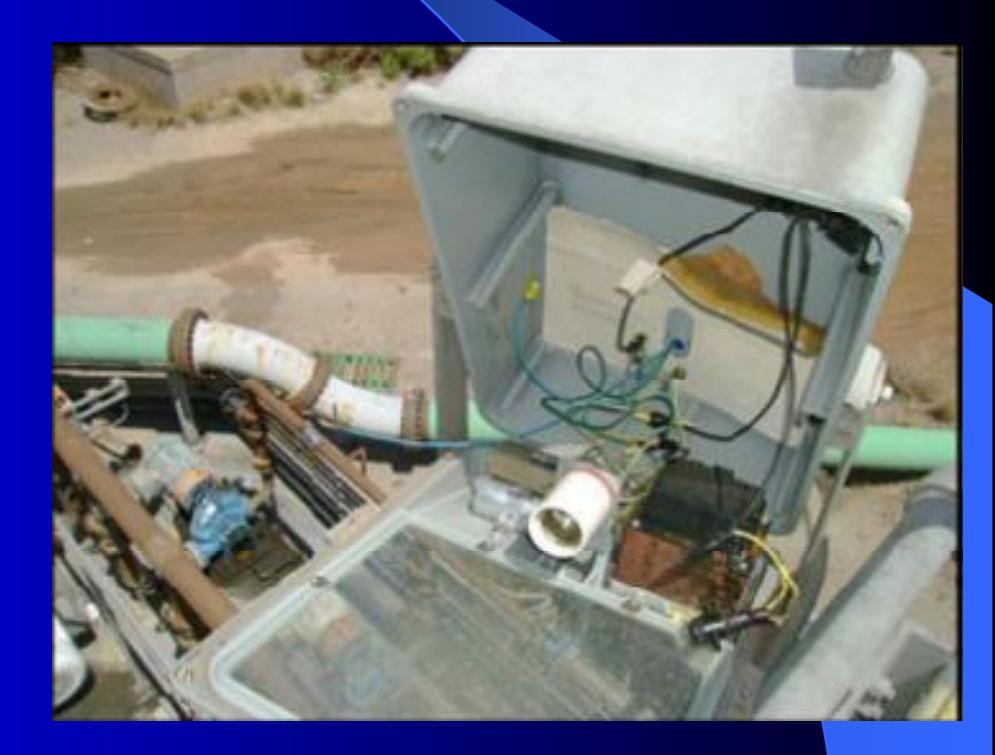
Electrical Fatality August 15, 2008

- An apprentice electrician was fatally injured while working on a 480-volt floodlight.
- He came into contact with the energized wiring supplying power to the light.
- Failure to lock out/tag out and test were key factors.

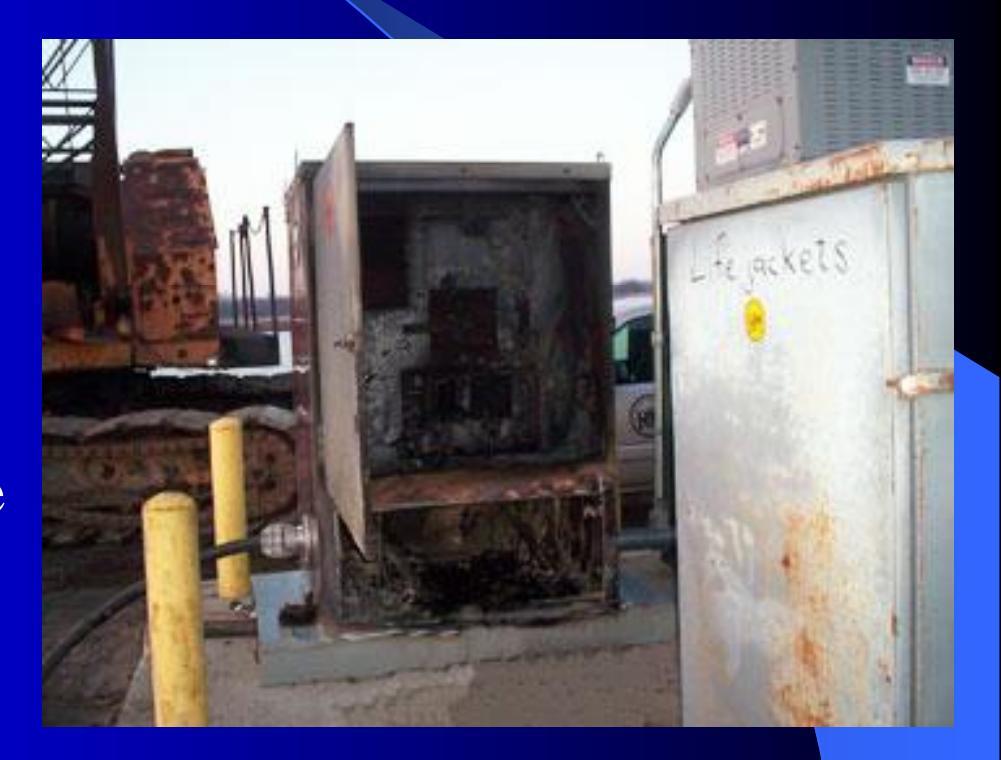
Electrical Fatality April 7, 2009

• A 36 - year old supervisor with 15 years of experience was fatally injured at a sand and gravel dredging operation. The victim was attempting to connect the 4160 volt cable for the dredge to load side terminals in the electrical panel when he came into contact with energized 4160 volt line side terminals.

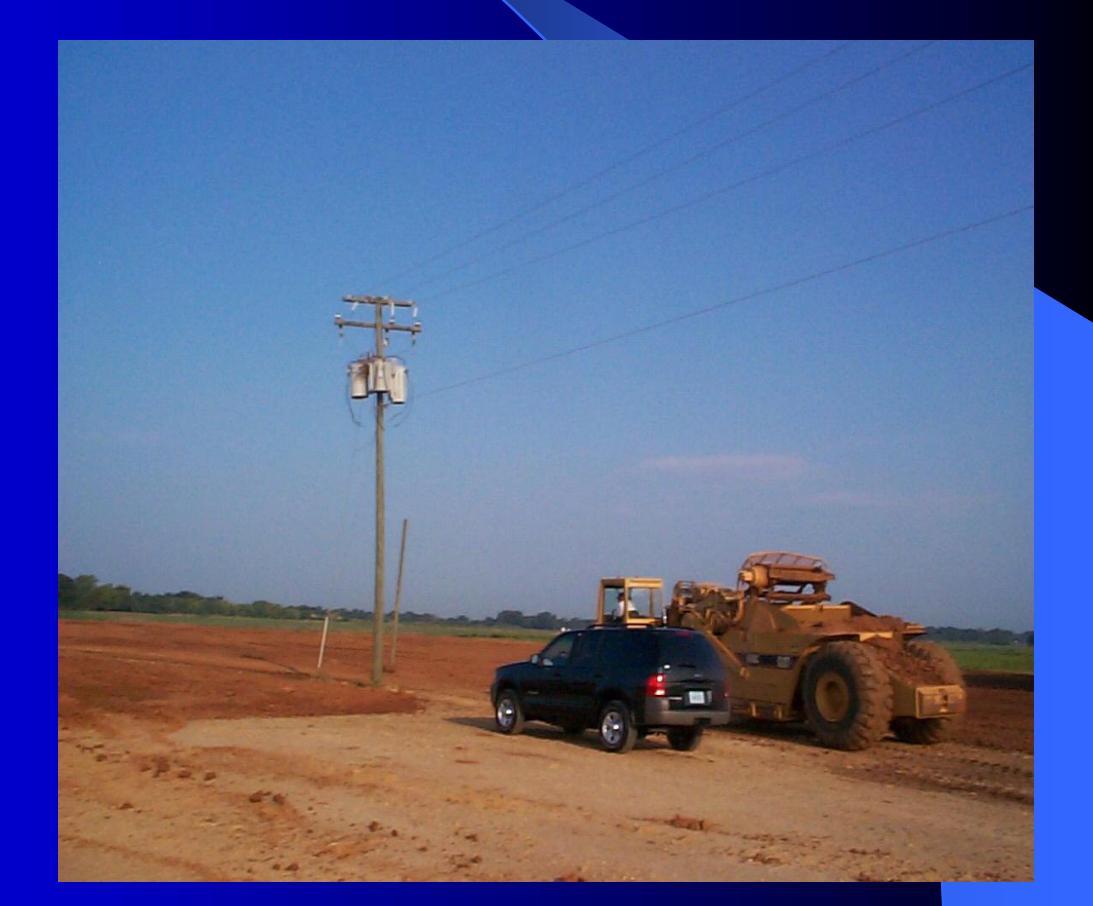
Utility Power Lines 4VAC25-40-2450

• Where metallic tools or equipment can come in contact with bare power lines, the lines shall be guarded or de-energized.

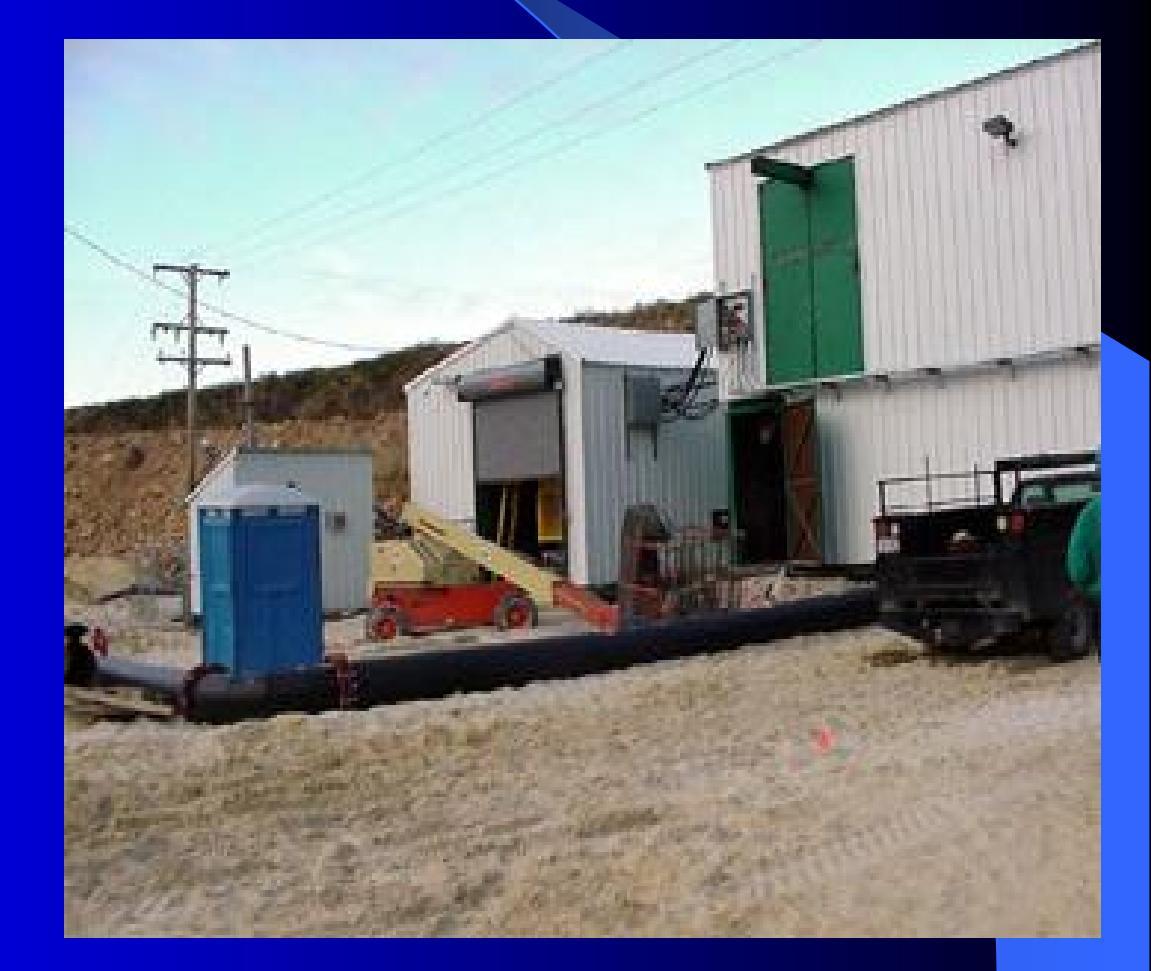
Electrical Fatality October 2, 2001

The victim was installing power lines to an electrical box on the side of a building. As he swung the man lift he was working from away from the building it contacted high voltage power lines that were located above his work area.

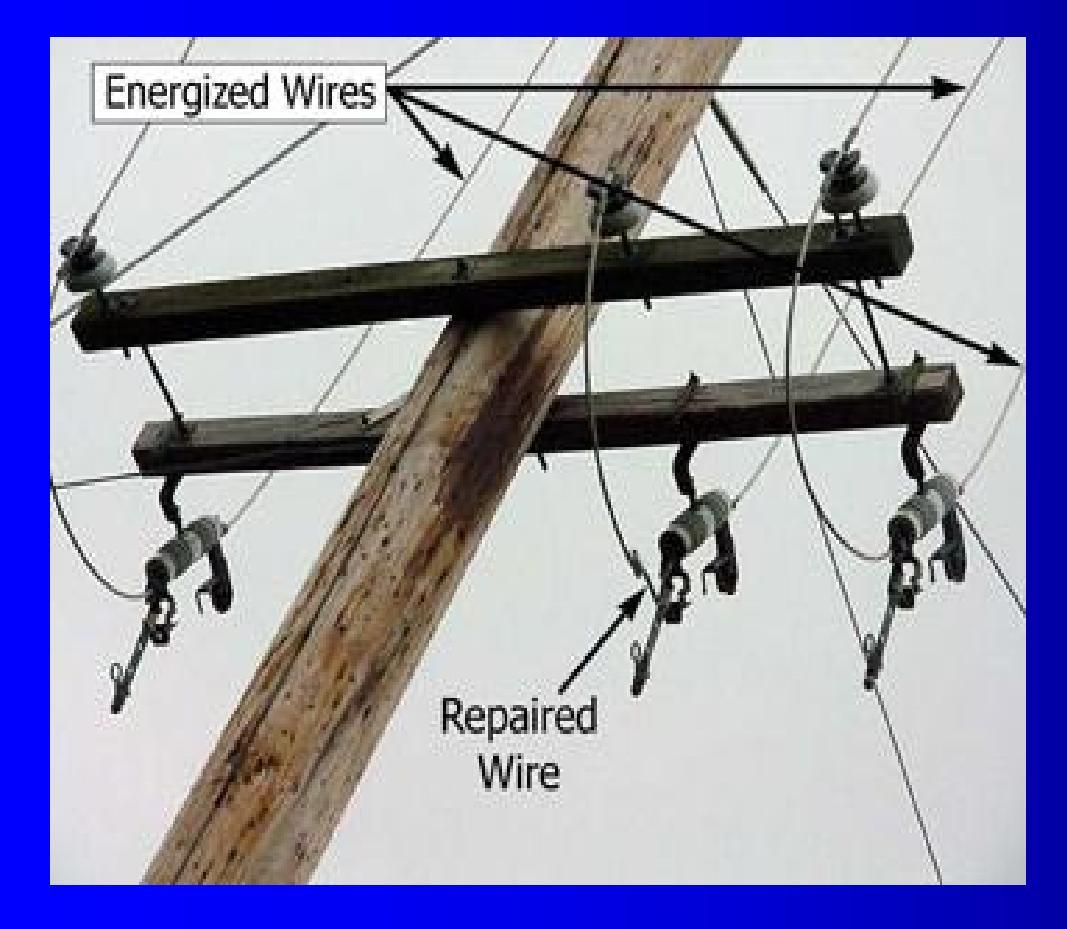
Electrical Fatality August 29, 2004

The victim contacted an energized power line while working on a power pole.

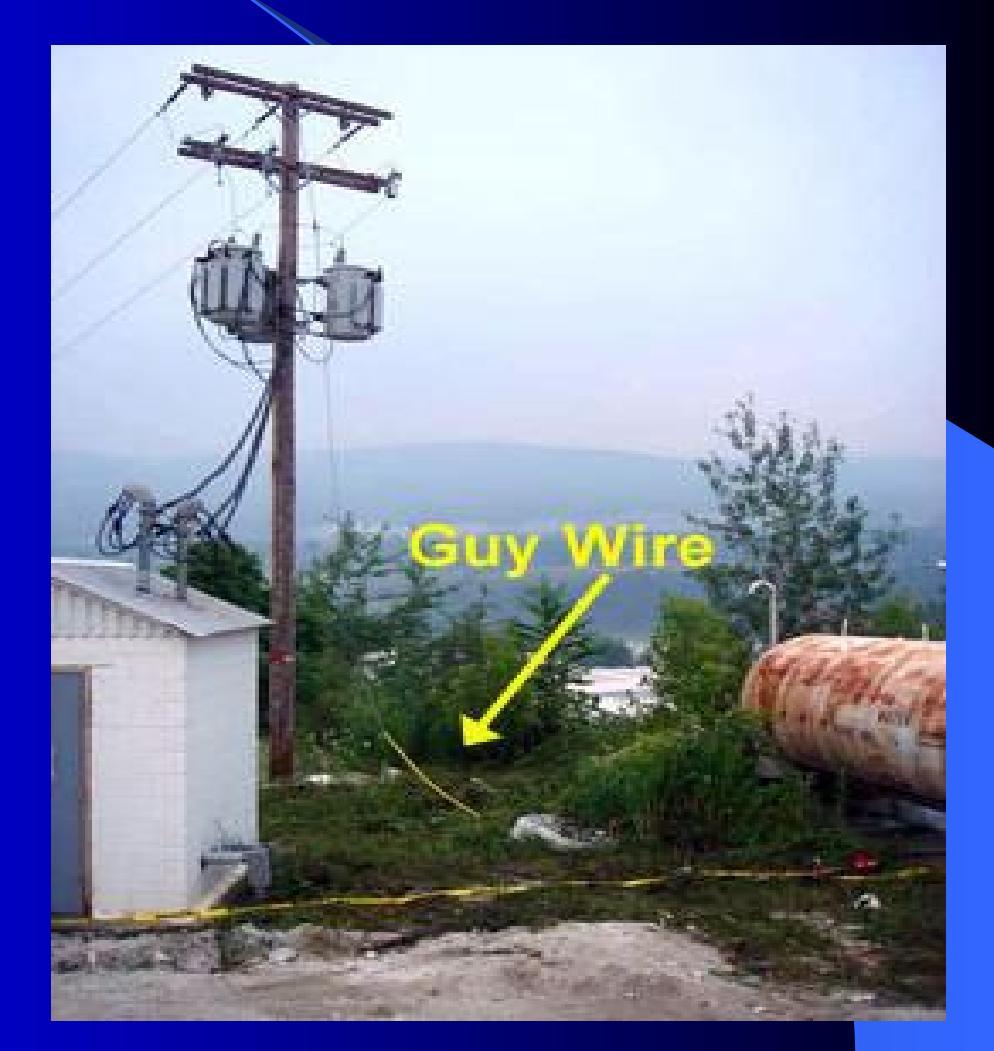
Electrical Fatality July 27, 2006

• A contract laborer was using a weed eater with a steel blade to cut weeds and brush near a power pole. He severed the guy wire causing it to contact an energized supply conductor electrocuting him.

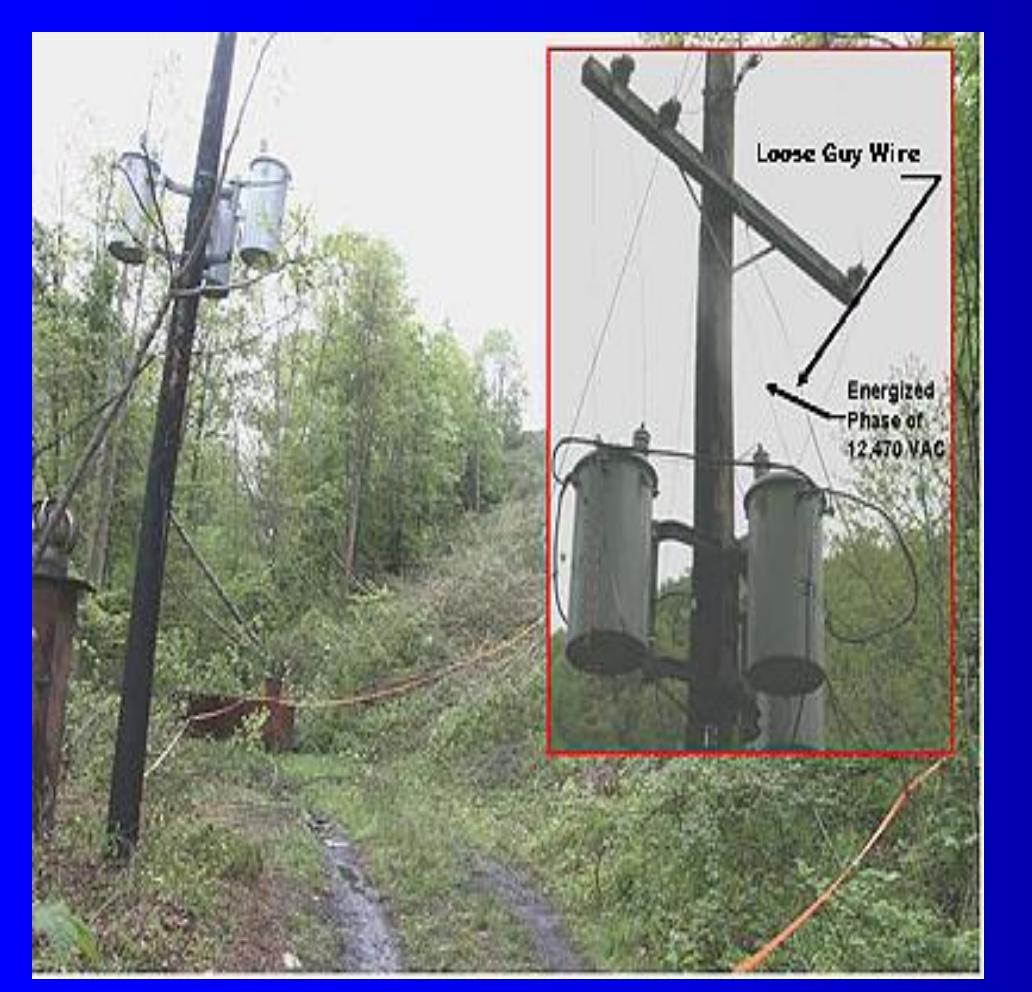
Coal Fatality - Buchanan County, Va. May 4, 2006

Contractor was clearing brush near a 12,470 VAC transmission line when he contacted an energized guy wire.

• There was no insulator, ground or proper anchor at ground level to prevent the guy wire from becoming energized.

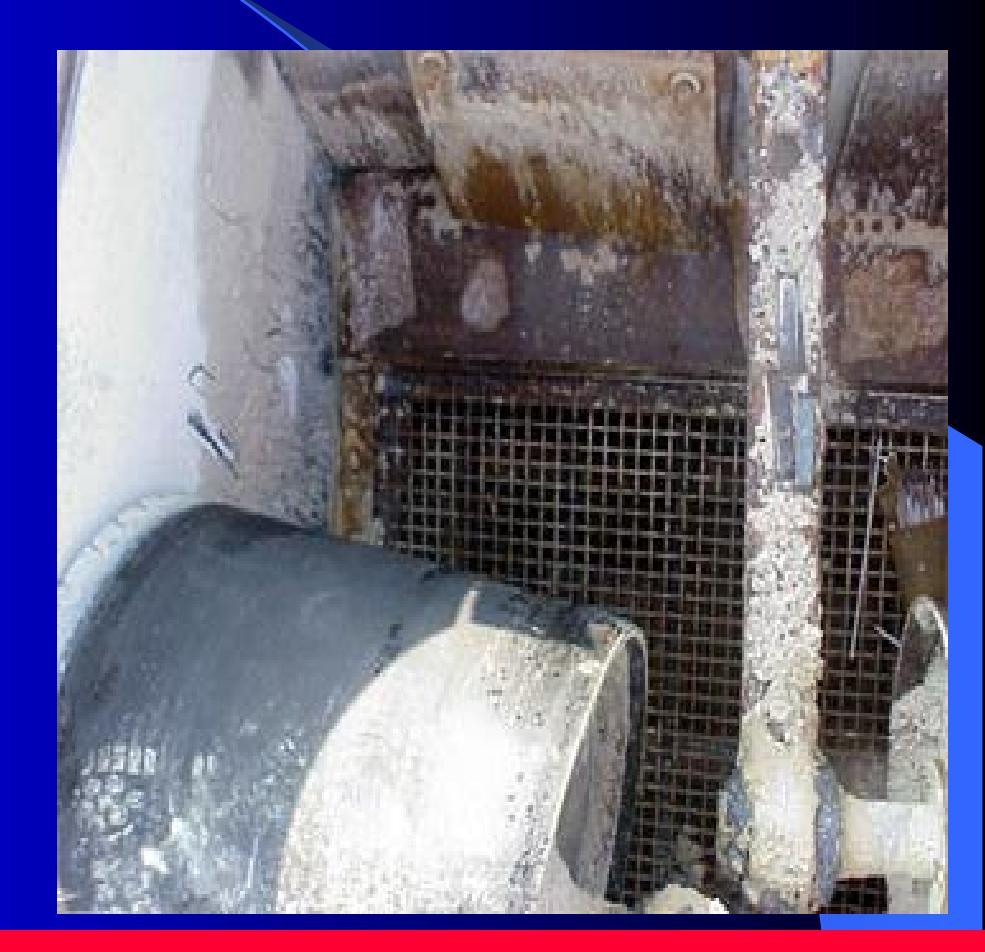
Electrical Fatality September 26, 2002

The victim was welding on a wet, metal screen deck in a confined area when he apparently touched the energized welding rod to his chest and received an electrical shock.

Proper protective matting and PPE are to be used when welding in confined spaces!

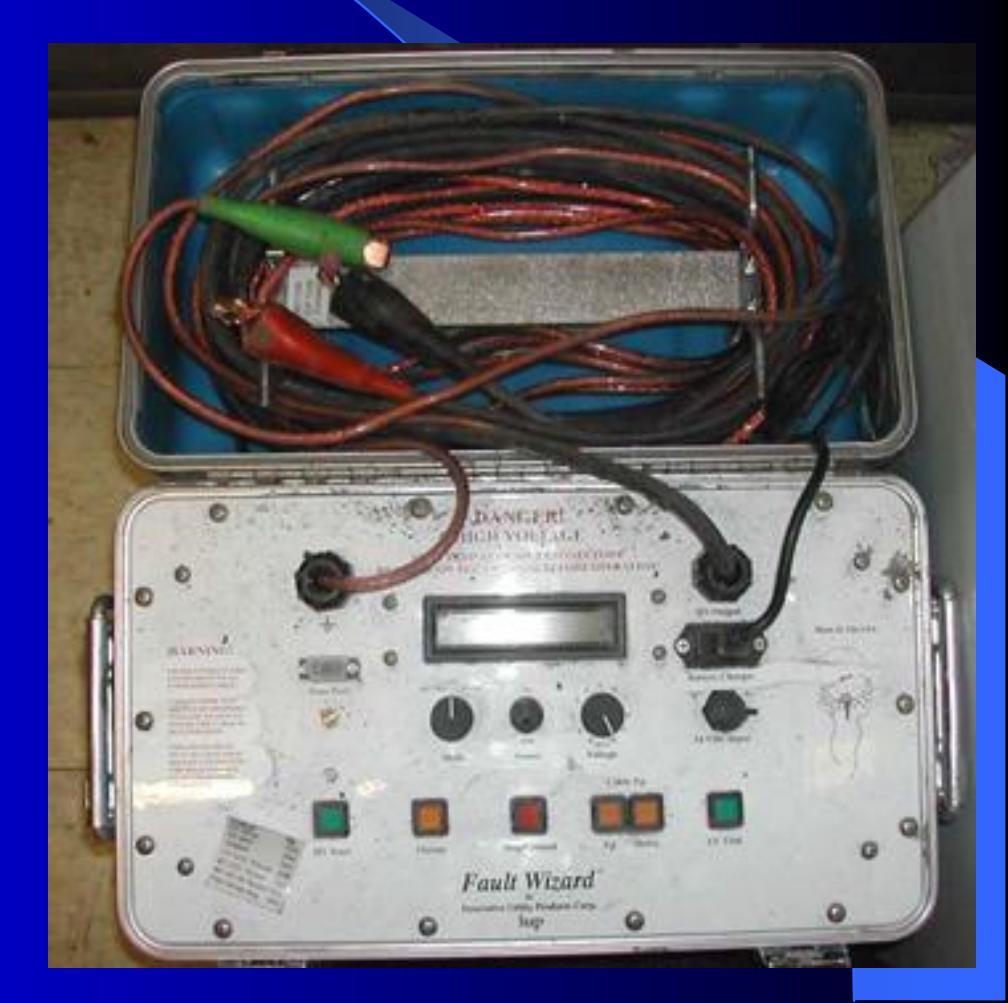
Electrical Fatality November 4, 2005

•A chief electrician was fatally injured while demonstrating the use of a high voltage cable fault locating device. The voltage selector was set on 10,000 volts at the time of the accident.

•Failure to follow the manufacturer's instructions, lack of specific task training and not using proper PPE were all factors in this accident.

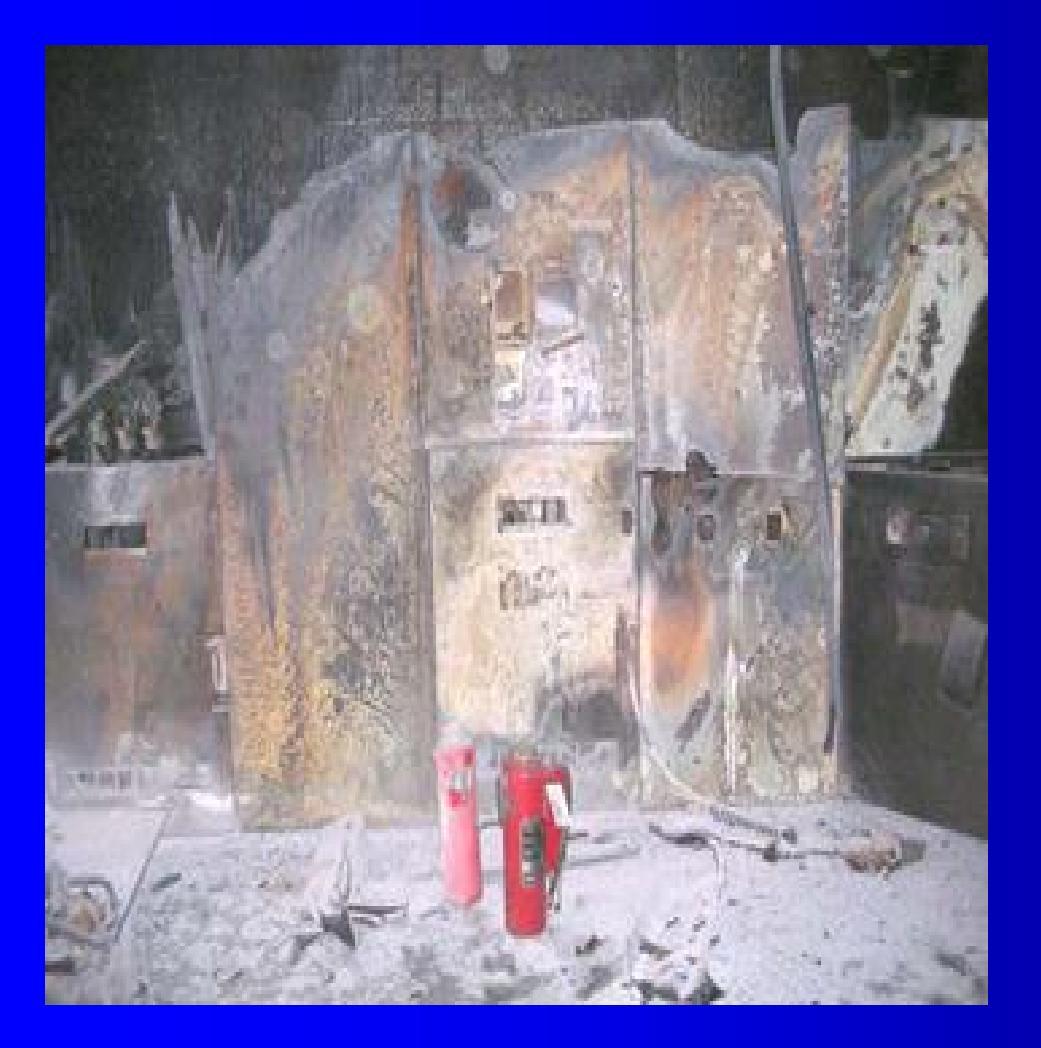
Electrical Fatality October 12, 2006

• A maintenance coordinator was troubleshooting an electrical fault in a high voltage motor control center when a sustained arc blast occurred.

• Calibration and maintenance of circuit protection devices and wearing proper PPE were factors in this accident.
