Electrical Safety AR Training Updated 2012

Division of Mineral Mining

Electrical Safety

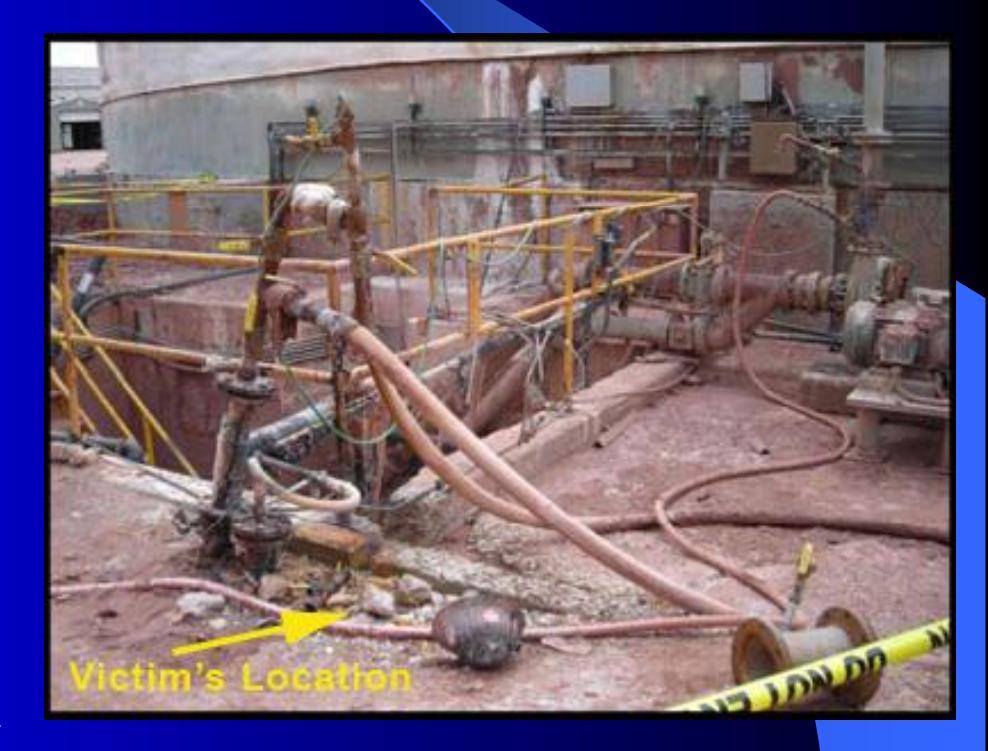
Electrical Fatality August 6, 2008

- A shift foreman with 15 years of mining experience was electrocuted when he contacted an energized steel water line.
- One conductor of a 480 volt circuit had short circuited to an abandoned heater tape.
- The heater tape, which was attached to the water line, overheated and energized the water line with 277 volts.

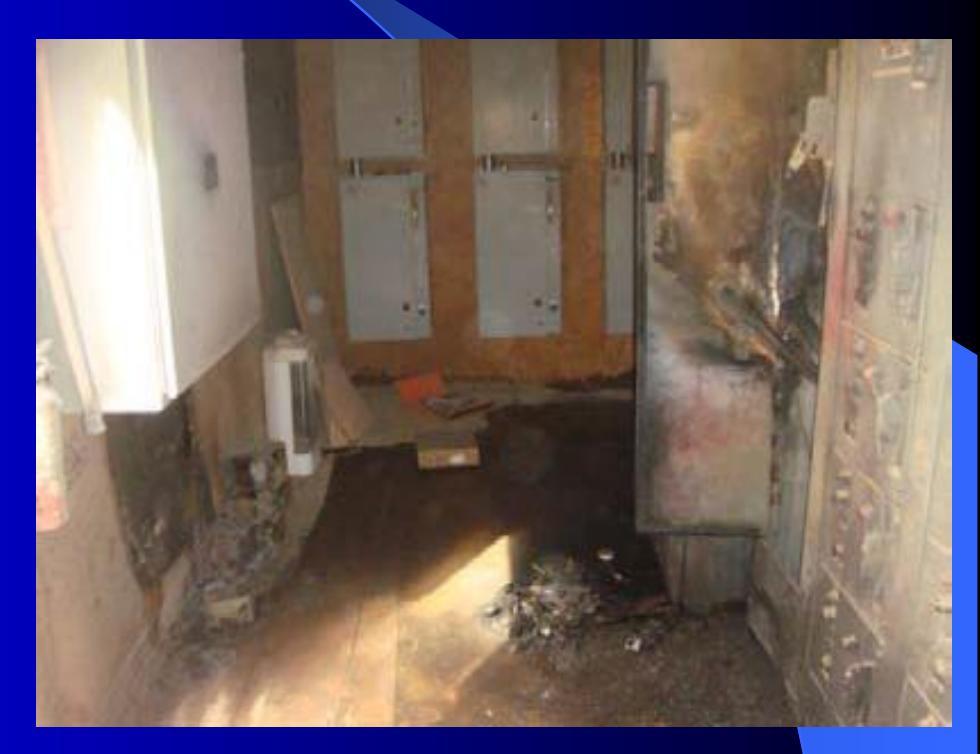
Electrical Fatality October 10, 2010

• A 42 year- old contract electrician with 4 years of experience was seriously injured at a granite operation. The victim and two co-workers were installing ground fault indicator lights in a circuit breaker enclosure when an arc flash occurred. The circuit breaker enclosure contained a bottom feed circuit breaker. All three workers were hospitalized and the victim died on October 12, 2010.

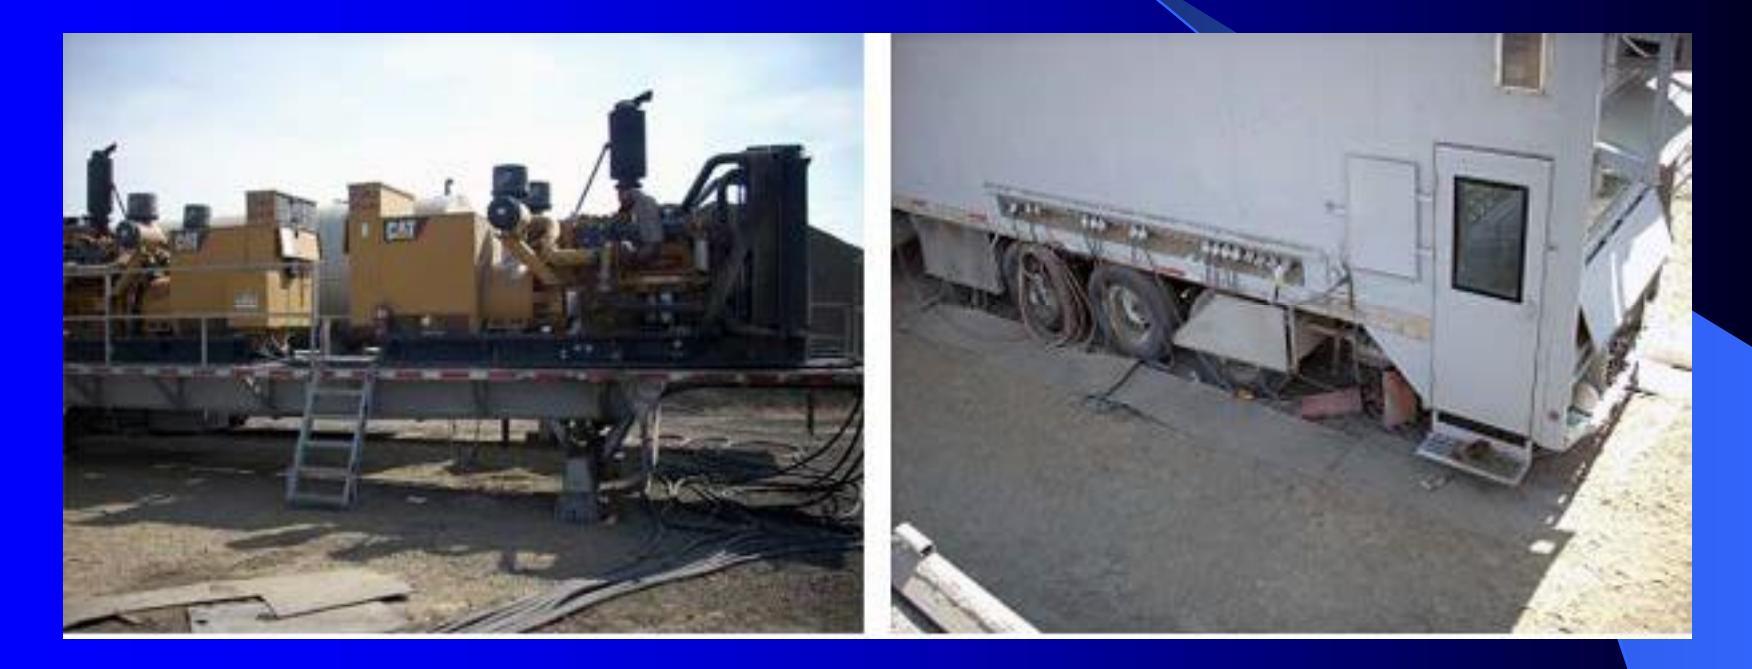
Electrical Fatality September 13, 2011

• A 38 year-old miner with 3 years of experience was killed at a portable sand and gravel operation. The victim opened the 480 volt feeder box at the motor control center and started to remove the leads when he received a fatal shock. One of two generator units was operating and supplying power to the control box.
