SAFETY ALERT: MINER SERIOUSLY INJURED **PERFORMING MAINTENANCE ON A SCREEN**

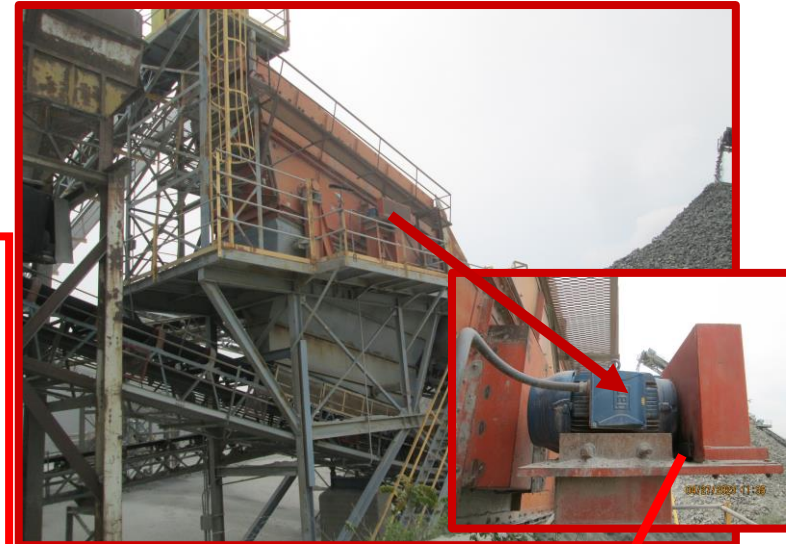
On 4/18/23, a maintenance employee with 36 weeks of mining experience was seriously injured while performing maintenance on a screen drive. The employee reached behind the guard to check the tension on the drive belt after the unit had been turned off but before it came to a complete stop and his hand became pinched between the drive belt and the pulley. The employee's injuries included a crushed finger and an open fractured finger on his left hand. The employee was in the hospital for 2 nights for surgery and recovery.

Screen with inset showing where accident occurred

- Maintenance should not be performed until machinery is de-energized, locked out, and blocked against hazardous motion. (4 VAC 25-40-350)
- Mine employees should be adequately task trained prior to performing any tasks on a mine site and training should include recognition of hazards associated with all tasks.

- Re-evaluate or establish safe work procedures for each task and review them with the miners assigned to those tasks.
- Remind miners of their responsibility to inspect their work areas prior to starting work and frequently thereafter. Unsafe conditions are to be corrected or reported to the certified mine foreman.

- Miners must be alert and remain clear of moving machinery or equipment and avoid potential pinch points that may be present.
- Review this accident and all contributing factors with all mine and contractor personnel. All employees should be aware of the position of their hands while performing repairs or maintenance on equipment. Hands should never be placed in a position where they could be crushed or pinched by the unexpected movement of tools or equipment.

- Follow the manufacturer's recommendations regarding procedures and tools to be used during equipment maintenance.

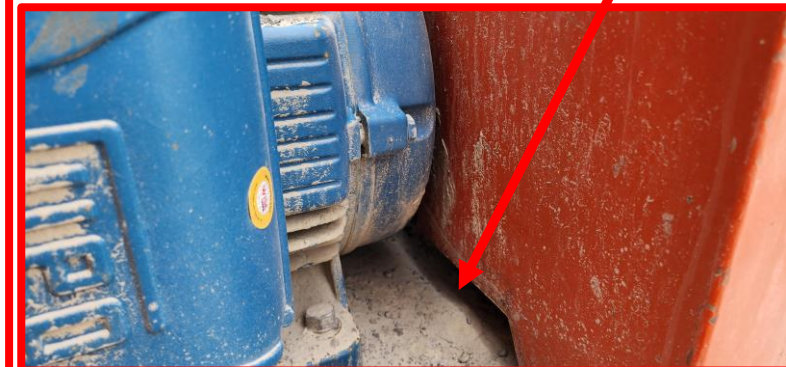
Arrow points to where miner inserted his hand
